# the construction specifier

## The Proven Durability of EPDM Roof Assemblies

by Jim D. Koontz, PE, RRC, and Thomas W. Hutchinson, CSI, AIA, FRCI, RRC, RRP

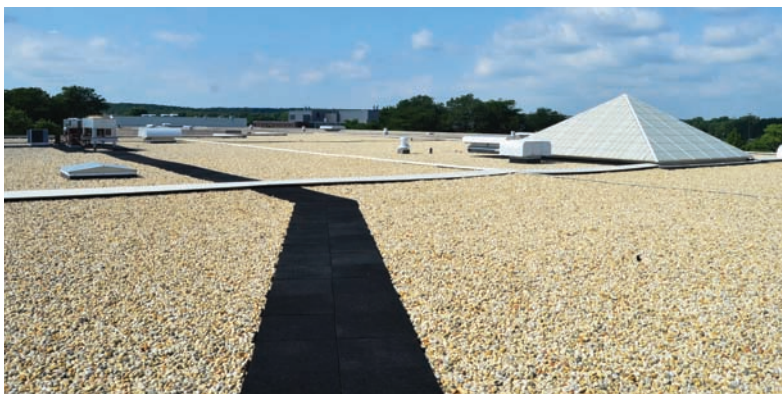
Ballasted ethylene propylene diene monomer (EPDM) systems can be energy-efficient in almost any climate because the ballast provides thermal mass, which helps minimize heat loss in the winter and solar heat gain in the summer.

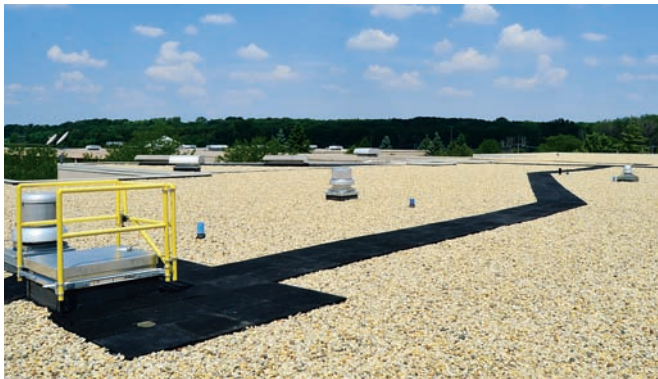
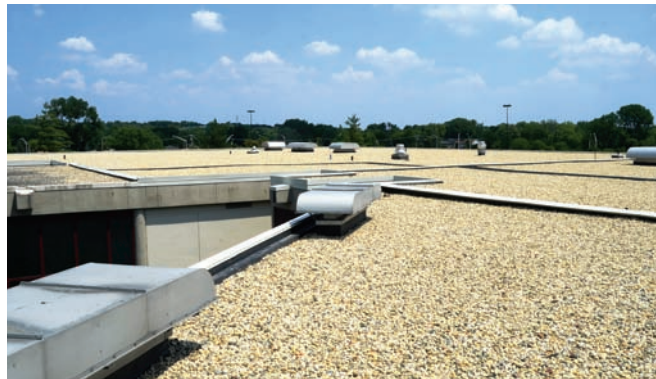
Ballasted EPDM roofing systems perform especially well in hailstorms, as the material atop the roofing membrane serves to break ice balls on impact, protecting the substrate from damage.

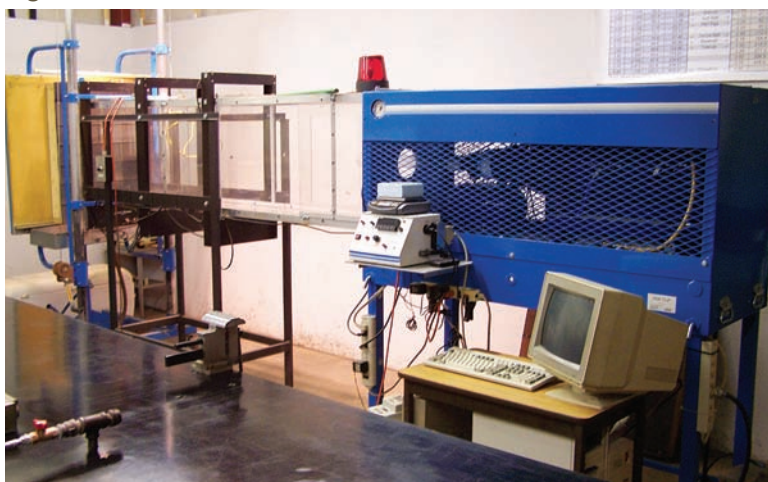
Figure 3

For the study, a hail launcher propelled ice spheres by employing the quick release of compressed air from a tank to a barrel.

A key factor in performing the test is to have reproducible impact energies with each shot of 'hailstone.' The hail gun or launcher (Figure 3)

propels ice spheres by employing the quick release of compressed air from a tank to a barrel. To achieve reproducibility, several factors have to be taken into consideration. Since consistent air pressure is required for each shot, it must be controlled to 70 Pa (0.01 psi).

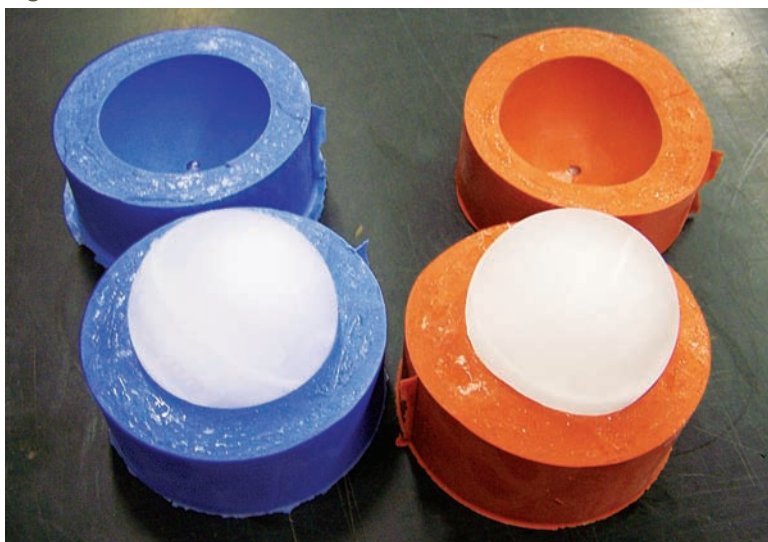
Figure 4

The 'hail' molds were fabricated using precise-diameter steel spheres.

Molds for ice spheres are fabricated using precise-diameter steel spheres (Figure 4). Each ice sphere of a given diameter is then weighed to 0.01 g before each shot. Laboratory-grade barrels or tubes with precise internal diameters are also necessary to develop consistent impact energies. Basically, the charge (*i.e.* air pressure), the quick release valve, and the bullets (*i.e.* ice spheres) require precise fabrication to achieve reproducible impact energies.

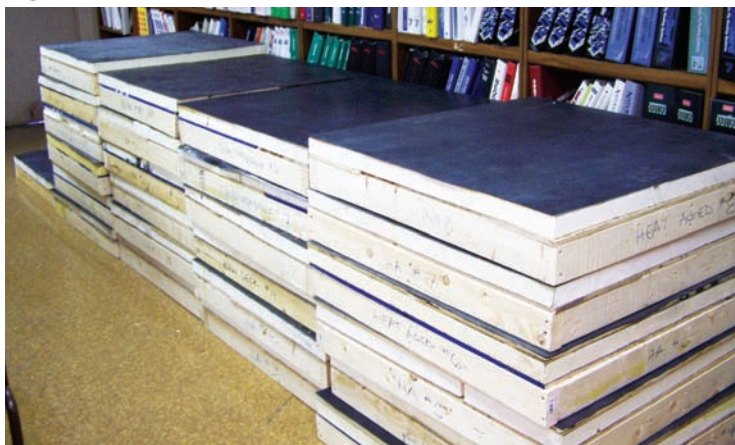
Figure 5

Manufacturers provided more than 80 targets constructed with 1524- $\mu$ m (60-mil) non-reinforced ethylene propylene diene monomer (EPDM) for impact testing.

Manufacturers provided a total of 81 test targets constructed with 1524- $\mu$ m (60-mil) non-reinforced EPDM for impact testing (Figure 5). There were 25 'new' samples and 20 samples heat-aged for 1440 hours at a temperature of 116 C (240 F) at Cascade Technical Services (Hillsboro, Oregon). The 36 samples for the field-aged/exposed category were collected from six states across the country, and they ranged in age from five to 20 years (Figure 6).

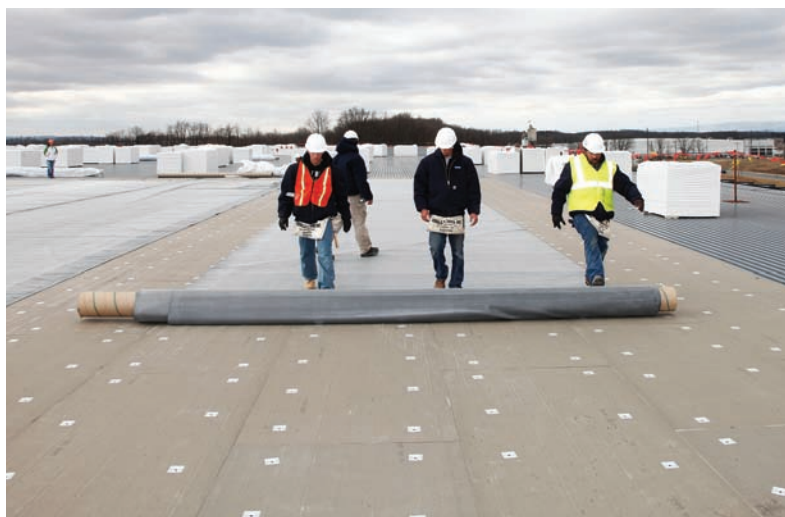
EPDM stays flexible throughout its lifecycle, providing good hail resistance even at the end of its estimated service life.
