REPAIR:
SEAM PARTIALLY DELAMINATED

NEW COATING ON EXISTING LOW SLOPE ROOFS

A-5

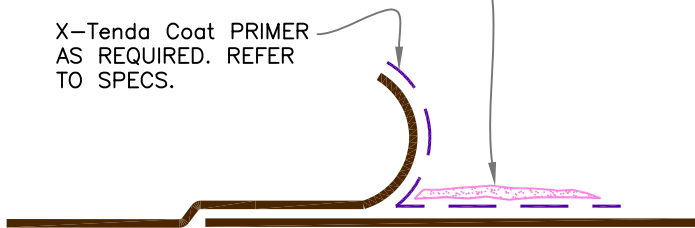
REPAIR STEP 1

USE MASTIC TO SET THE
MEMBRANE AND PRESS
DOWN

X-Tenda Coat PRIMER
AS REQUIRED. REFER
TO SPECS.

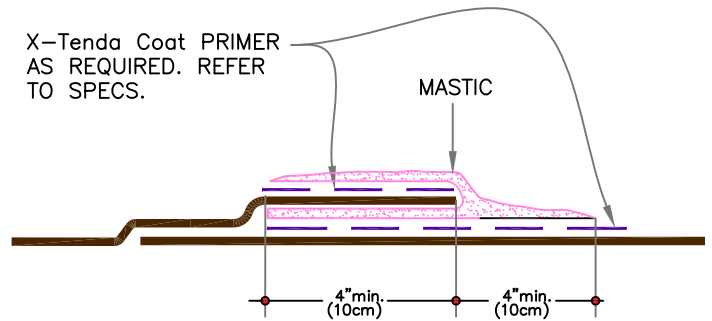
REPAIR STEP 2

X-Tenda Coat PRIMER
AS REQUIRED. REFER
TO SPECS.

MASTIC
