# COMPARATIVE PERFORMANCE OF EPDM RUBBER ROOFING MEMBRANE AS PROTECTION AGAINST HAIL DAMAGE

*By Ric Vitiello  
President*

*Forensic Roof Consulting and  
Hail Damage Assessment Training*  
[www.benchmark-services.com](http://www.benchmark-services.com)

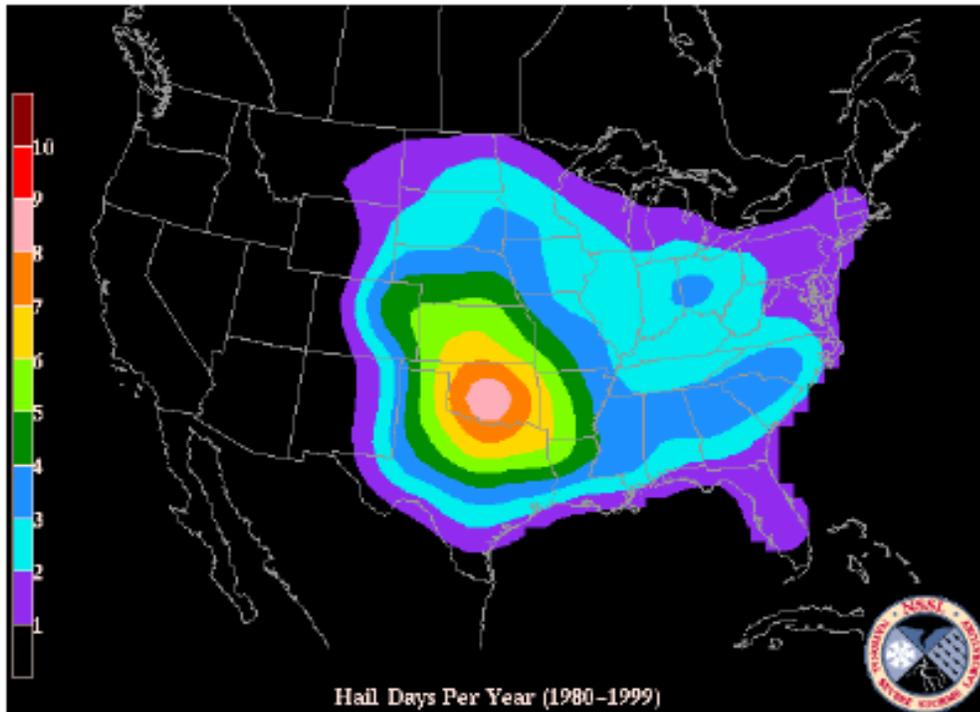
Figure 1. Average number of days per year where hail greater than or equal to 0.75" in diameter may occur within 25 miles of any point in the United States base upon NWS reports for the years 1980 to 1999 (source: DOC/NOAA/National Severe Storms Laboratory).

The “hail belt” area of the United States, the region most susceptible to hailstorms, appears to be getting larger, according to research from the National Oceanic and Atmospheric Administration’s (NOAA) National Severe Storms Laboratory. Areas of the country that were not particularly vulnerable to hailstorms now seem to be receiving hail fall and areas that regularly received hailstorms are seeing more storms with larger hail. The map in figure 1 below shows sections of the Midwest and the East that are particularly prone to receiving hailfall greater than  $\frac{3}{4}$  inch in diameter. This is the size that is generally considered the minimum threshold for property damage.

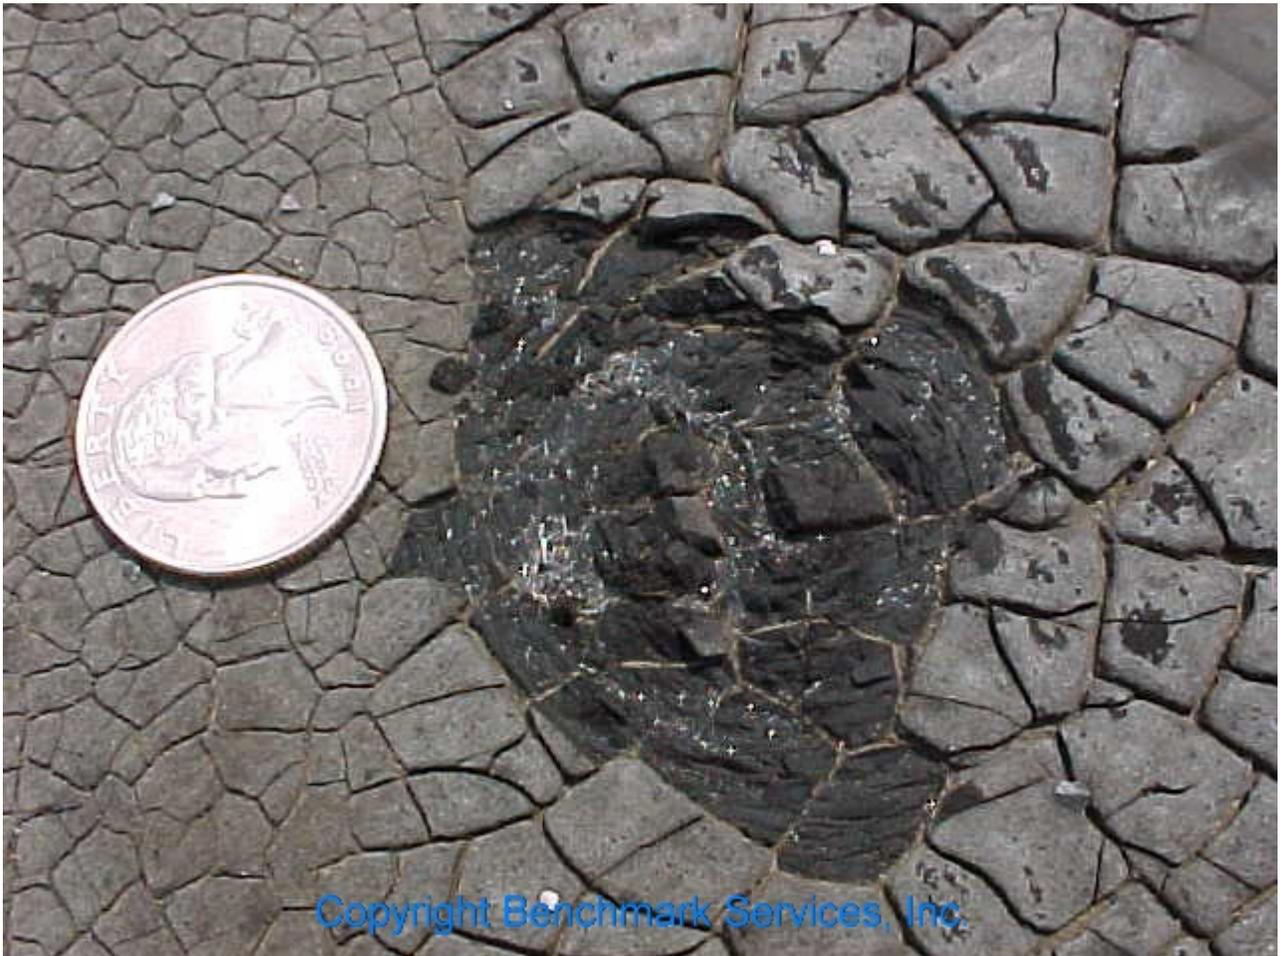
**Figure 2 - Built -up roof damaged by 1 1/2" hail**

Smooth surfaced or gravel, the result is the same. The asphalt or pitch is displaced or cracked at the surface and the fiberglass felt may be fractured allowing water infiltration and the beginnings of premature deterioration. Water infiltration into the insulation may spread and what begins as a small puncture may become a large repair. Multiple hail blemishes may require tear-off and re-roof as the only practical remedy. The photo in figure 2 below shows a hail impact fracture on a smooth surfaced asphalt built up roof.

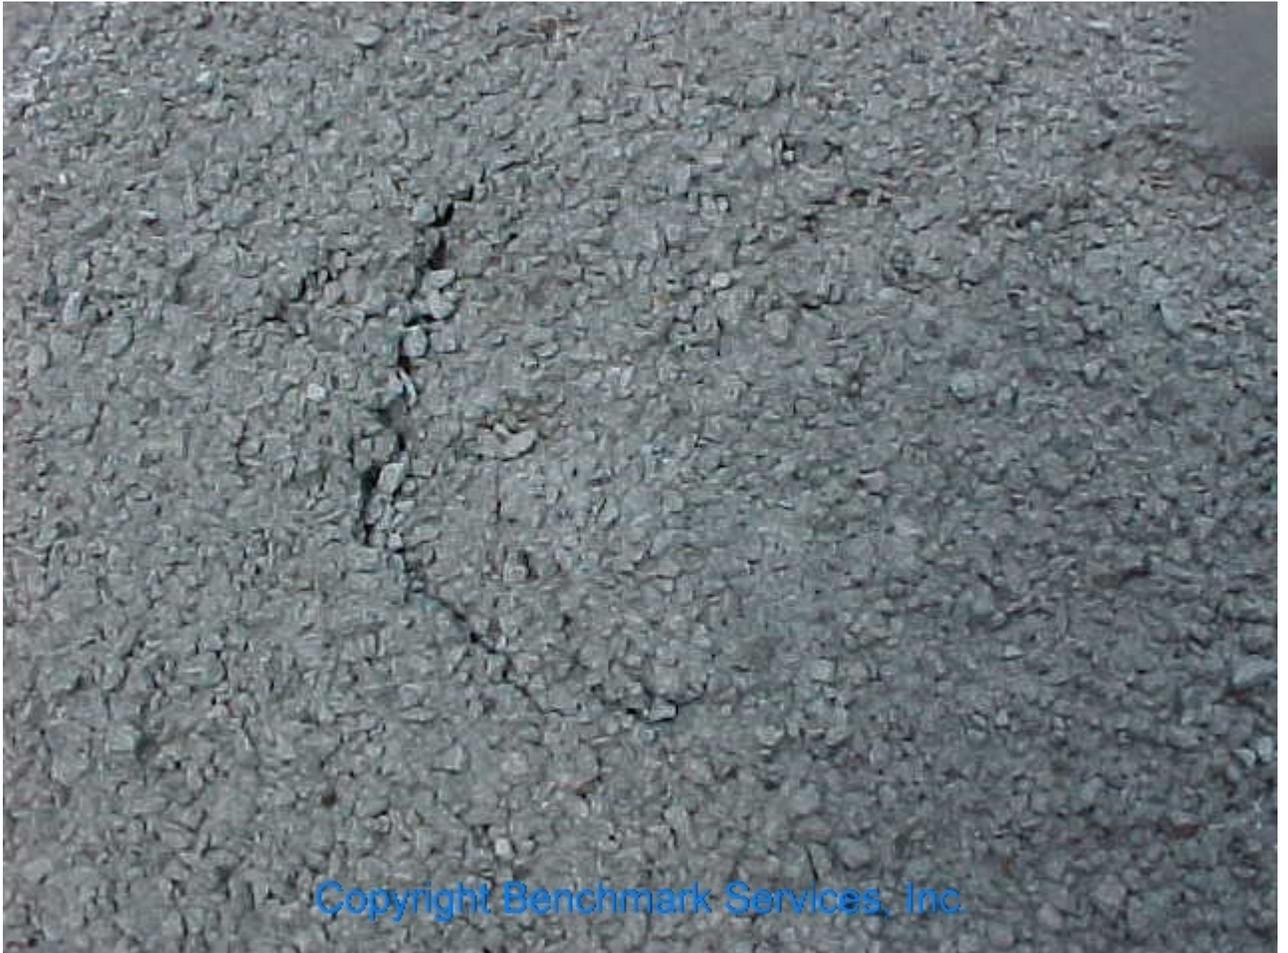
**Figure 3 - Hail Damaged granule surfaced SPUF Roof**

SPUF (Sprayed Polyurethane Foam) roofs are popular in some areas where hailstorms are becoming more frequent. Although the foam is closed cell and may not leak immediately after damage by hail, the required repairs to this type of roof can be very costly and the fractures can be particularly difficult to find on some of the newer granule surfaced systems. Hail damage on these roofs can be repaired unless the number of hail fractures is very large which then may require tear-off and re-roof or at least scarifying of the surface and re-coating. The photo in figure 3 reveals a fracture of the SPUF coating caused by hail impact approximately 1 1/2 inch in diameter.

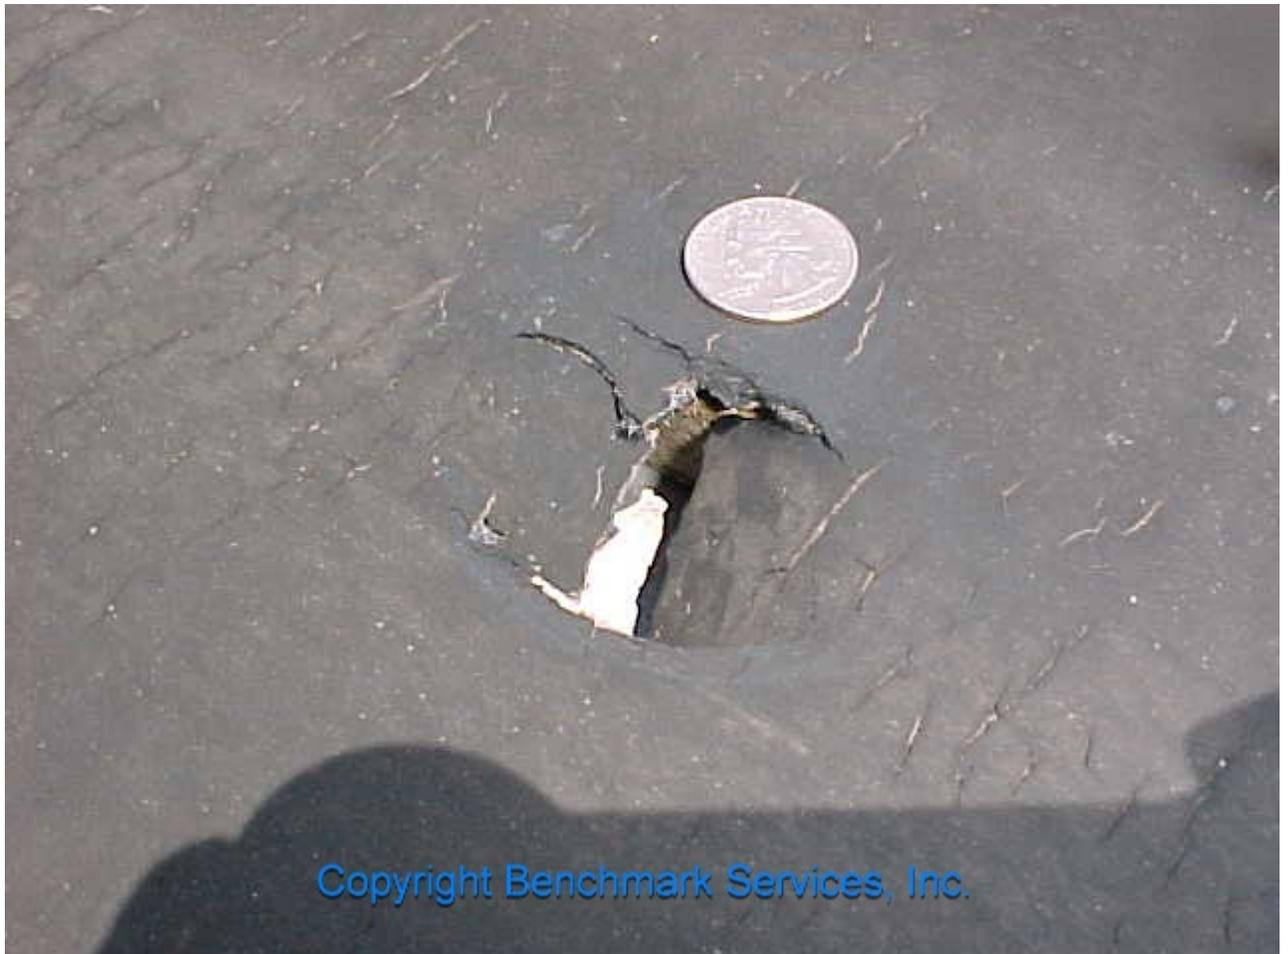
**Figure 4 - APP Modified Bitumen Punctured By Hail**

Modified bitumen systems are typically more hail resistant than smooth surface built up roofs but other factors come into play. The APP membrane is modified with a plastic and so is less flexible than rubber. This makes it somewhat vulnerable to fracture by hail. The SBS membrane is modified with a type of rubber that is vulnerable to ultraviolet degradation which the sun will deteriorate in short order.

Because of this, the membrane is protected by a granule surface. This granule surfacing may be displaced by hail impact and even though the membrane is not fractured, it would require replacement due to the granule displacement. Both APP and SBS membrane systems can be damaged by hail impact since they are still asphaltic products. The photos in figures 4 and 5 show an unsupported area on a smooth surfaced APP membrane and an SBS granule surfaced membrane. Both were damaged by approximately 1 ½ inch diameter hail.

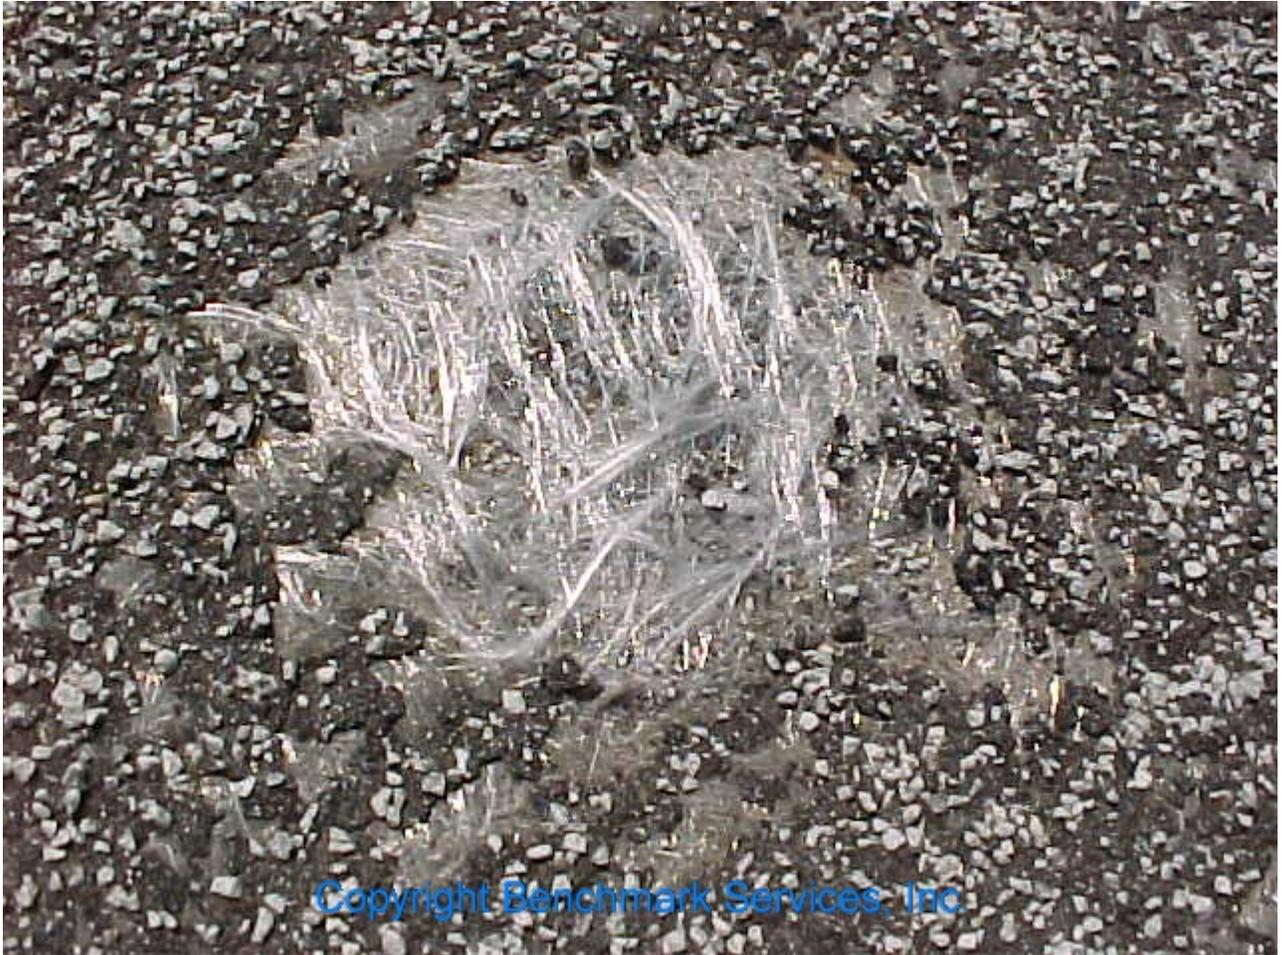
**Figure 5 - SBS Modified Bitumen Roof Granule Displacement Caused By Hail**

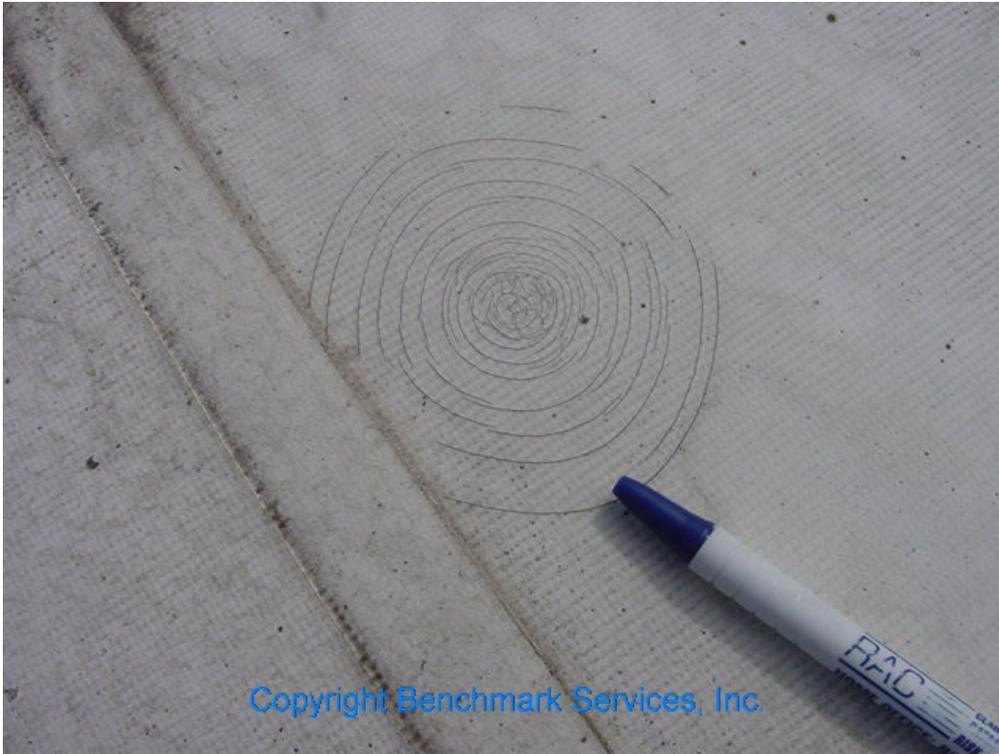
**Figure 6 - Reinforced PVC Membrane Hail Fractured**

The type of plasticizer used can make a great difference in whether the membrane becomes brittle as it ages and then more vulnerable to hail damage. PVC membrane is typically reinforced with a polyester fabric but some of the older types were not. The following photos in figures 6 and 7 show PVC roofs that have been impacted by  $\frac{3}{4}$  inch to  $1\frac{1}{2}$  inch hail. The first is reinforced and the second is not. The circular fractures eventually transfer through the membrane and develop into leaks.

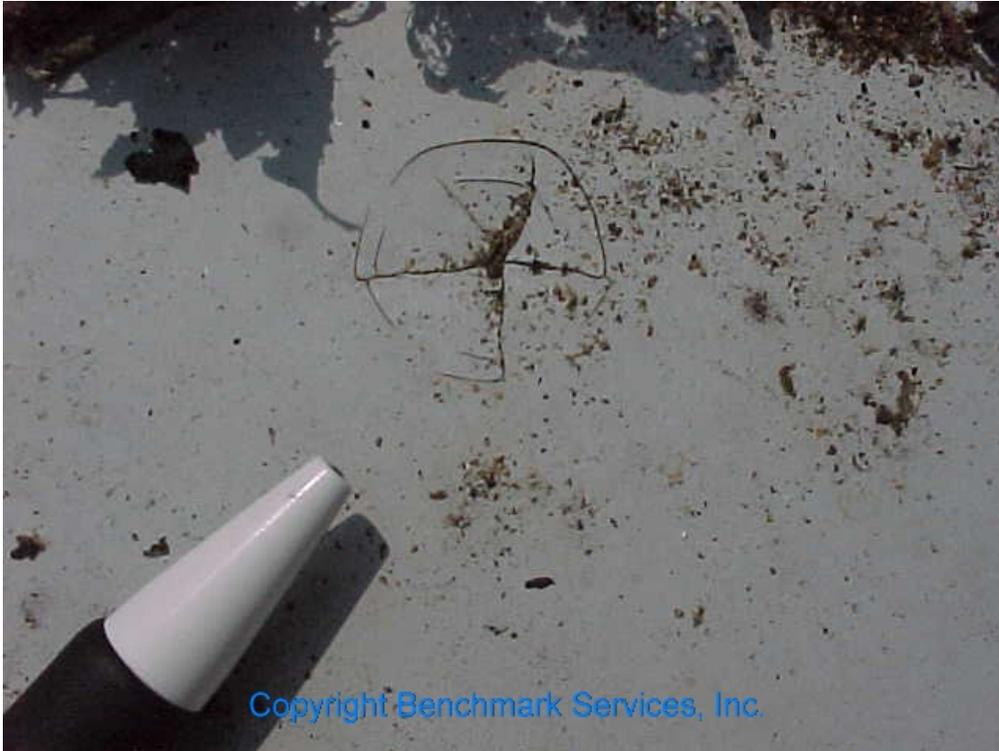
**Figure 7 - Non-Reinforced PVC Membrane Damaged By Small Hail**

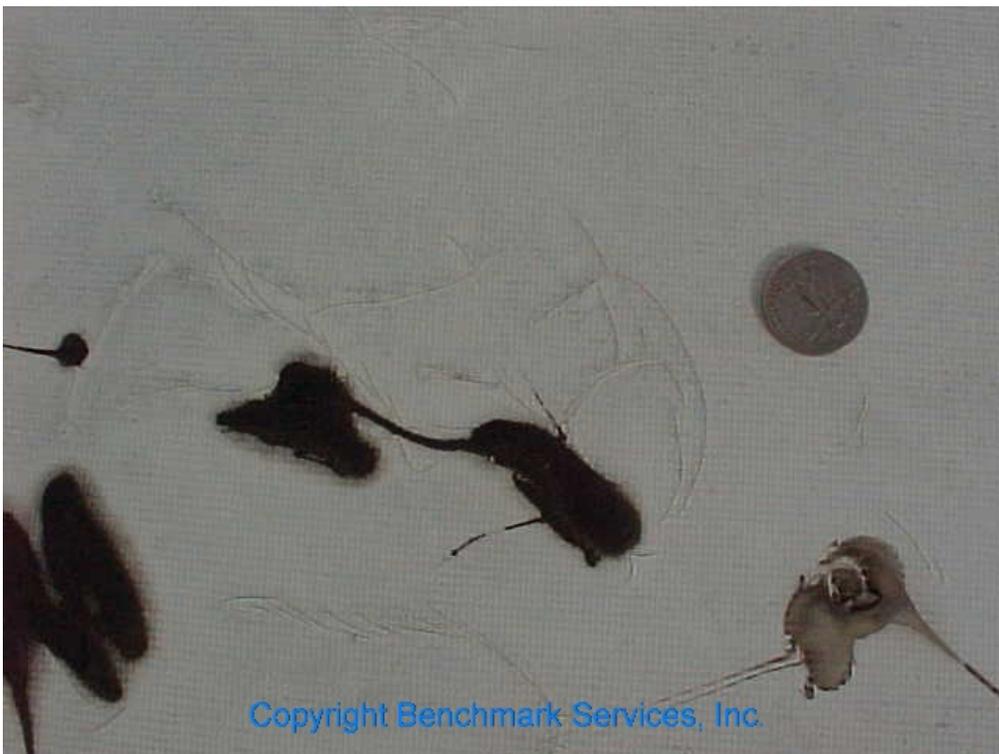
**Figure 8 - Hail Damaged Reinforced PVC Membrane, Temporary Caulk Repairs**

The last two photos in this series are figures 8 and 9. They show a PVC roof approximately three years after a hailstorm. Repeated repairs were done with various types of surface caulking until the owner finally realized that it would not be possible to seal all of the hail fractures that continued to open up and leak.

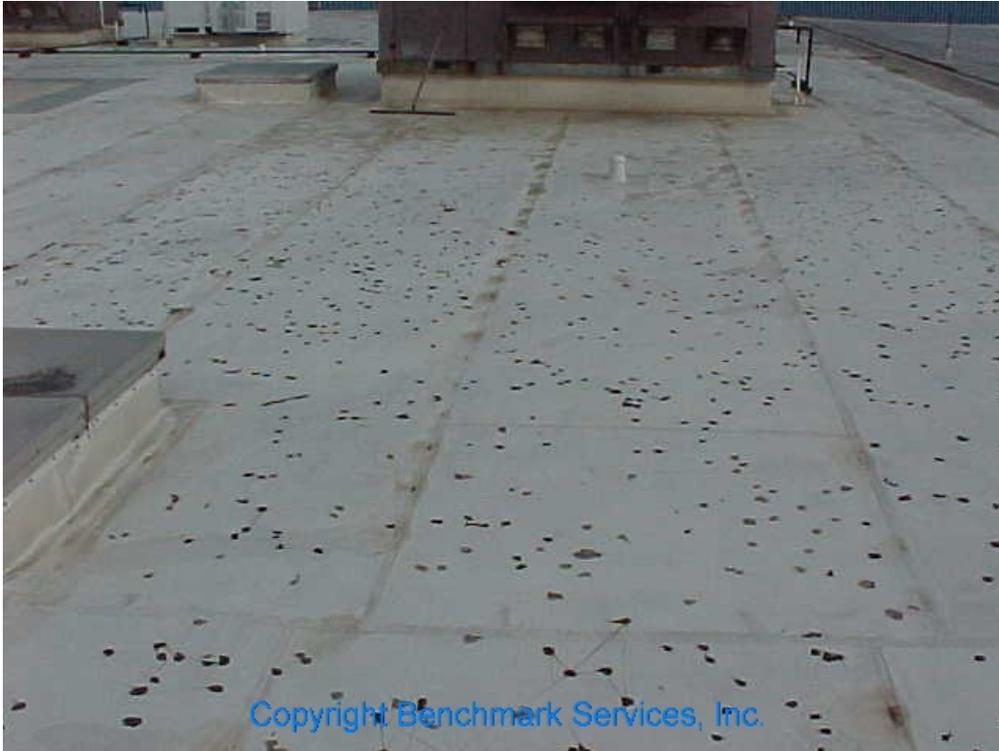
**Figure 9 – Hail Damaged PVC Membrane With Thousands Of Temporary Caulk Repairs**

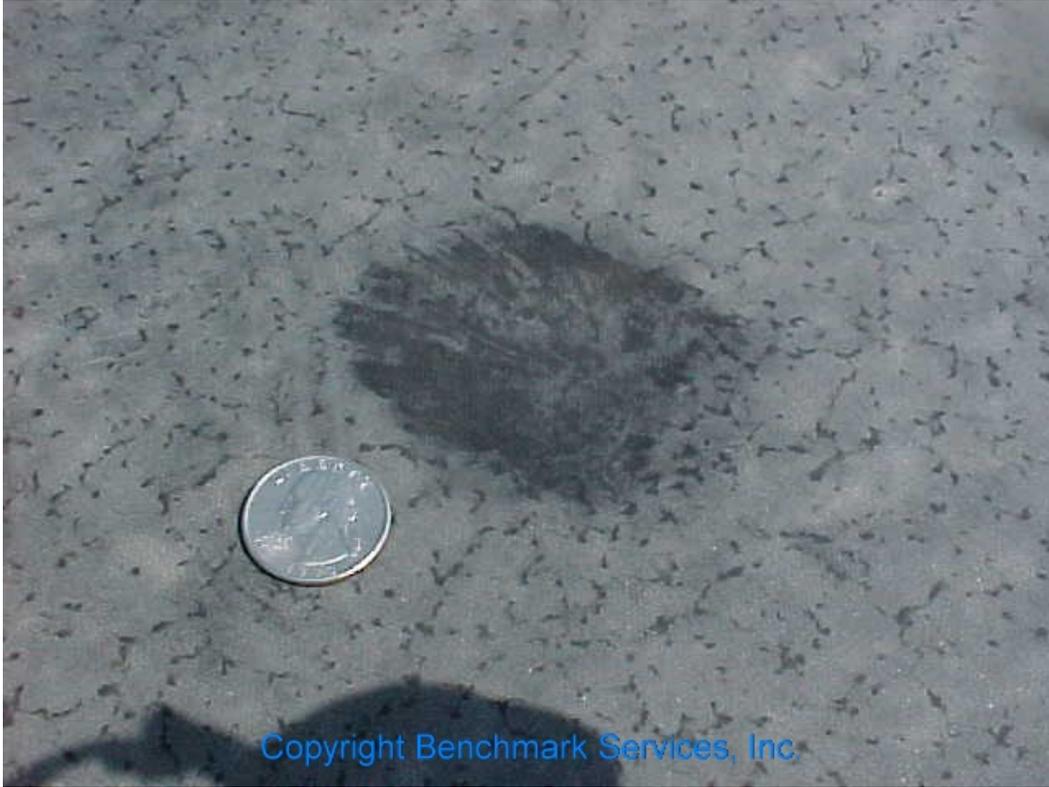
Figure 10 - EPDM Membrane Impacted by 2 1/2" Hail, No Membrane Damage

EPDM roof membrane provides benefits similar to some other popular membranes like low installation cost, low life cycle, maintenance and repair costs, quick installation and it can even be coated with white acrylic coating to improve its energy efficiency.\* In addition to all of the typical benefits of a high quality roof membrane, EPDM can be installed in such a way to allow for a 30 year warranty against hail damage. The photos below in figures 10 and 11 show EPDM roofs that have been impacted by hail as large as 2½ inches in diameter with no resulting membrane damage, and therefore no leaks.

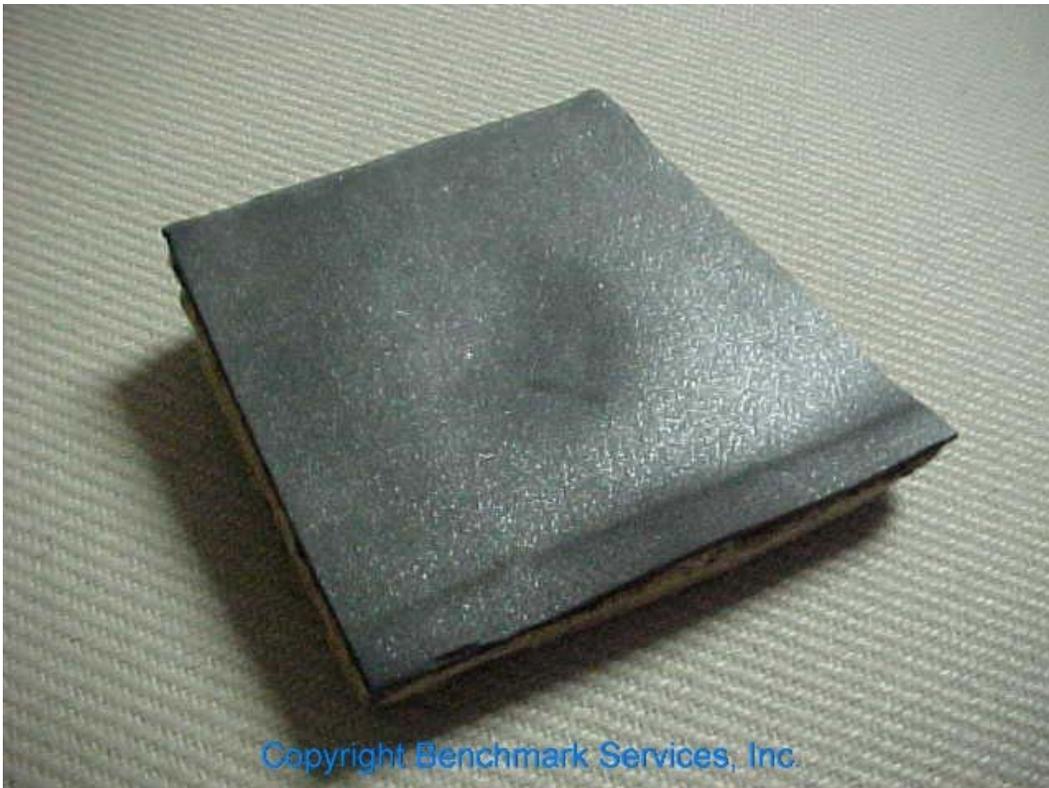
Figure 11 - EPDM Fully Adhered To Fiberboard Insulation, No Membrane Damage
