HAIL IMPACT TESTING OF EPDM ROOFS ASSEMBLIES

Jim D. Koontz, PE, RRC
Thomas W. Hutchinson, AIA, CSI, FRCI, RRC

RCI 24th International Convention & Trade Show
March 12 - 17, 2009
Dallas, Texas

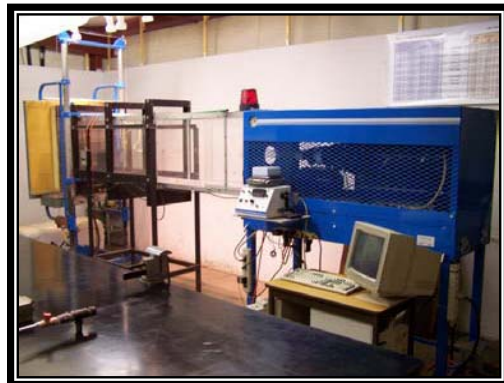
The Canadians, UL and FMG use steel darts to impact targets, typically at room temperature. Other organizations such as ASTM have developed impact tests that use steel darts, ASTM D 3746⁵. Within the last few years, greater consideration has been given to impacting targets with ice spheres. Prior research by Jim Koontz and Associates, Inc. (JKA)⁶ has also reviewed the issue of ice spheres versus steel darts. The use of ice spheres, obviously, comes closer to replicating what occurs during a real hailstorm event.

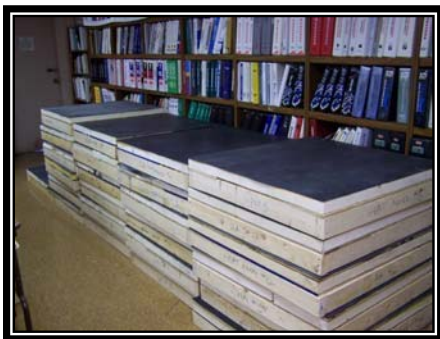
Carlisle and Firestone provided a total of eighty-one test targets constructed with 60-mil non-reinforced EPDM for impact testing. The new, heat aged and field aged targets listed in **Table C** included:
