FleeceBACK® EPDM
Roofing Systems

CASE STUDY

**Carlisle & Clarkson University:
Whipping Students into Shape**

CLARKSON UNIVERSITY – POTSDAM, NY

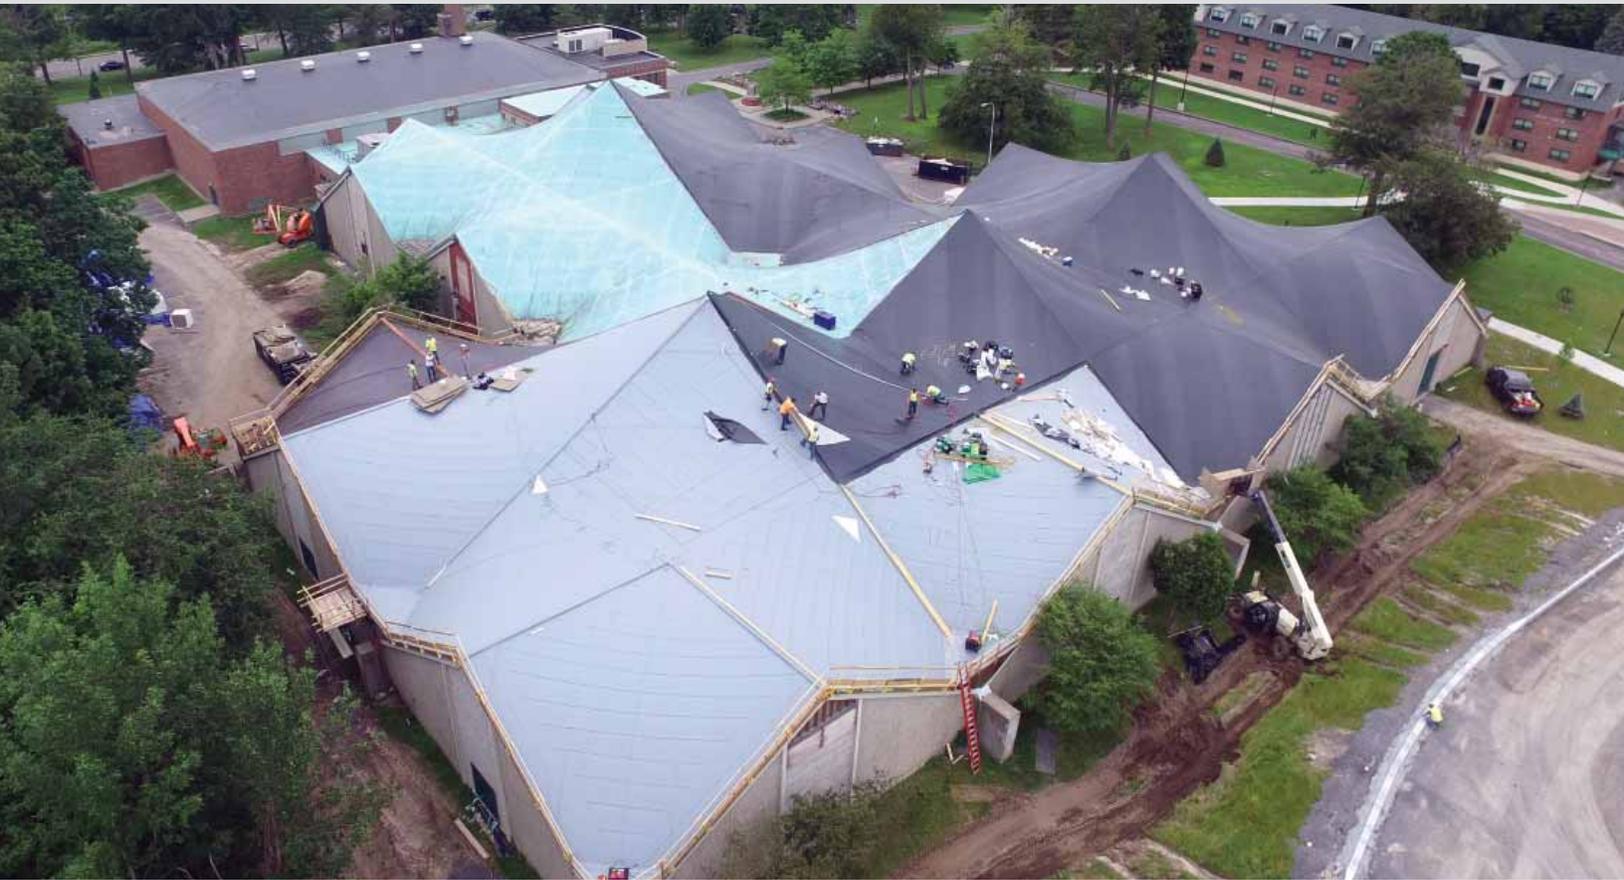
By May 2017, the Indoor Recreation Center was in need of a complete reroof, due to severe rooftop discoloration and multiple roof leaks throughout the facility. Clarkson University chose to work with LaBella Associates of Rochester, New York to design the new roofing system for this unique structure. One of the design challenges with this building was the structure of the rooftop itself, which was a 66,300-square-foot hyperbolic paraboloid.

Because of this unique structure, the rooftop material chosen for this re-roofing project needed to be flexible, while also being durable and energy-efficient to protect the building and those inside from the extreme northern winters. With all of these elements in mind, a one-of-a-kind roofing system manufactured by Carlisle SynTec Systems was chosen: Carlisle's FleeceBACK EPDM fully adhered roofing membrane.

The first step in this installation was tearing off the existing roofing membrane and installing new perimeter wood blocking around the existing wood deck. The installation crew from RSI Roofing then installed Carlisle's 725TR vapor barrier directly to the wood deck using CCW-702 LV Primer.

The next step was to mechanically install two layers of 2.6-inch polyiso insulation, followed by a half-inch layer of Carlisle's SecurShield™ HD cover board, using metal fasteners and plates.

Finally, the rooftop was ready for the new membrane. The installation crew applied a full spray of Carlisle's FAST adhesive to the cover board, and then rolled out the 115-mil FleeceBACK EPDM membrane. The use of FAST adhesive added thermal efficiency to this already energy-efficient system for even greater environmental protection and reduced energy costs for Clarkson University. RSI used the Patriot Jr. machine to apply the FAST adhesive to increase productivity.

Once the membrane was in place, RSI added the finishing touch to this unique design by installation perimeter sheet metal with new gutters and downspouts. The entire rooftop installation took exactly three months and was completed in August 2017, just in time for returning students.
