WALL BASE FLASHING (BRIDGING CONDITION) - STEP I

DETAIL EPDM ROOF RESTORATION

FLASHING WITH BATTEN
ATTACHMENT - PAGE 1 OF 3. (SEE 5.2.2
& 5.2.3 FOR 3D VIEWS.

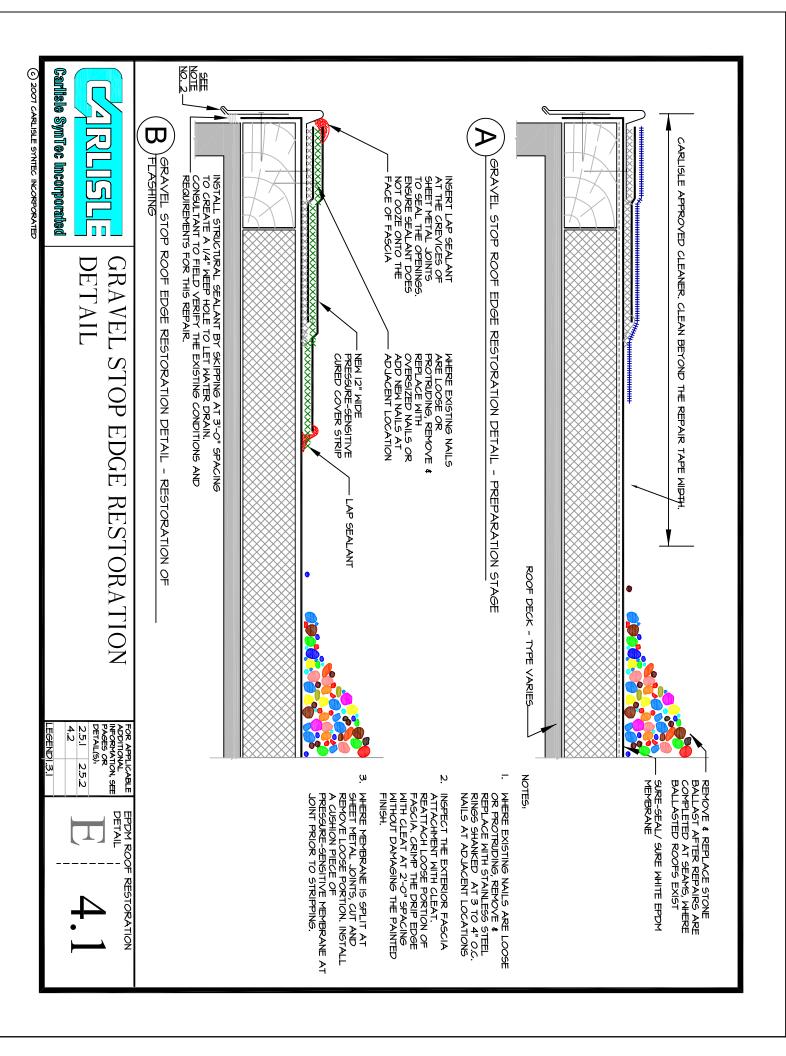
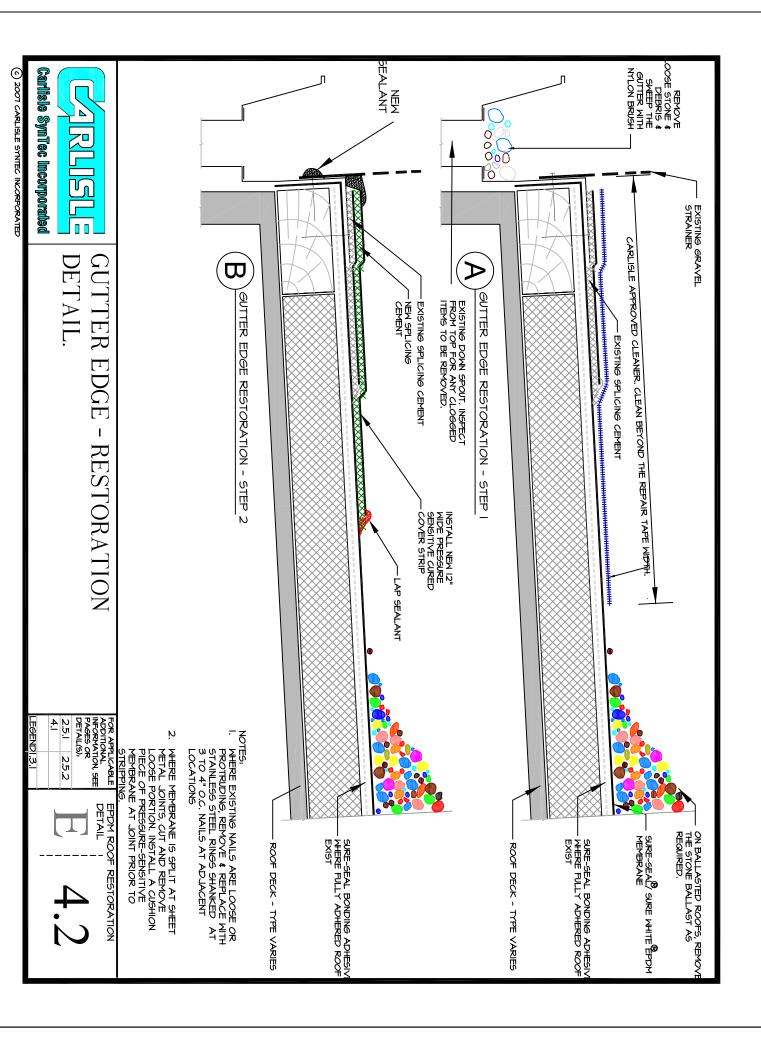
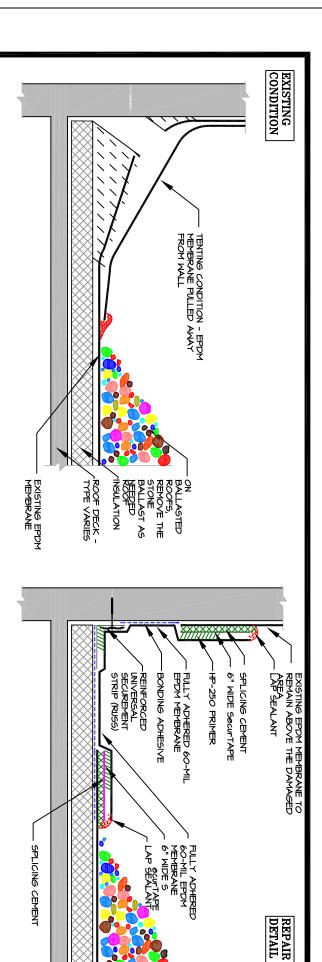
VERTICAL TRANSITIONS OR RISING FLASHING TENTING CONDITION AT

- FOLLOWING ARE LIMITED OUTLINE NOTES TO REPAIR ABOVE AREAS. REFER TO CARLISLE SPECIFICATION FOR MEANS AND METHOD TO MAKE REPAIRS.
- INSPECT EXISTING BASE FLASHING AT RISING WALL AND MARK AREAS WHERE MEMBRANE IS STRETCHED OR UNBONDED FROM THE CORNER. REINFORCED UNIVERSAL SECURMENT STRIP (RUSS) OR WALL
- 'n REMOVE STONE ON BALLASTED ROOF AREAS AS NEEDED.
 CAREFULLY INSPECT FOR CUTS, HOLES, PUNCTURES OR SIMILAR
 CONDITIONS PRIOR TO RINSING THE MEMBRANE. AT SUCH CONDITIONS, INSTALL A TEMPORARY PATCH.
- WITHIN DEFICIENT AREA, CLEAN THE RECEIVING AREA PRIOR TO CUTTING OF MEMBRANE TO KEEP THE INSULATION DRY. CLEAN WITH CARLISLE'S SPECIFIED CLEANING SOLUTION AND THOROUGHLY CLEAN WITH WARM WATER TO RINSE AFTER CLEANING.

WALL BASE FLASHING (BRIDGING CONDITION) - STEP 2

Ġ, INSPECT FOR THE PRESENCE OF MOISTURE AT EXPOSED OUT IN INSULATION AREAS AND REPLACE WET INSULATION TO MATCH IN KIND & THICKNESS WITH EXISTING.

CUT OUT THE SLACKED OR TENTED PORTION OF MEMBRANE.

- .1 CLEAN THE ENTIRE BASE FLASHING AT RECEIVING AREAS
- ò APPLY PRIMER AND 6" WIDE SECURTAPE
- 9. INSTALL NEW EPDM MEMBRANE FLASHING
- IO. ROLL THE SPLICE WITH A 2" WIDE STEEL ROLLER AND APPLY LAP SEALANT.

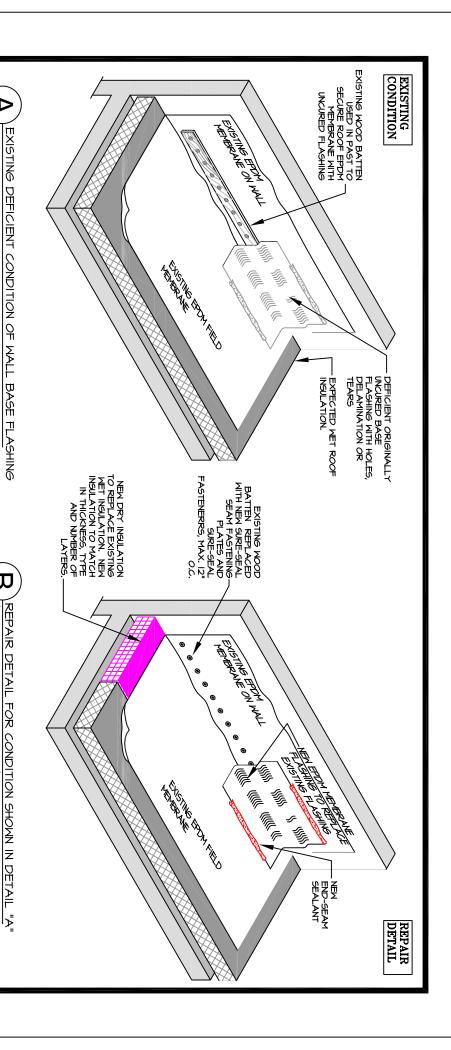
3-D VIEW OF DETAIL 5.2.1 'A' & 'B'

WITH WOOD BATTEN

(PARTIAL OR SPOT REPAIR)

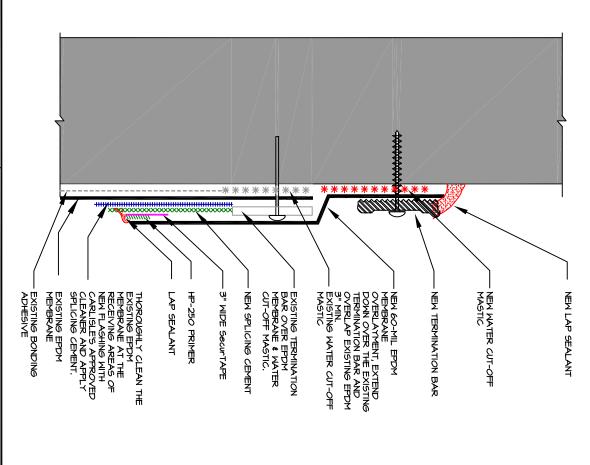
TERMINATION BAR RESTORATION OF FLASHING AT

- PRIOR TO ANY WORK, COORDINATE WITH THE OWNER TO DISCOVER ANY LEAKS OR HISTORY OF LEAKS AT AREAS BELOW. IF LEAK(S) EXISTS, DO NOT INSTALL THIS FLASHING AND CONDUCT A THOROUGH INSPECTION TO VERIFY THE CAUSES OF LEAKS. INSTALLATION OF THIS DETAIL MAY WORSEN THE LEAK CONDITION IF EXISTING CONDITIONS ARE NOT COMPLETELY ANALYZED.
- IF NO LEAKS EXIST, THEN INSPECT THE EXISTING CONDITIONS OF THE FLASHING AND LOOK FOR THE FOLLOWING ITEMS:

IDENTIFY THE TYPE OF SUBSTRATE WALL AND ITS CONSTRUCTION

UNDERSTAND THE EXISTING INSTALLATION DETAIL ¢ ITS DRAINAGE

- ? ENSURE THERE ARE NO WEEP HOLES ABOVE THE TOP OF TERMINATION BAR AREA THAT SHOULD NOT BE COVERED WITH NEW FLASHING (PARTICULARLY WHERE STEEP SLOPED ROOF EXIST AND MASONRY THROUGH WALL FLASHING IS BUILT IN STEPS), AVOID COVERING WEEPS IN THIS CONDITION ALSO.

- ٩ IF THERE ARE HAIRLINE CRACKS, OPEN JOINTS OF WALL SYSTEMS, OPEN HEAD JOINTS IN MASONRY, OR SIMILAR CONDITIONS THAT MAY HELP THE MIGRATION OF WATER, COORDINATE WITH THE CONSULTANT TO RESOLVE THESE ISSUES PRIOR TO INSTALLATION OF REMEDIAL

- Ġ VERTICALLY STAGGER NEW NAILING PATTERN WITH EXISTING TO AVOID SECUREMENT IN THE SAME AREA). DEVELOPMENT OF CRACKS IN THE SUBSTRATE (DUE TO ADDITIONAL

- VERIFY IF THERE ARE LOOSE NAILS/SCREWS WHICH ARE PROTRUDING AND RESET THEM PRIOR TO NEW FLASHING INSTALLATION.
- 'n AT THE JUNCTION OF PARAPET & RISING WALLS, COORDINATE WITH CONSULTANT TO RESOLVE THE UNSIGHTLY APPEARANCE OF NEW FLASHING ABOVE PARAPET WALL.

- AT EXPANSION JOINTS, SEALANT TO BE REPAIRED/REPLACED BY OTHERS
- ৸ ENSURE SUBSTRATE IS DRY, SMOOTH & STRUCTURALLY SOUND. WHERE COMMON GRADE BRICKS ARE SPALLING OR DETERIORATED TO UNACCEPTABLE LEVEL, THERE REPLACE COMMON GRADE BRICKS WITH NEW SM-GRADE (SEVERE MEATHER GRADE) BRICKS. THE MASONRY MUST BE REPLACED BY OTHERS TO ACHIEVE A SOUND SUBSTRATE.
