GUTTER WITH METAL BAR EDGE TERMINATION

MRI T1.4

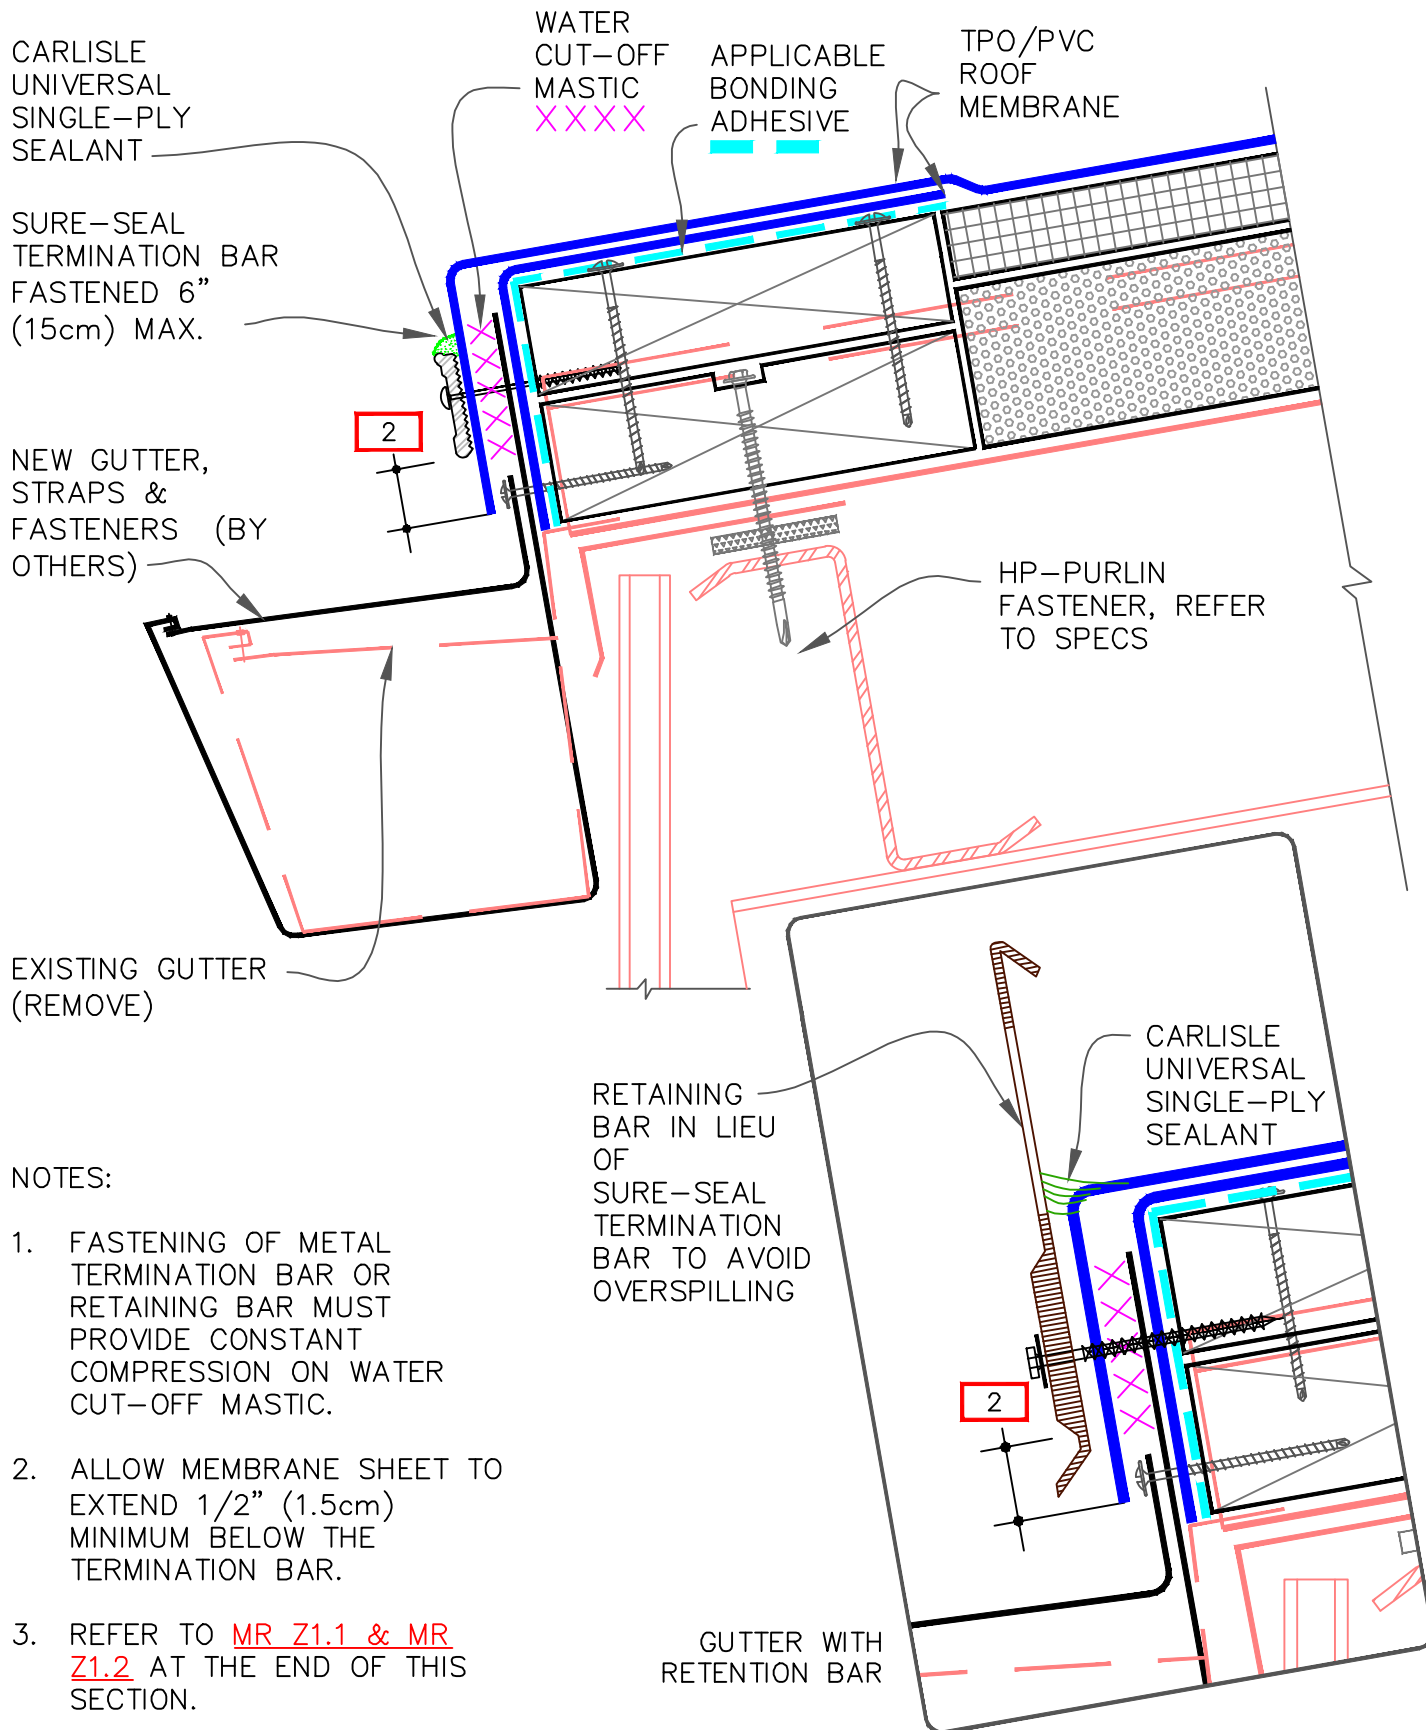
POLYISOCYANURATE INSULATION

ROOF MEMBRANE

IN-FILL INSULATION

WOOD NAILER (BY OTHERS)
