X-TENDA COAT™

COATING SYSTEM

Restoration Coatings

July 2024

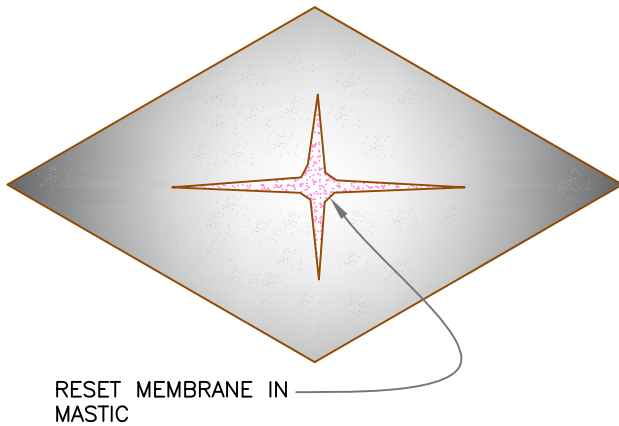
1. IDENTIFY BLISTERS AND WRINKLES IN THE FIELD AND MARK THEM WITH PAINT OR CRAYON.
2. MAKE A CROSS CUT WITHIN BLISTERED SURFACE & LIFT UP THE EDGES TO RELEASE THE AIR & MOISTURE. TRIM EDGES AS NEEDED.
3. REMOVE DEBRIS AND THOROUGHLY CLEAN THE BLISTERED AREA. ENSURE SURFACE IS DRY. PRIME SURFACES AS REQUIRED, REFER TO SPECS.
4. APPLY X-Tenda Coat MASTIC WITHIN THE CUT AREA. PUSH MASTIC UNDER THE LIFTED EDGES AND COMPLETELY EMBED ALL FOUR EDGES.

<p>VERSICO ROOFING SYSTEMS</p>	REPAIR – METHOD A (MASTIC): BLISTERS / WRINKLES	X-Tenda Coat
	NEW COATING ON EXISTING LOW SLOPE ROOFS	XCR-2E
	For additional information, refer to Specifications	
<p>— X-Tenda Coat COATING</p> <p>— X-Tenda Coat PRIMER</p> <p>~ REINFORCEMENT</p> <p>••••• X-Tenda Coat MASTIC</p> <p>0 NOTE(S)</p>

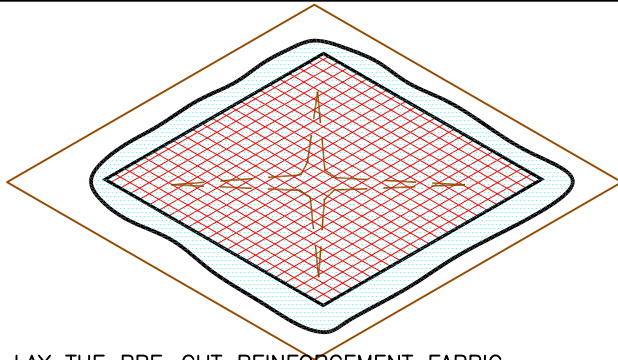
1. IDENTIFY BLISTERS AND WRINKLES IN THE FIELD AND MARK THEM WITH PAINT OR CRAYON.
2. MAKE A CROSS CUT WITHIN BLISTERED SURFACE & LIFT UP THE EDGES TO RELEASE THE AIR & MOISTURE. TRIM EDGES AS NEEDED.
3. REMOVE DEBRIS AND THOROUGHLY CLEAN THE BLISTERED AREA. ENSURE SURFACE IS DRY. PRIME SURFACES AS REQUIRED, REFER TO SPECS.
4. APPLY X-Tenda Coat MASTIC WITHIN THE CUT AREA. PUSH MASTIC UNDER THE LIFTED EDGES AND COMPLETELY EMBED ALL FOUR EDGES.

5. RESET MEMBRANE IN MASTIC

6. CUT REINFORCEMENT FABRIC TO COVER THE AREA. FABRIC SHALL EXTEND MIN. 2" (5cm) BEYOND THE CROSS-CUT LIMITS.

7. APPLY LAYER OF COATING MIN. 2" (5cm) BEYOND THE DIMENSIONS OF PRE-CUT REINFORCEMENT FABRIC.

8. LAY THE PRE-CUT REINFORCEMENT FABRIC, CENTRALLY ALIGNED OVER BLISTER REPAIR. EMBED FABRIC IN BOTTOM COATING.

9. APPLY THE UPPER COATING A MIN. 2" (5cm) BEYOND THE WIDTH OF REINFORCING FABRIC.

<p>VERSICO ROOFING SYSTEMS</p> <p>— X-Tenda Coat COATING — X-Tenda Coat PRIMER — REINFORCEMENT</p> <p>— X-Tenda Coat MASTIC</p> <p>0 NOTE(S)</p>	REPAIR – METHOD B: (REINFORCING FABRIC) BLISTERS/WRINKLES	X-Tenda Coat
	NEW COATING ON EXISTING LOW SLOPE ROOFS	XCR-12
	For additional information, refer to Specifications
