# **X-TENDA COAT™**

## Coating System

### **Restoration Coatings**

July 2024

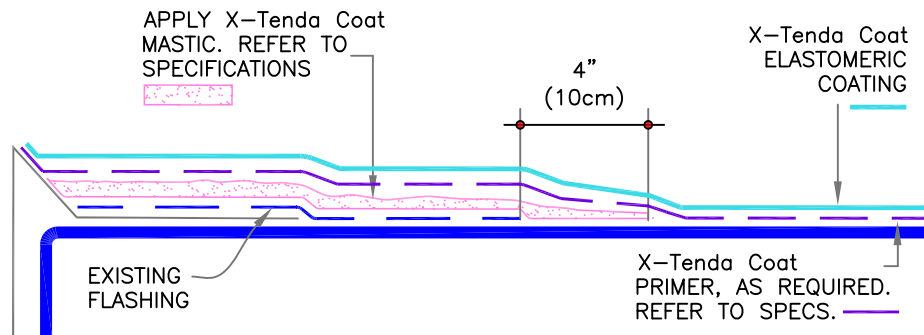
METHOD A: MASTIC APPLICATION

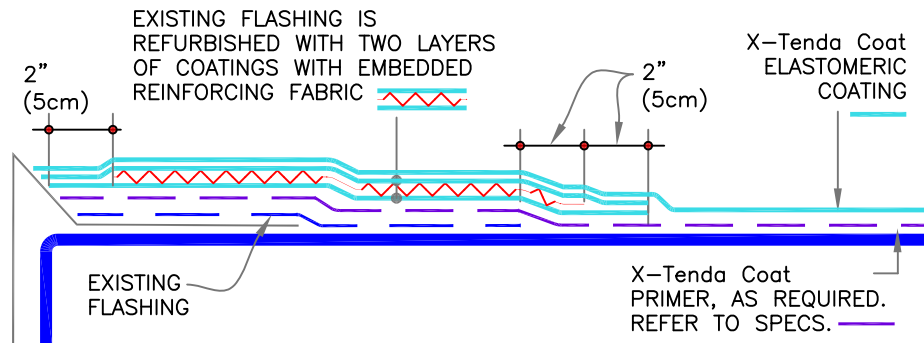
METHOD B: COATING WITH FABRIC

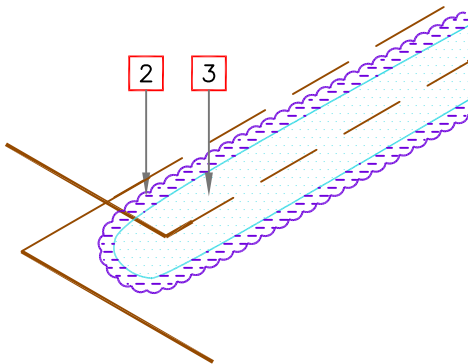
## STEP 1:

1. THOROUGHLY CLEAN THE REPAIR AREA.
2. APPLY X-Tenda Coat PRIMER AS REQUIRED. REFER TO SPECS.
3. APPLY LAYER OF COATING 2" (5cm) MIN. BEYOND THE WIDTH OF REINFORCING FABRIC.

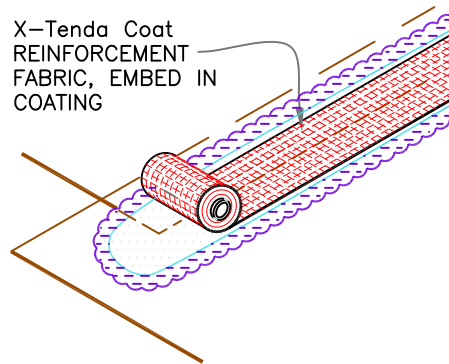
## STEP 2:

1. IMMEDIATELY, LAY THE X-Tenda Coat REINFORCEMENT FABRIC, CENTRALLY ALIGNED AT SEAM EDGE.
2. COMPLETELY SOAK AND EMBED THE FABRIC IN COATING.

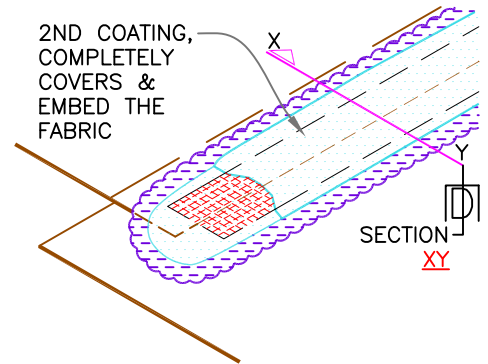
## STEP 3:

1. IMMEDIATELY, APPLY A 2ND LAYER OF COATING COMPLETELY COVERING THE REINFORCEMENT FABRIC.

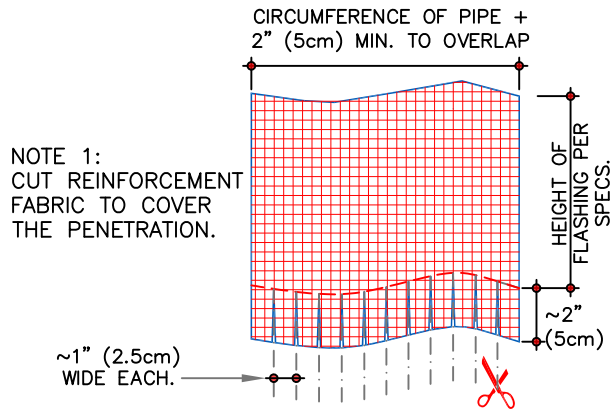
1. ENSURE COATING RECEIVING AREAS ARE CLEAN, SMOOTH AND DRY.
2. PRIME SURFACES AS REQUIRED. REFER TO SPECS.
3. APPLY BOTTOM COATING MIN. 2" (5cm) BEYOND THE DIMENSIONS OF PRE-CUT REINFORCEMENT FABRIC.

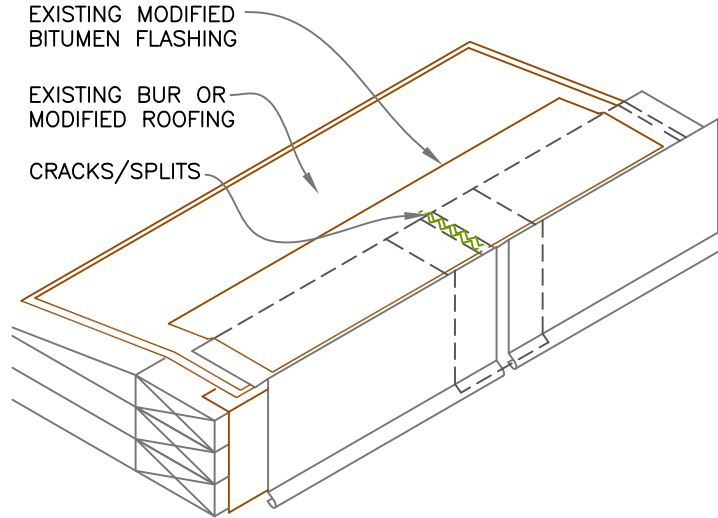
EXISTING CONDITION

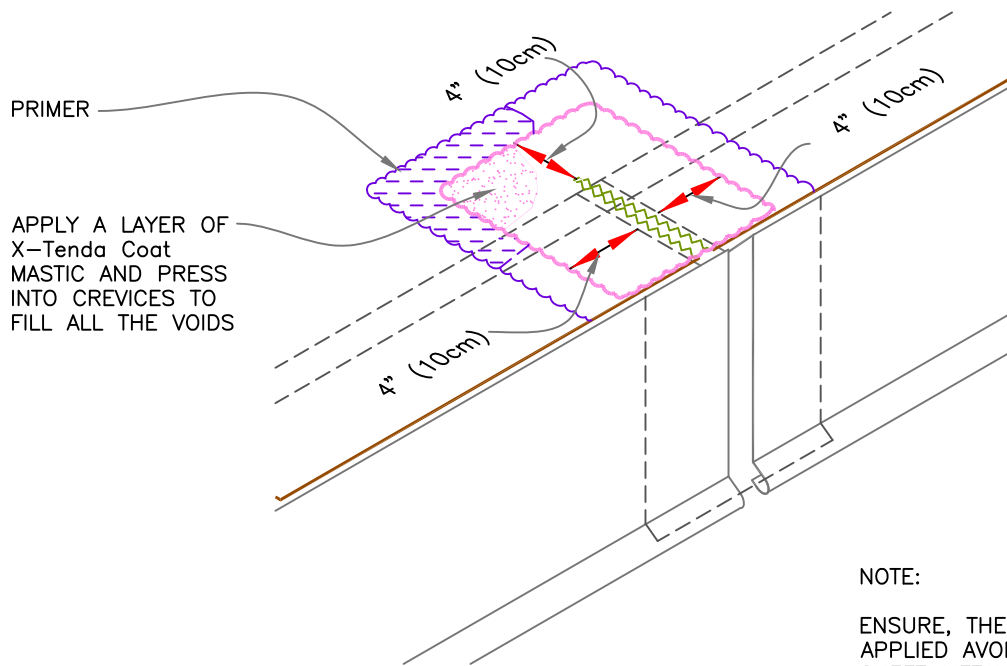
REPAIR DETAIL

REPAIR: SPLIT FLASHING AT METAL JOINT – BITUMINOUS ROOFS		X-Tenda Coat
	NEW COATING ON EXISTING LOW SLOPE ROOFS		XCR-1
	For additional information, refer to Specifications

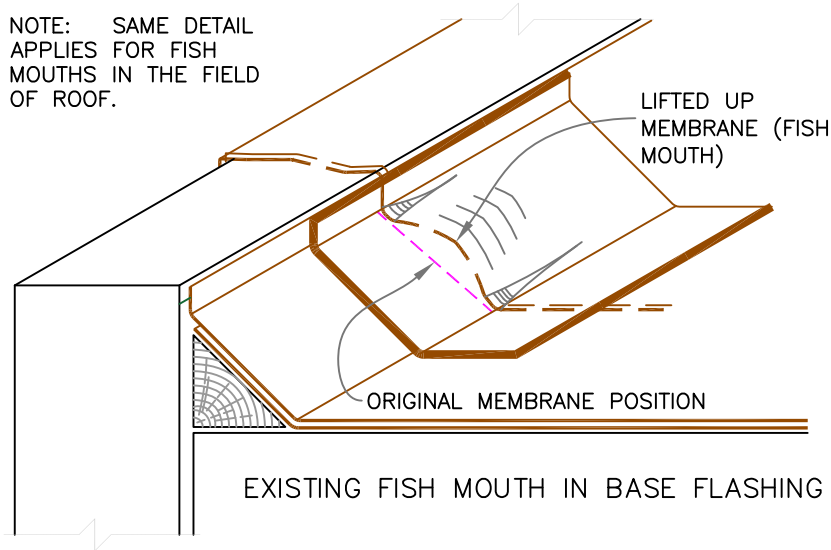
NOTE: SAME DETAIL APPLIES FOR FISH MOUTHS IN THE FIELD OF ROOF.

AT EXISTING FISH MOUTH CUT PERPENDICULAR TO FISH MOUTH UP TO LOOSE CONDITION.

1. At field seams that have not been repaired for the purpose of this restoration work:
  - a. Cut and remove fish mouths and loose membrane. Areas shall filled with mastic and allowed to cure.

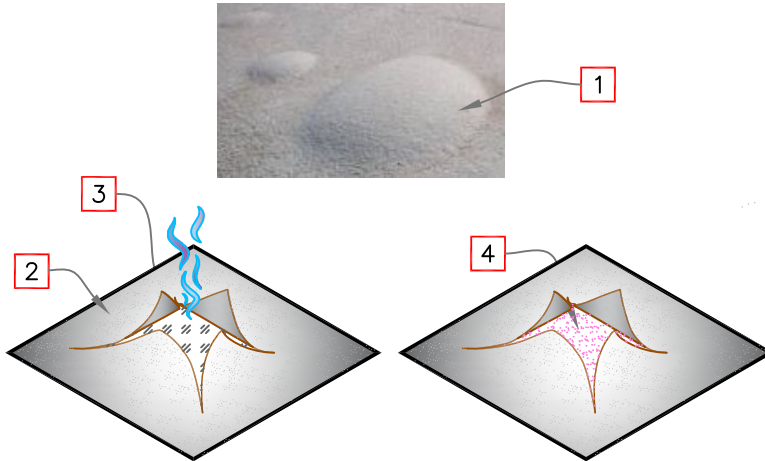
1. IDENTIFY BLISTERS AND WRINKLES IN THE FIELD AND MARK THEM WITH PAINT OR CRAYON.
2. MAKE A CROSS CUT WITHIN BLISTERED SURFACE & LIFT UP THE EDGES TO RELEASE THE AIR & MOISTURE. TRIM EDGES AS NEEDED.
3. REMOVE DEBRIS AND THOROUGHLY CLEAN THE BLISTERED AREA. ENSURE SURFACE IS DRY. PRIME SURFACES AS REQUIRED, REFER TO SPECS.
4. APPLY X-Tenda Coat MASTIC WITHIN THE CUT AREA. PUSH MASTIC UNDER THE LIFTED EDGES AND COMPLETELY EMBED ALL FOUR EDGES.

REPAIR – METHOD A (MASTIC): BLISTERS / WRINKLES	X-Tenda Coat
	NEW COATING ON EXISTING LOW SLOPE ROOFS For additional information, refer to Specifications	XCR-2D

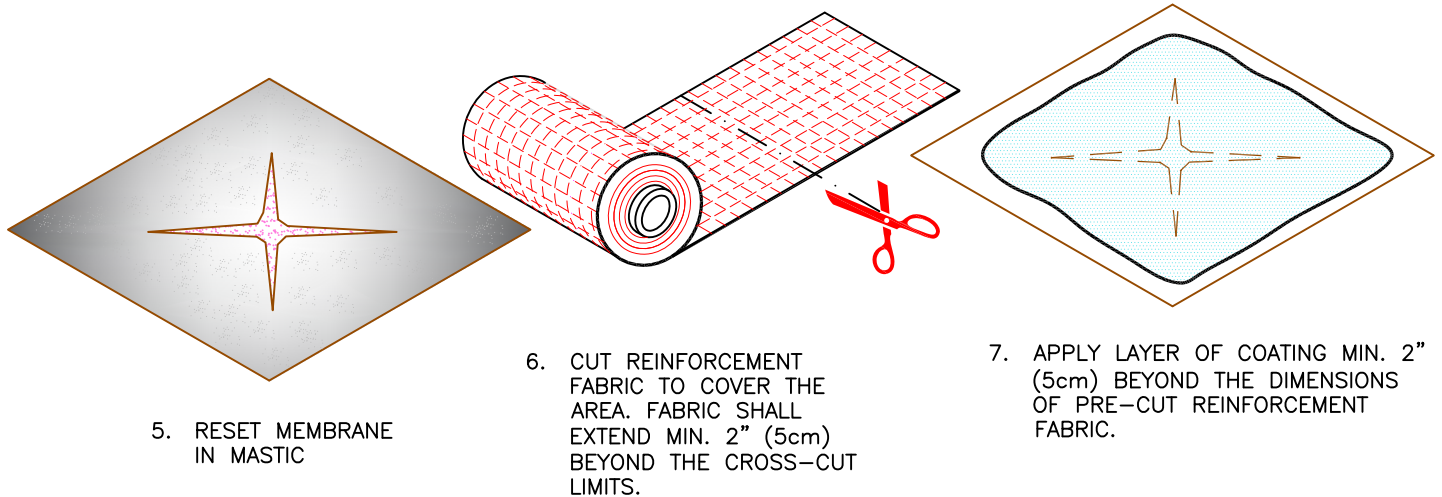
5. RESET MEMBRANE IN MASTIC

6. CUT REINFORCEMENT FABRIC TO COVER THE AREA. FABRIC SHALL EXTEND MIN. 2" (5cm) BEYOND THE CROSS-CUT LIMITS.

7. APPLY LAYER OF COATING MIN. 2" (5cm) BEYOND THE DIMENSIONS OF PRE-CUT REINFORCEMENT FABRIC.

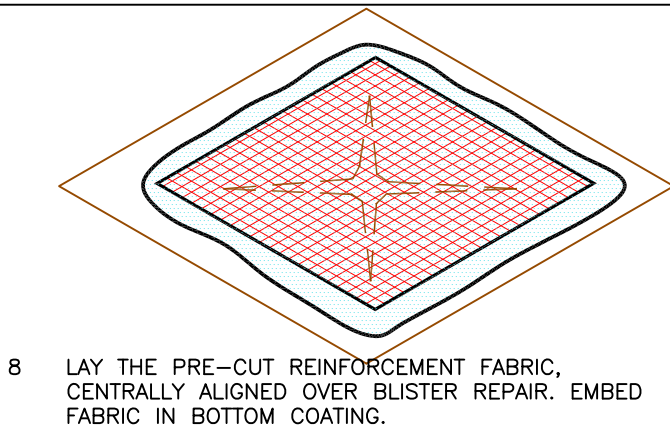
8. LAY THE PRE-CUT REINFORCEMENT FABRIC, CENTRALLY ALIGNED OVER BLISTER REPAIR. EMBED FABRIC IN BOTTOM COATING.

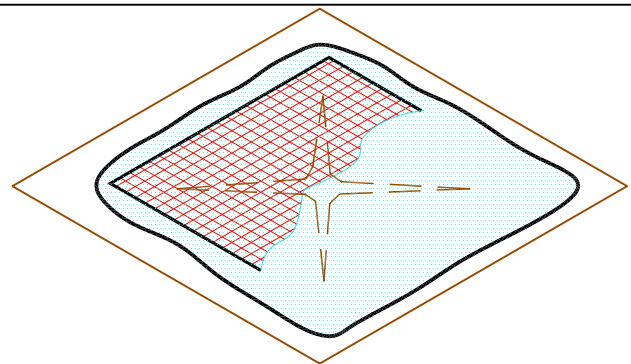
9. APPLY THE UPPER COATING A MIN. 2" (5cm) BEYOND THE WIDTH OF REINFORCING FABRIC.

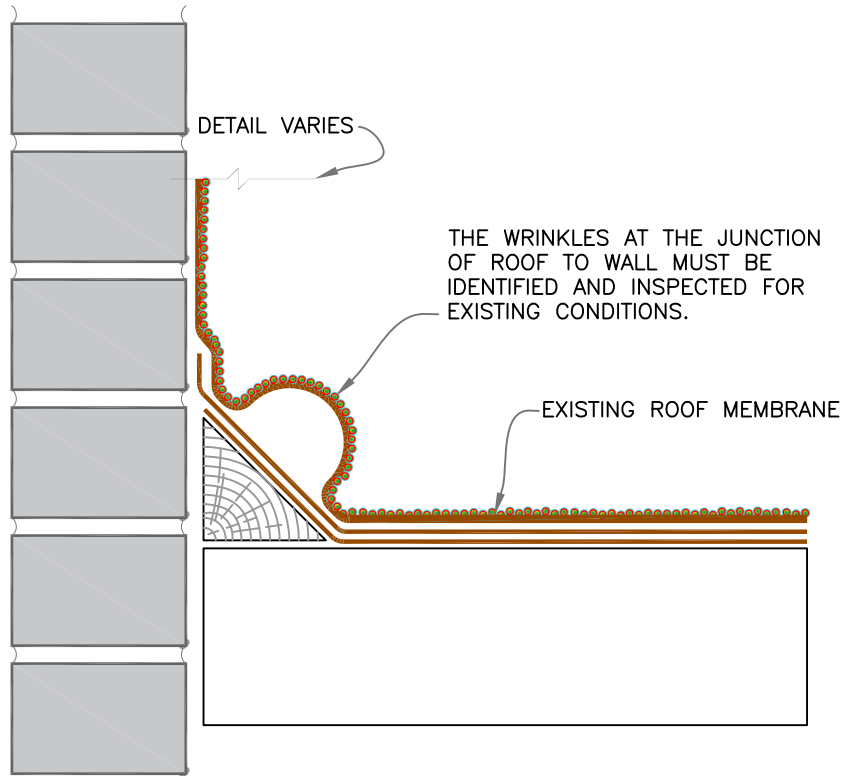
## EXISTING WRINKLED BASE FLASHING

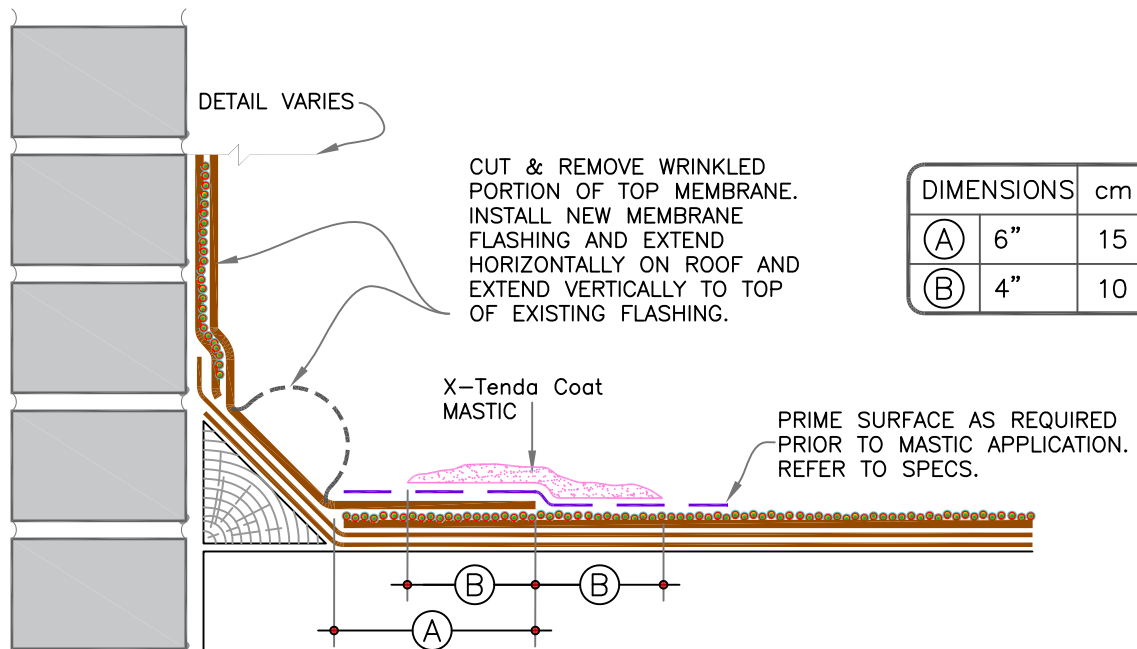
## REPAIR & COATING

DIMENSIONS		cm	
(A)	6"	15	
(B)	4"	10	MIN.

REPAIR:  
WRINKLES AT ROOF-TO-WALL JUNCTION

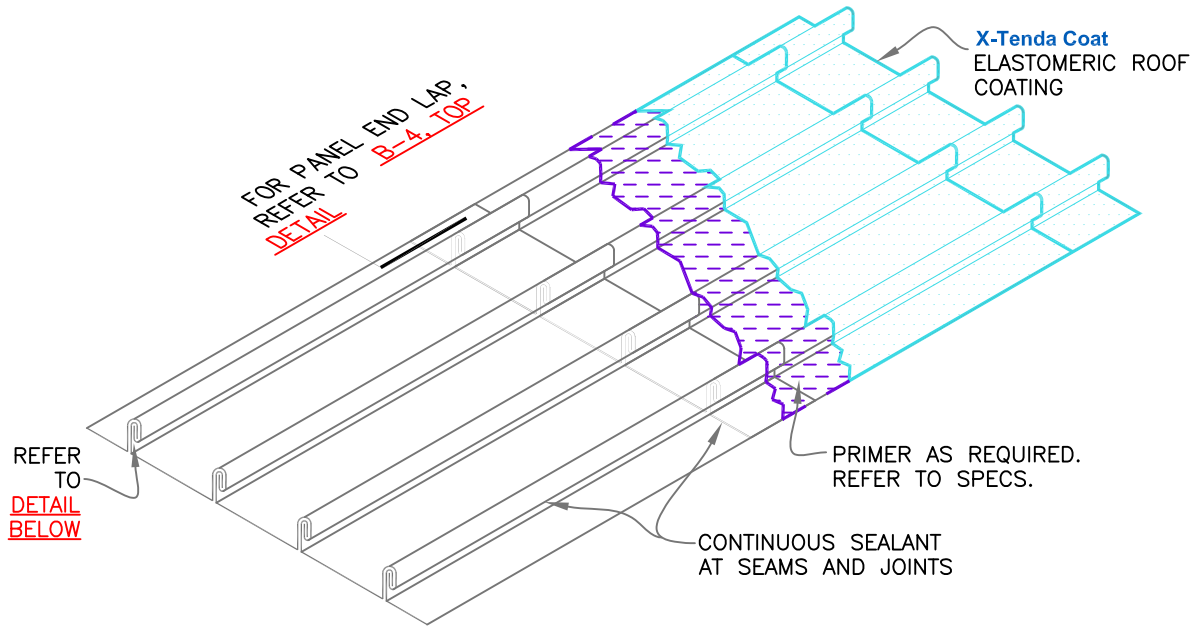
## A: 3D VIEW OF TYPICAL METAL ROOF

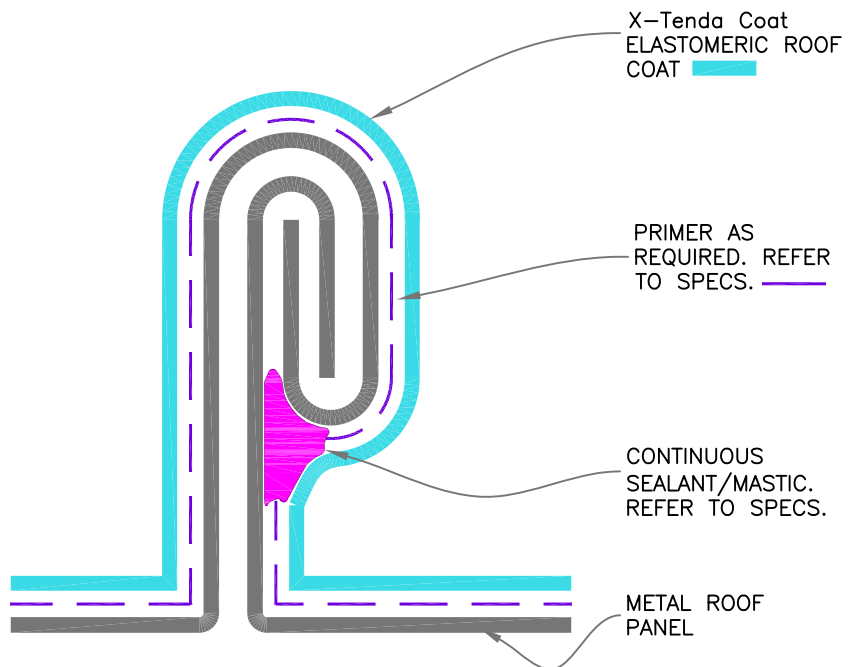
## B: COATING DETAIL AT STANDING SEAM

THIS IS A REFERENCE DETAIL DEPICTING A GENERIC STANDING SEAM OF METAL ROOF AND HOW TO TREAT IT PRIOR TO COATING PROCESS. SAME APPLIES TO OTHER SIMILAR SEAMS WITH DIFFERENT PROFILES SHOWN ON [B-2](#)

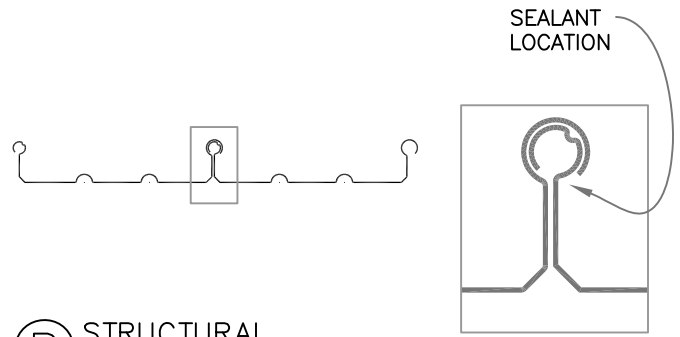
**(B)** STRUCTURAL  
STANDING SEAM ROOF

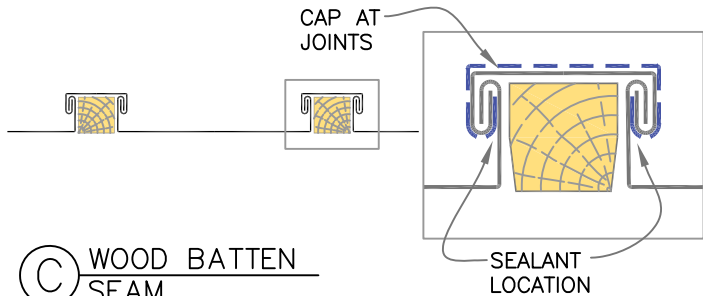
**(C)** WOOD BATTEN  
SEAM

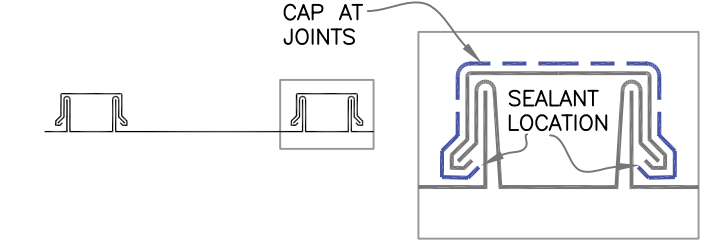
**(D)** APPLIED BATTEN  
SEAM

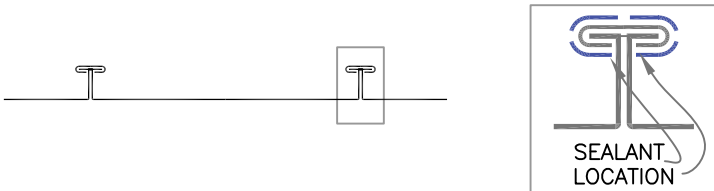
**(E)** TEE / CAPPED  
SEAM

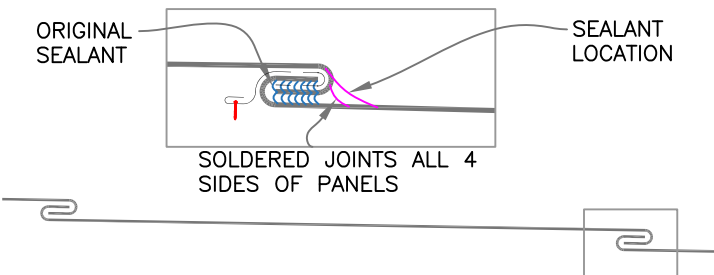
**(F)** BERMUDA TYPE ROOF  
(HORIZONTAL SEAMS)

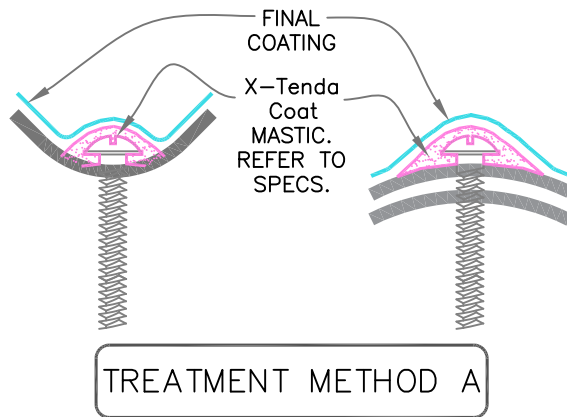
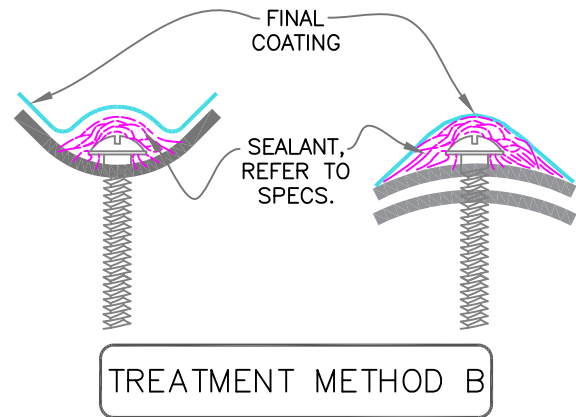
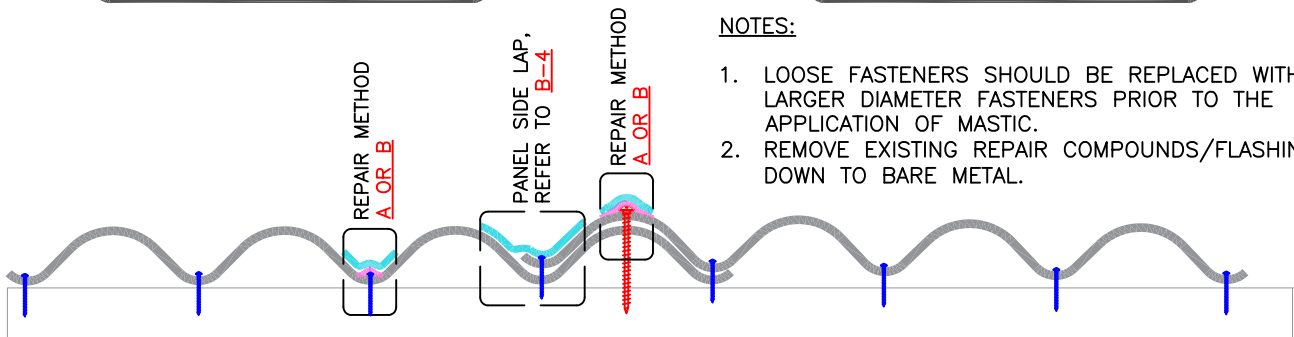
## FASTENER HEAD TREATMENT PRIOR TO COATING

### NOTES:

1. LOOSE FASTENERS SHOULD BE REPLACED WITH A LARGER DIAMETER FASTENERS PRIOR TO THE APPLICATION OF MASTIC.
2. REMOVE EXISTING REPAIR COMPOUNDS/FLASHINGS DOWN TO BARE METAL.

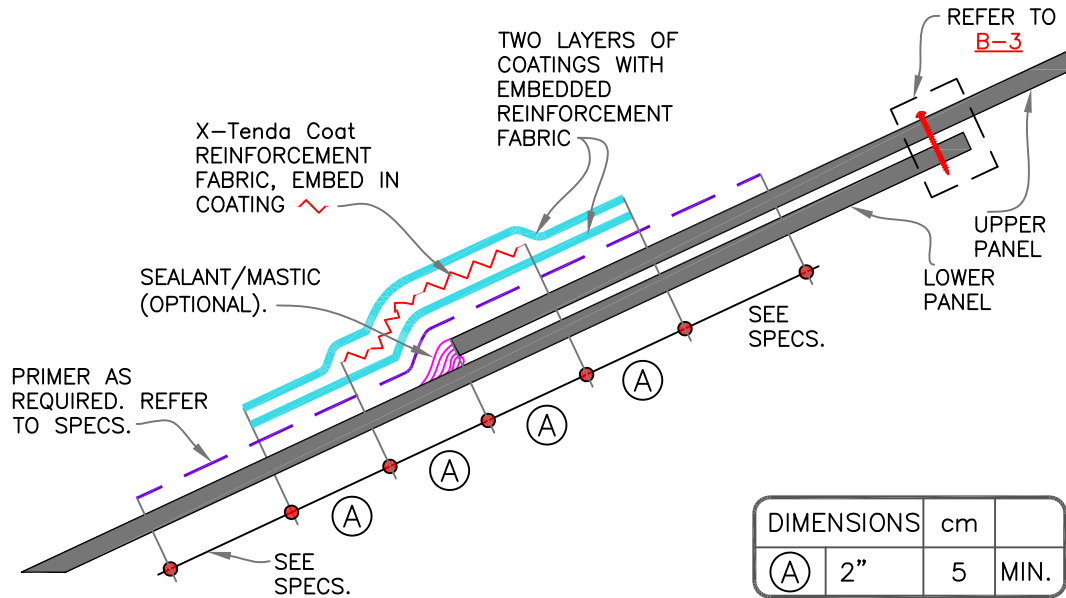
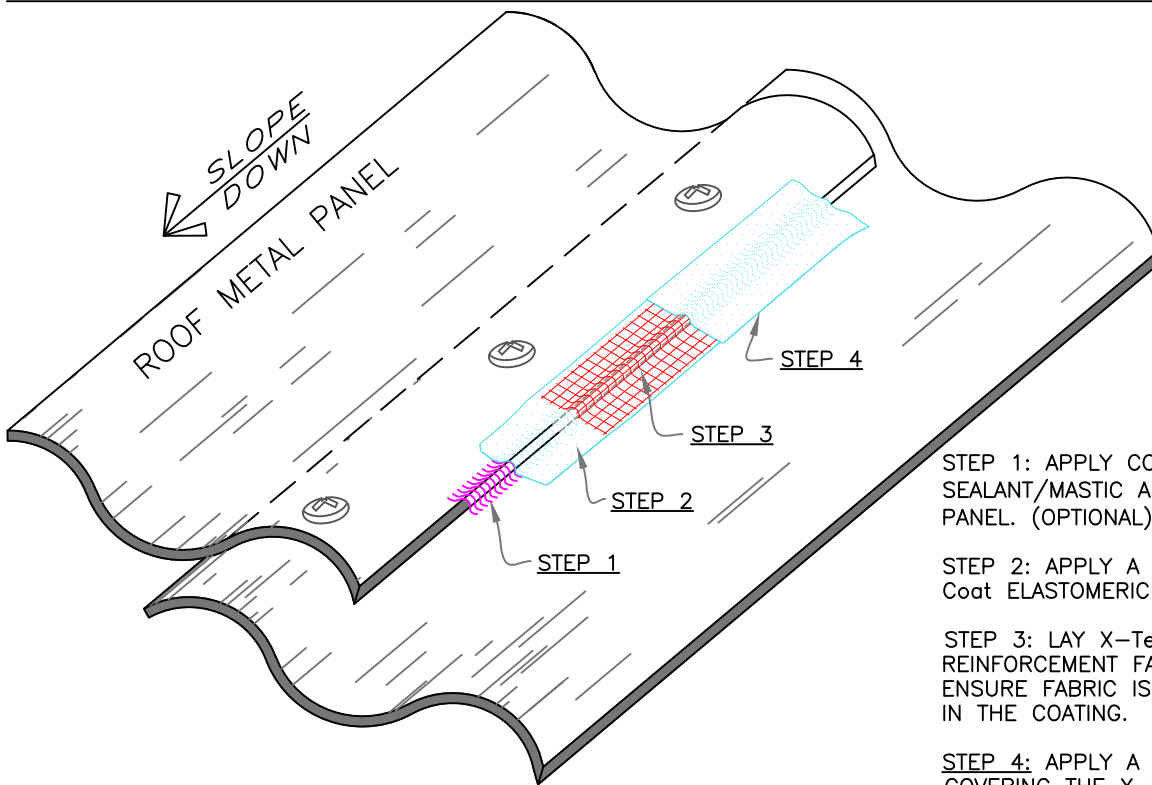
XCM-2C

## PANEL END-LAP

STEP 1: APPLY CONTINUOUS SEALANT/MASTIC ALONG THE EDGE OF PANEL. (OPTIONAL).

STEP 2: APPLY A LAYER OF X-Tenda Coat ELASTOMERIC COATING.
