Restoration Coatings

X-TENDA COAT™

Coating System

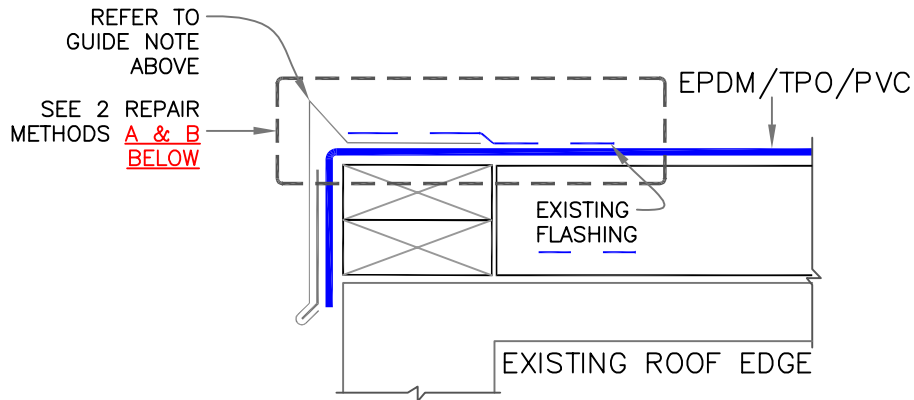
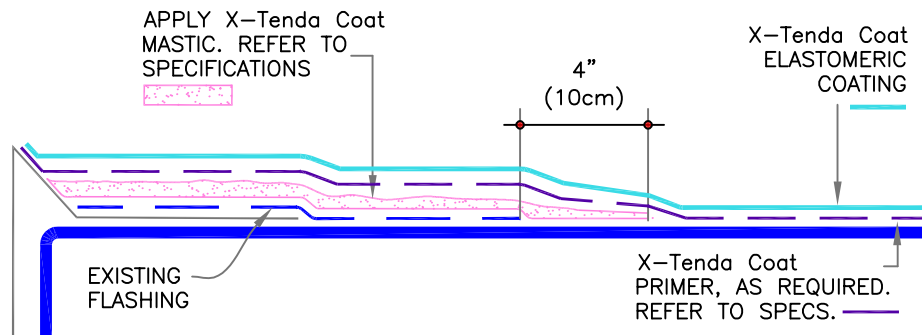
GUIDE
NOTE

WHERE GUTTER EXISTS, TO MAINTAIN POSITIVE DRAINAGE, USE METAL DRIP EDGE WITHOUT DAM.

METHOD A: MASTIC APPLICATION

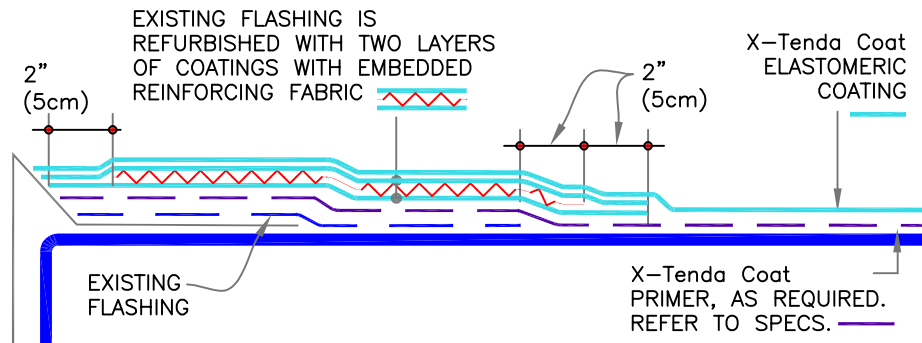
METHOD B: COATING WITH FABRIC

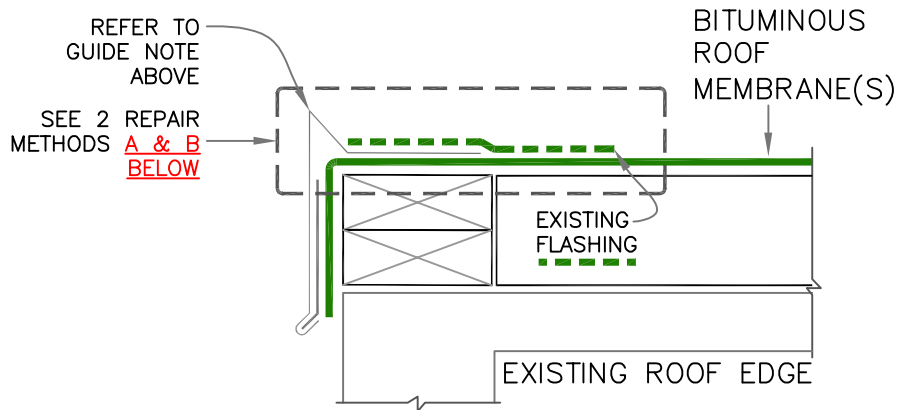
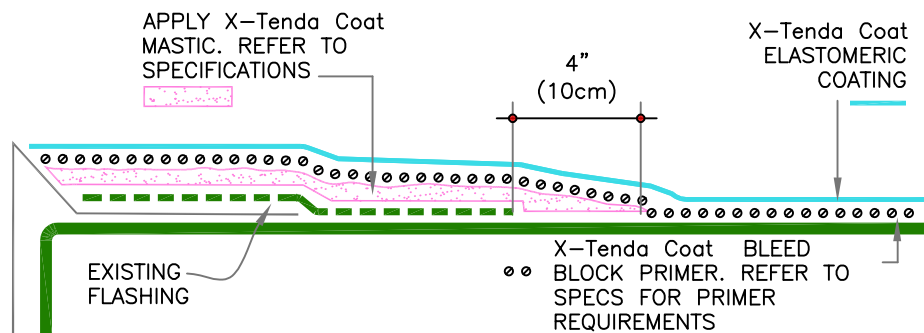
GUIDE
NOTE

WHERE GUTTER EXISTS, TO MAINTAIN POSITIVE DRAINAGE, USE METAL DRIP EDGE WITHOUT DAM.

METHOD A: MASTIC APPLICATION

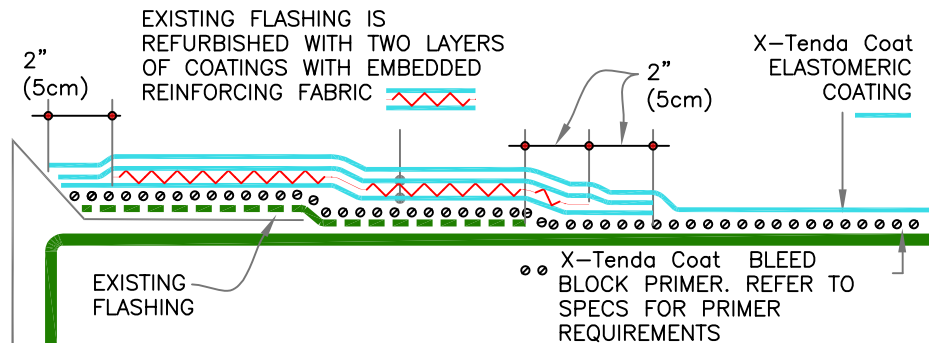
METHOD B: COATING WITH FABRIC

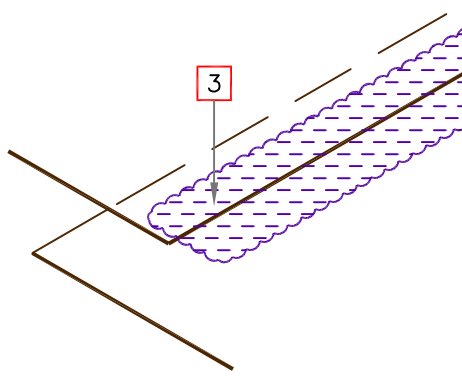
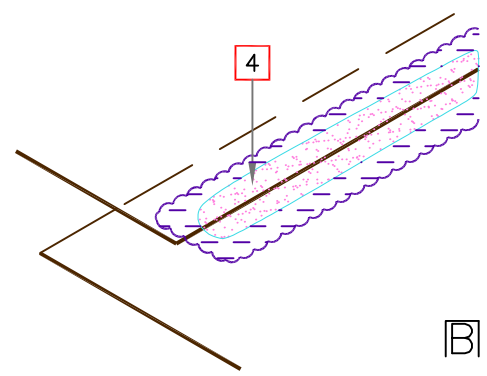
NOTES:

1. THIS REPAIR LEVEL TO BE USED ON SEAMS WITH ACCEPTABLE CONDITIONS. FOR MORE DETERIORATED SEAMS, SEE REPAIR LEVEL 2 BELOW. THIS WILL APPLY TO ALL THE SIDE AND END LAPS.
2. THOROUGHLY CLEAN THE REPAIR AREA.
3. APPLY X-Tenda Coat PRIMER AS REQUIRED. REFER TO SPECS.
4. APPLY X-Tenda Coat MASTIC, EXTENDING MIN. 4" (10cm) ON EACH SIDE OF SEAM.

TREATMENT METHOD B

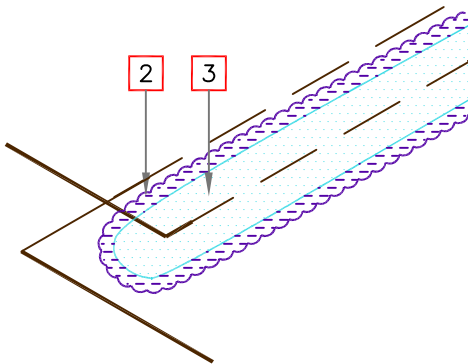
STEP 1:

1. THOROUGHLY CLEAN THE REPAIR AREA.
2. APPLY X-Tenda Coat PRIMER AS REQUIRED. REFER TO SPECS.
3. APPLY LAYER OF COATING 2" (5cm) MIN. BEYOND THE WIDTH OF REINFORCING FABRIC.

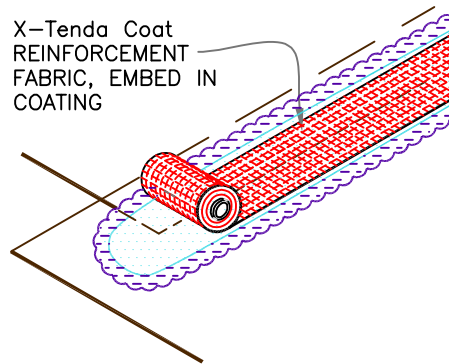
STEP 2:

1. IMMEDIATELY, LAY THE X-Tenda Coat REINFORCEMENT FABRIC, CENTRALLY ALIGNED AT SEAM EDGE.
2. COMPLETELY SOAK AND EMBED THE FABRIC IN COATING.

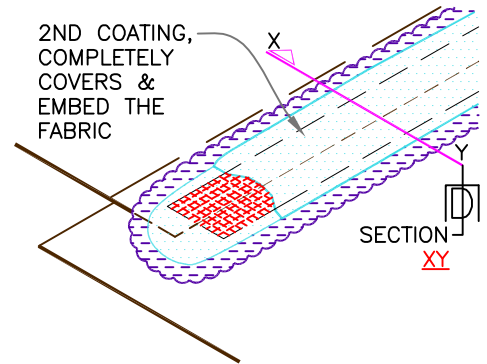
STEP 3:

1. IMMEDIATELY, APPLY A 2ND LAYER OF COATING COMPLETELY COVERING THE REINFORCEMENT FABRIC.

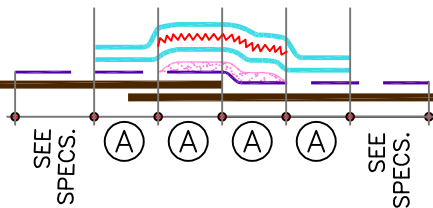
SECTION XY

DIMENSIONS		cm	
(A)	2"	5	MIN.

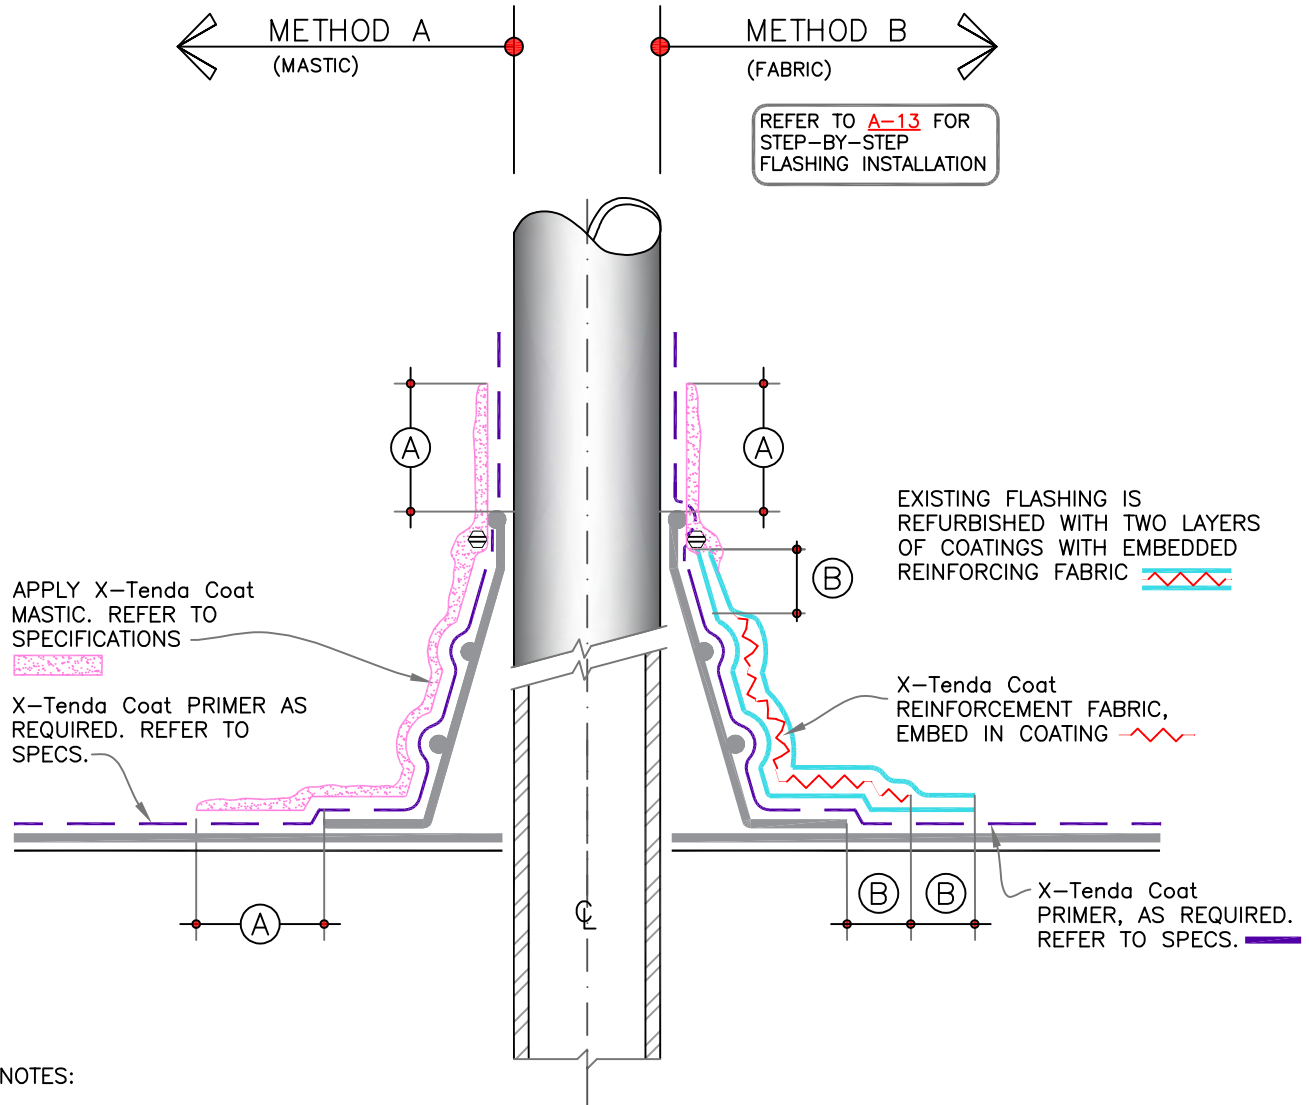
XC-2

DIMENSIONS		cm	
(A)	4"	10	MIN.
(B)	2"	5	MIN.

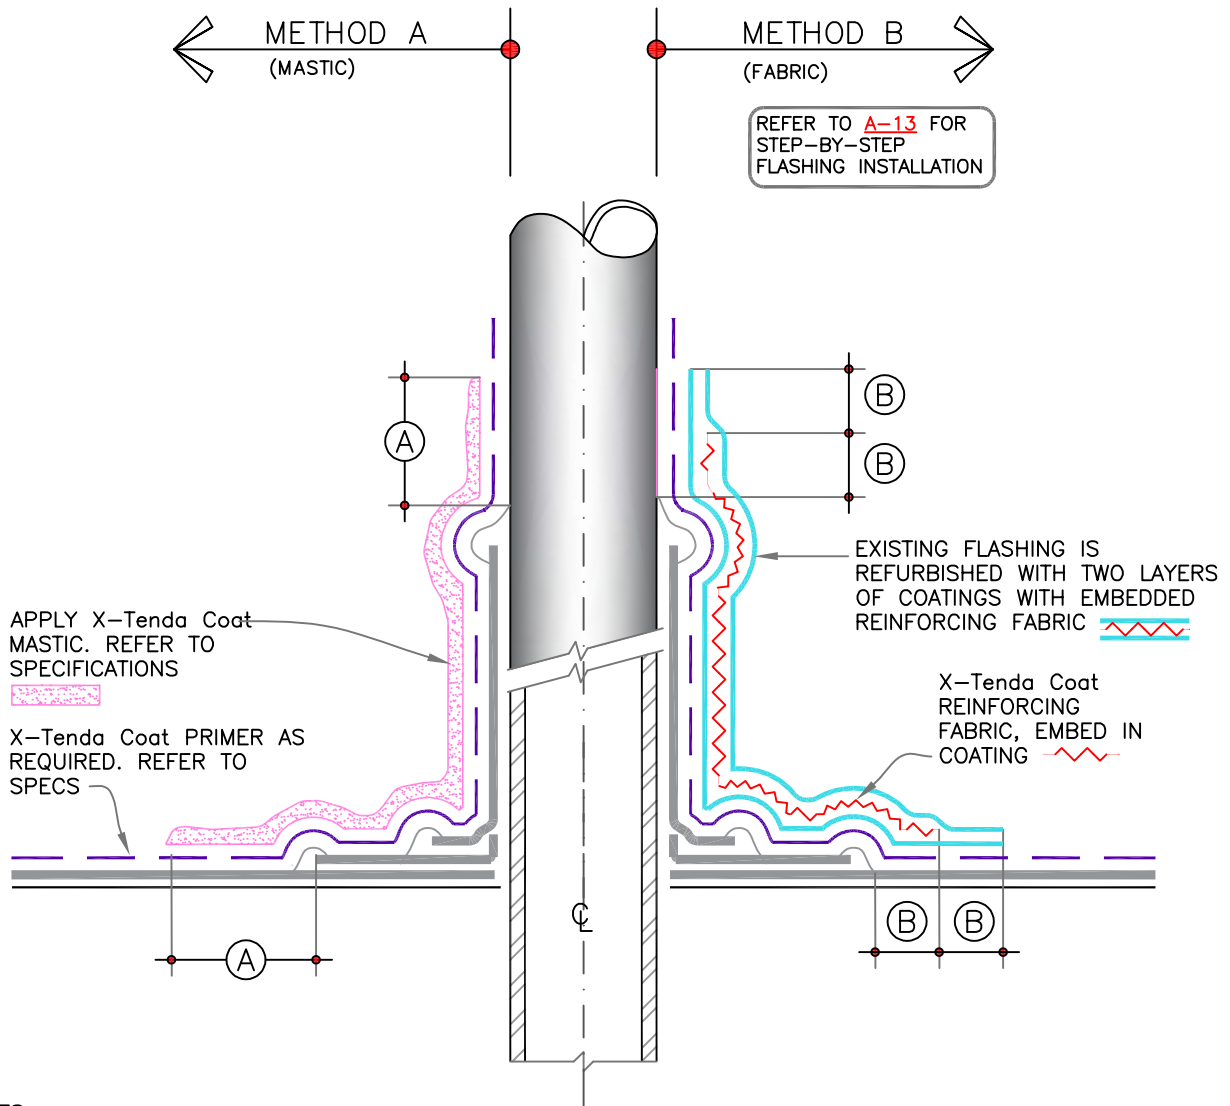
XC-8A

DIMENSIONS		cm	
(A)	4"	10	MIN.
(B)	2"	5	MIN.

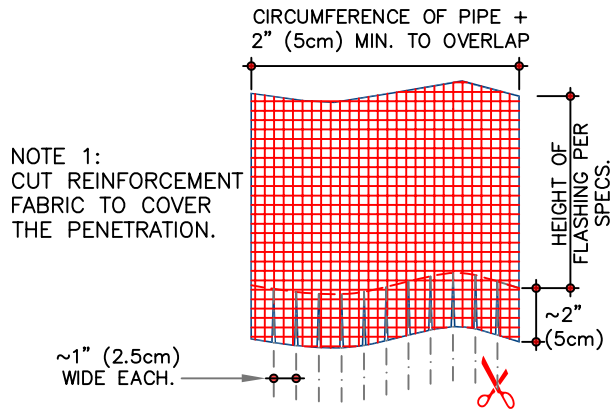
1. ENSURE COATING RECEIVING AREAS ARE CLEAN, SMOOTH AND DRY.
2. PRIME SURFACES AS REQUIRED. REFER TO SPECS.
3. APPLY BOTTOM COATING MIN. 2" (5cm) BEYOND THE DIMENSIONS OF PRE-CUT REINFORCEMENT FABRIC.

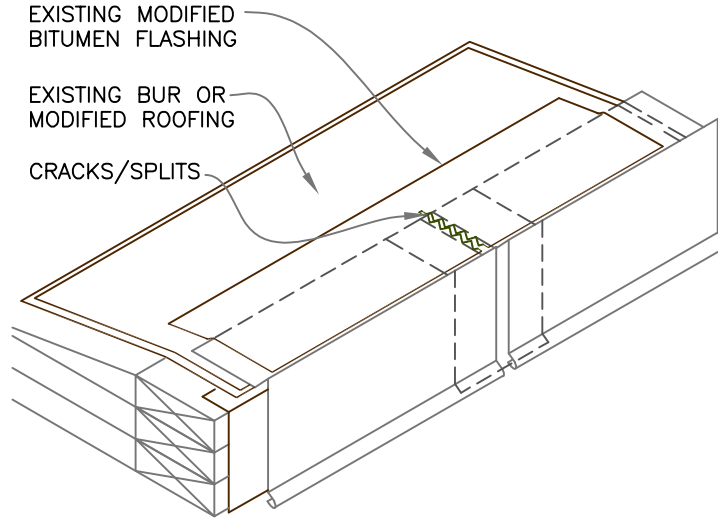
XC-8C

EXISTING CONDITION

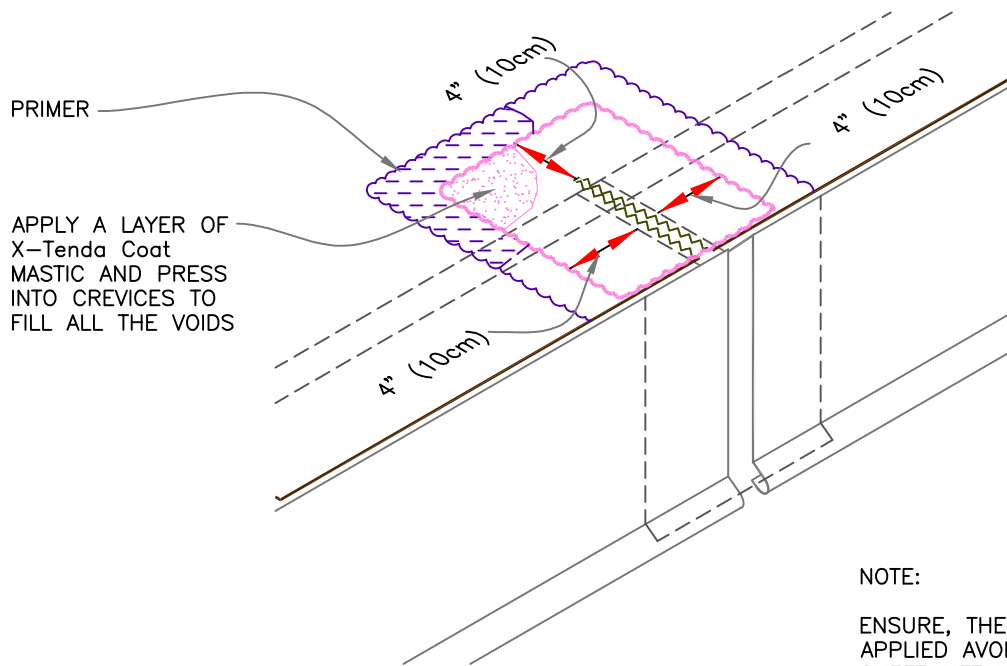
REPAIR DETAIL

<p>REPAIR: SPLIT FLASHING AT METAL JOINT – BITUMINOUS ROOFS</p>	<p>X-Tenda Coat</p>
<p>— X-Tenda Coat COATING</p> <p>— X-Tenda Coat PRIMER</p> <p>— REINFORCEMENT</p> <p>— X-Tenda Coat MASTIC</p> <p>0 NOTE(S)</p>	<p>NEW COATING ON EXISTING LOW SLOPE ROOFS</p> <p>For additional information, refer to Specifications</p>	<p>XCR-1</p>

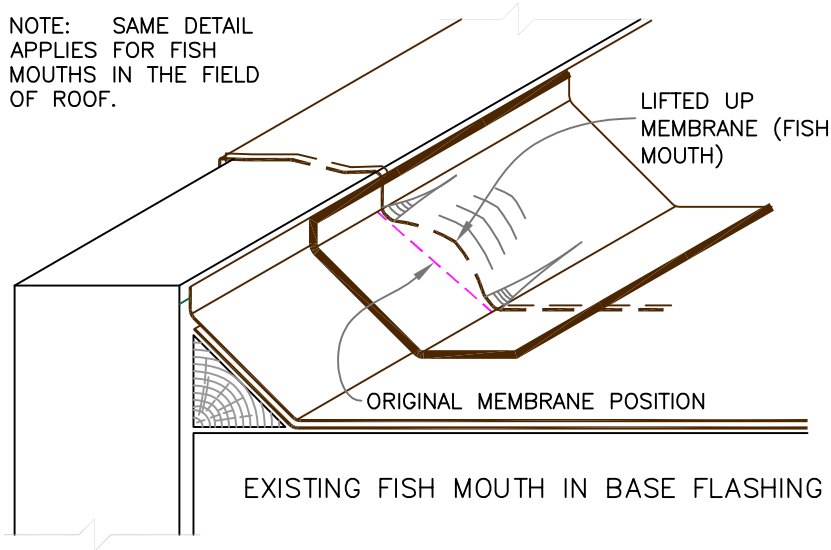
NOTE: SAME DETAIL APPLIES FOR FISH MOUTHS IN THE FIELD OF ROOF.

AT EXISTING FISH MOUTH CUT PERPENDICULAR TO FISH MOUTH UP TO LOOSE CONDITION.

1. At field seams that have not been repaired for the purpose of this restoration work:
 - a. Cut and remove fish mouths and loose membrane. Areas shall filled with mastic and allowed to cure.

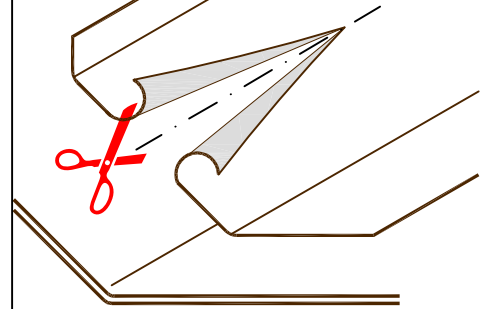
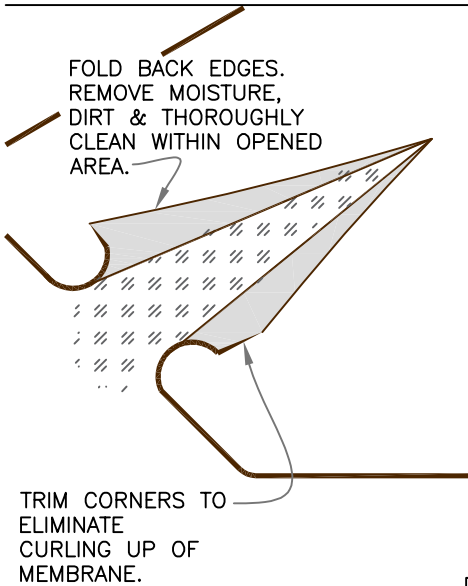
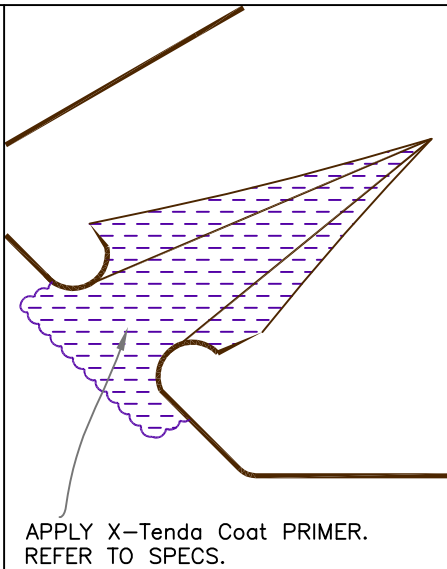
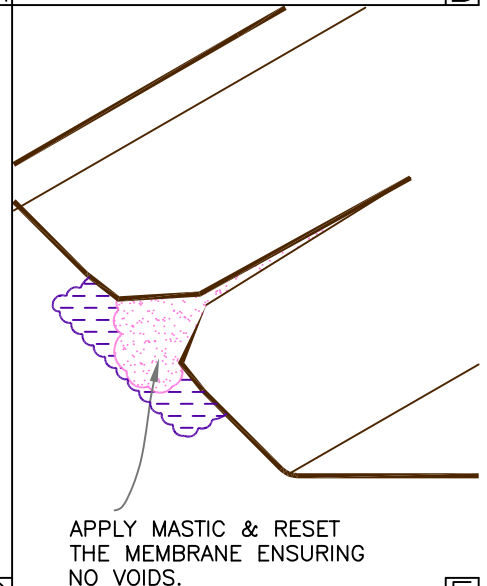
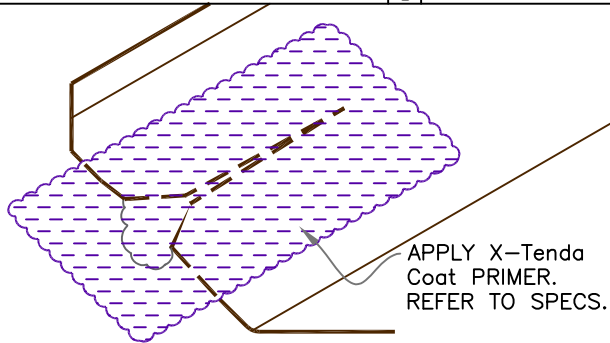
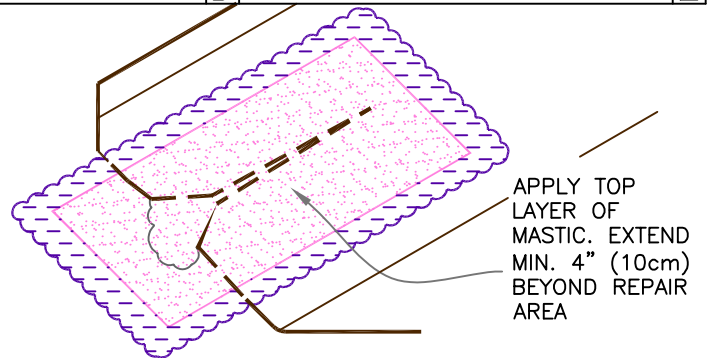
DEFICIENCY:
SIDE SEAM, OPEN,
WRINKLED OR FISH
MOUTH CONDITION.

NOTE:
REPAIR BOTH DEFICIENCIES
PER STEPS **B TO G**.

LIFT UP AND
CUT THE SEAM
AT THE PEAK
OF FISHMOUTH
OR LOOSE SEAM

FOLD BACK
EDGES. REMOVE
MOISTURE, DIRT
& THOROUGHLY
CLEAN WITHIN
OPENED AREA.

APPLY TOP LAYER OF MASTIC. EXTEND MIN. 4"
(10cm) BEYOND REPAIR AREA

REPAIR:
SEAM GAP OR WRINKLE

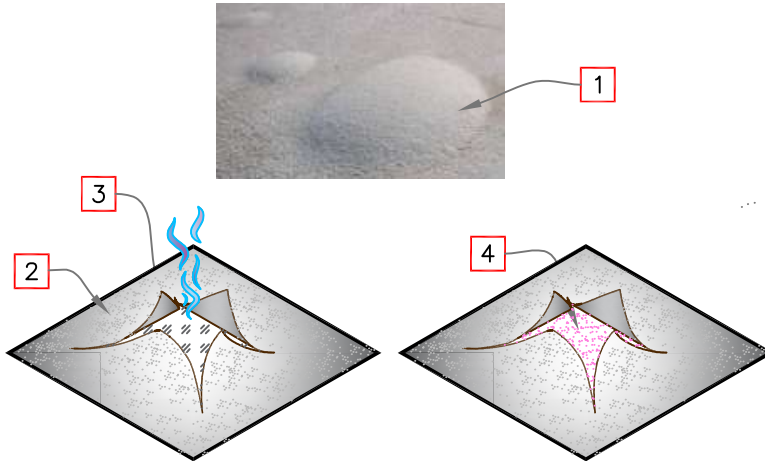
XCR-2C

1. IDENTIFY BLISTERS AND WRINKLES IN THE FIELD AND MARK THEM WITH PAINT OR CRAYON.
2. MAKE A CROSS CUT WITHIN BLISTERED SURFACE & LIFT UP THE EDGES TO RELEASE THE AIR & MOISTURE. TRIM EDGES AS NEEDED.
3. REMOVE DEBRIS AND THOROUGHLY CLEAN THE BLISTERED AREA. ENSURE SURFACE IS DRY. PRIME SURFACES AS REQUIRED, REFER TO SPECS.
4. APPLY X-Tenda Coat MASTIC WITHIN THE CUT AREA. PUSH MASTIC UNDER THE LIFTED EDGES AND COMPLETELY EMBED ALL FOUR EDGES.

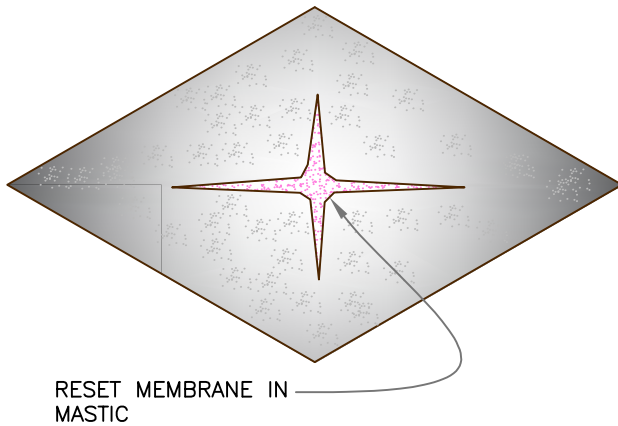
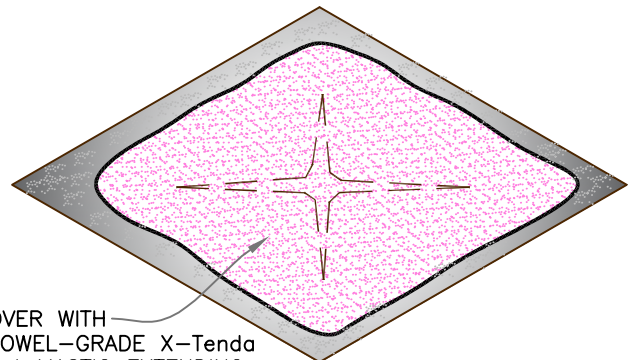
COVER WITH
TROWEL-GRADE X-Tenda
Coat MASTIC EXTENDING
4" (10cm) BEYOND ALL
CUTS IN MEMBRANE.

<div></div> <div><div><div></div><div>X-Tenda Coat COATING</div></div><div><div></div><div>X-Tenda Coat MASTIC</div></div><div><div></div><div>X-Tenda Coat PRIMER</div></div><div><div></div><div>REINFORCEMENT</div></div><div><div><div>0</div></div><div>NOTE(S)</div></div></div>	REPAIR – METHOD A (MASTIC): BLISTERS / WRINKLES	X-Tenda Coat
	NEW COATING ON EXISTING LOW SLOPE ROOFS	XCR-2D
	For additional information, refer to Specifications

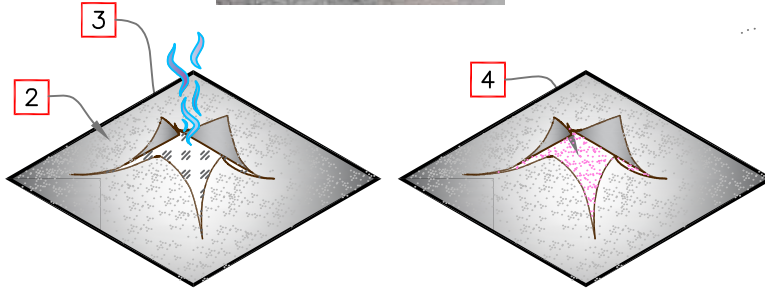
1. IDENTIFY BLISTERS AND WRINKLES IN THE FIELD AND MARK THEM WITH PAINT OR CRAYON.
2. MAKE A CROSS CUT WITHIN BLISTERED SURFACE & LIFT UP THE EDGES TO RELEASE THE AIR & MOISTURE. TRIM EDGES AS NEEDED.
3. REMOVE DEBRIS AND THOROUGHLY CLEAN THE BLISTERED AREA. ENSURE SURFACE IS DRY. PRIME SURFACES AS REQUIRED, REFER TO SPECS.
4. APPLY X-Tenda Coat MASTIC WITHIN THE CUT AREA. PUSH MASTIC UNDER THE LIFTED EDGES AND COMPLETELY EMBED ALL FOUR EDGES.

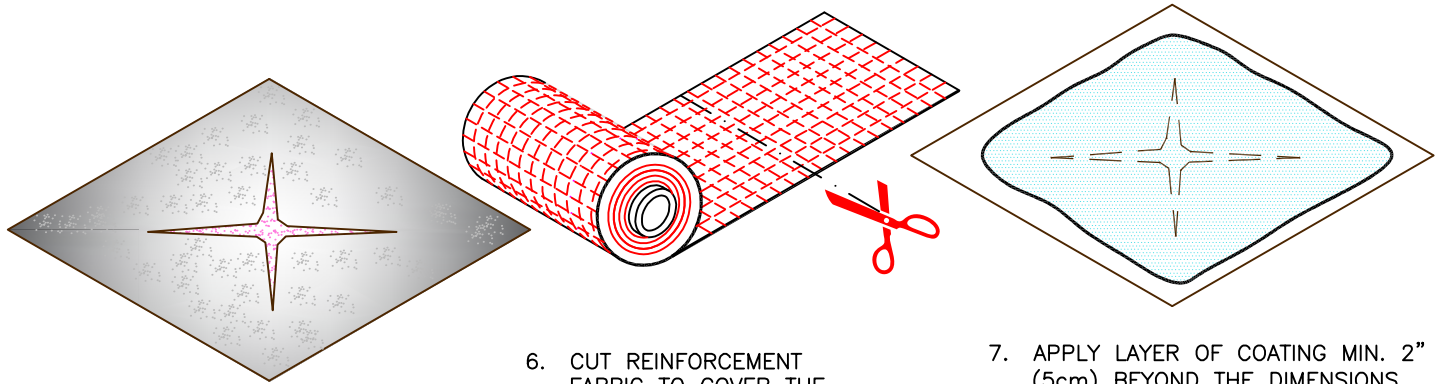
5. RESET MEMBRANE IN MASTIC

6. CUT REINFORCEMENT FABRIC TO COVER THE AREA. FABRIC SHALL EXTEND MIN. 2" (5cm) BEYOND THE CROSS-CUT LIMITS.

7. APPLY LAYER OF COATING MIN. 2" (5cm) BEYOND THE DIMENSIONS OF PRE-CUT REINFORCEMENT FABRIC.

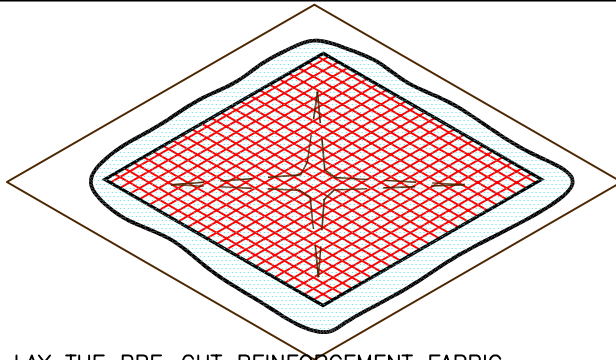
8. LAY THE PRE-CUT REINFORCEMENT FABRIC, CENTRALLY ALIGNED OVER BLISTER REPAIR. EMBED FABRIC IN BOTTOM COATING.

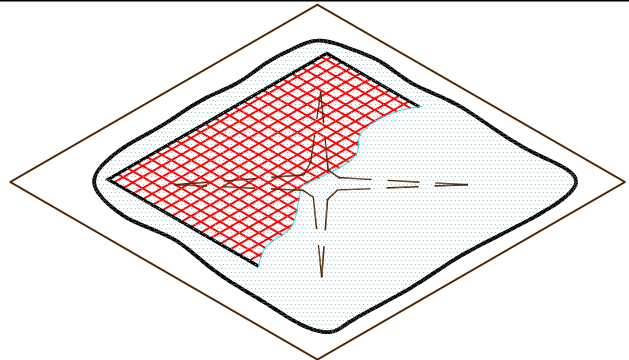
9. APPLY THE UPPER COATING A MIN. 2" (5cm) BEYOND THE WIDTH OF REINFORCING FABRIC.

REPAIR – METHOD B:
(REINFORCING FABRIC) BLISTERS/WRINKLES

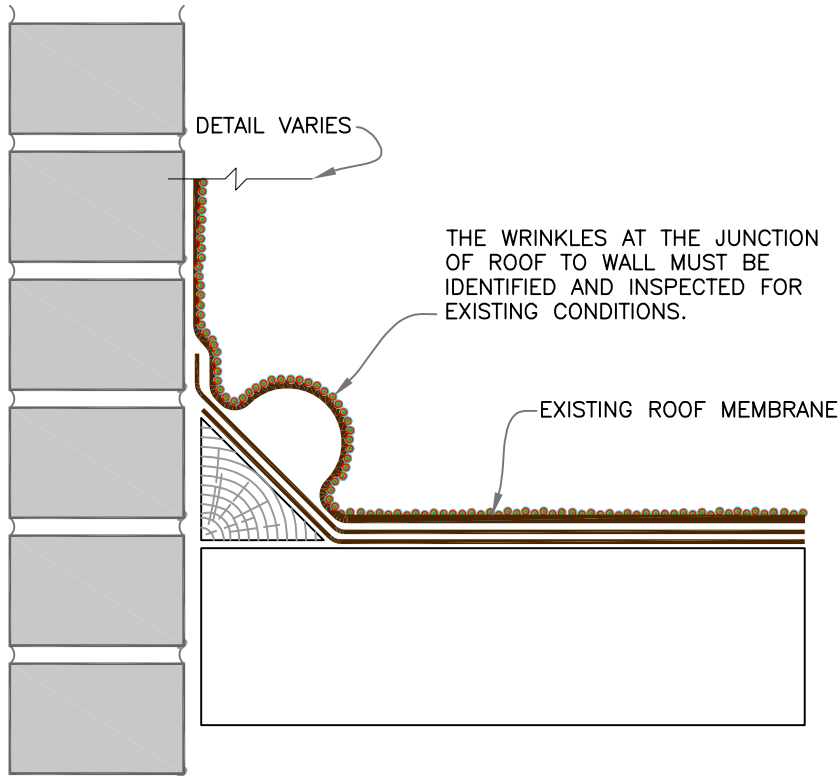
EXISTING WRINKLED BASE FLASHING

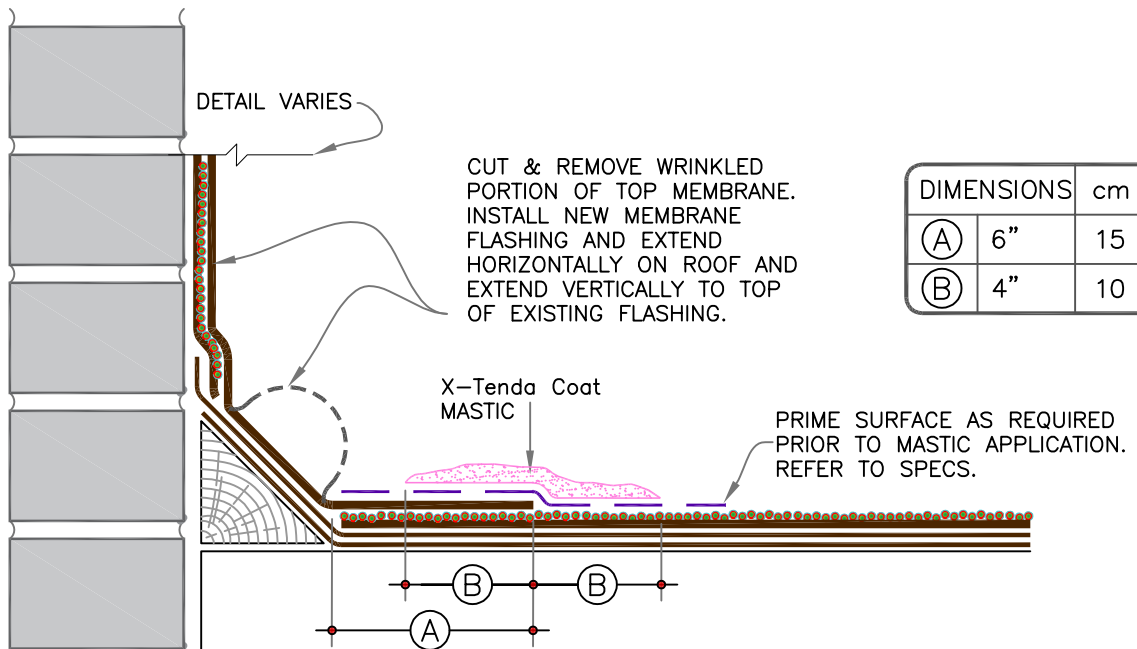
REPAIR & COATING

DIMENSIONS		cm	
(A)	6"	15	
(B)	4"	10	MIN.

REPAIR:
WRINKLES AT ROOF-TO-WALL JUNCTION

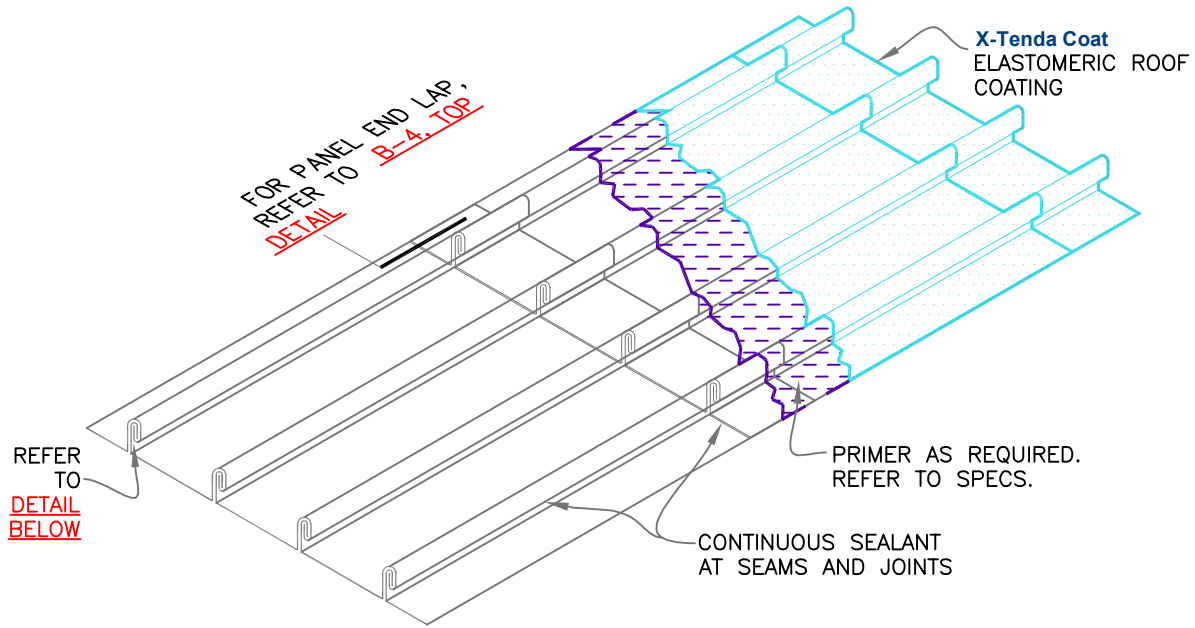
A: 3D VIEW OF TYPICAL METAL ROOF

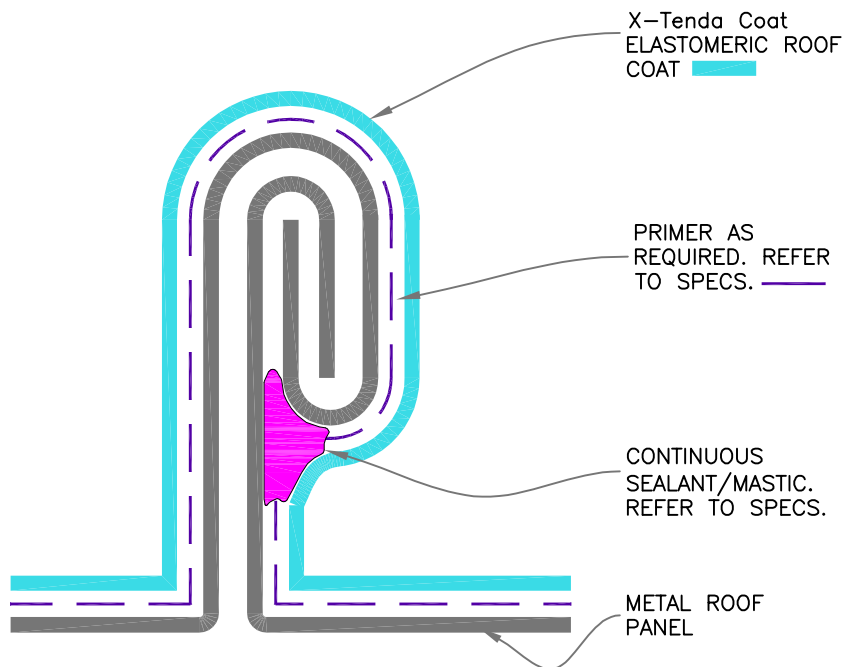
B: COATING DETAIL AT STANDING SEAM

THIS IS A REFERENCE DETAIL DEPICTING A GENERIC STANDING SEAM OF METAL ROOF AND HOW TO TREAT IT PRIOR TO COATING PROCESS. SAME APPLIES TO OTHER SIMILAR SEAMS WITH DIFFERENT PROFILES SHOWN ON [B-2](#)

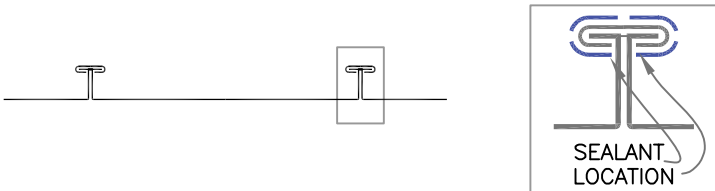
(E) TEE / CAPPED
SEAM

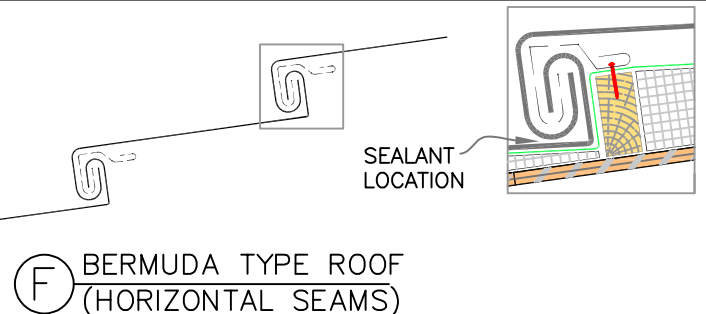
(F) BERMUDA TYPE ROOF
(HORIZONTAL SEAMS)

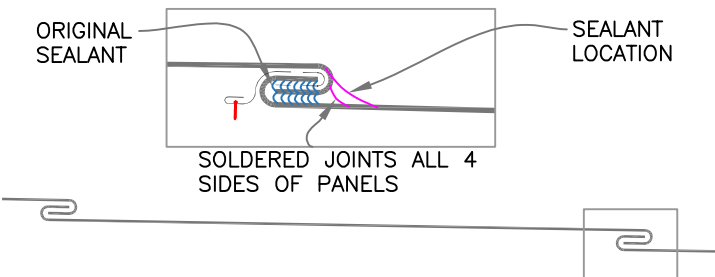
(G) LOW-SLOPE (FLAT)
COPPER ROOF

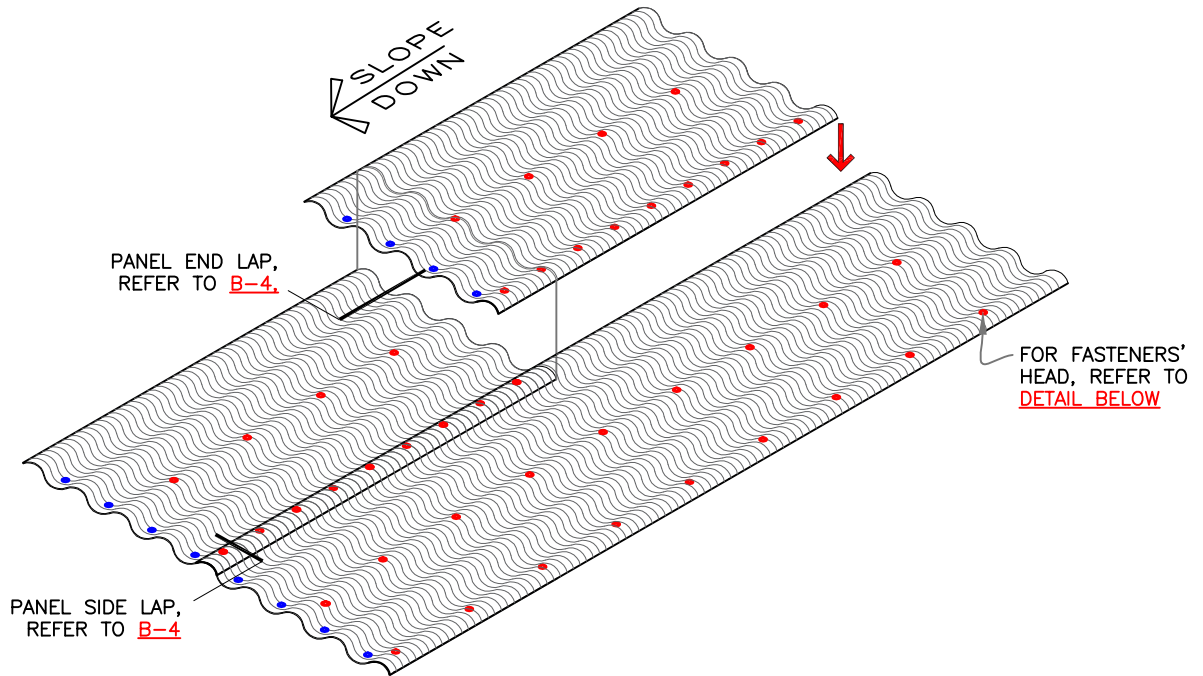
XCM-2B

DETAIL LOCATIONS

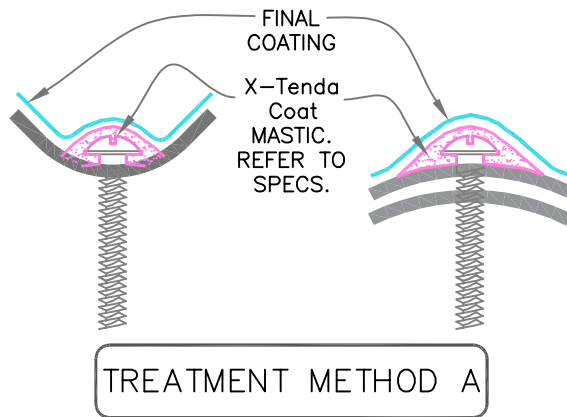
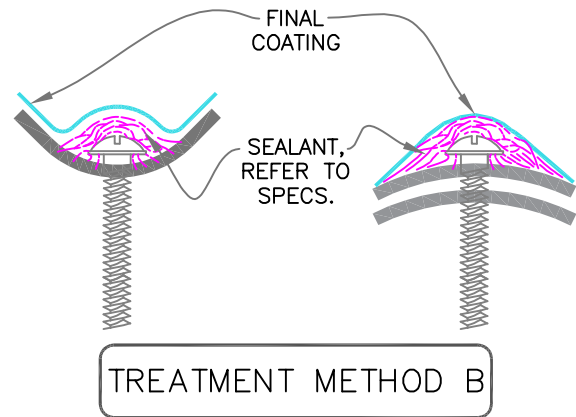
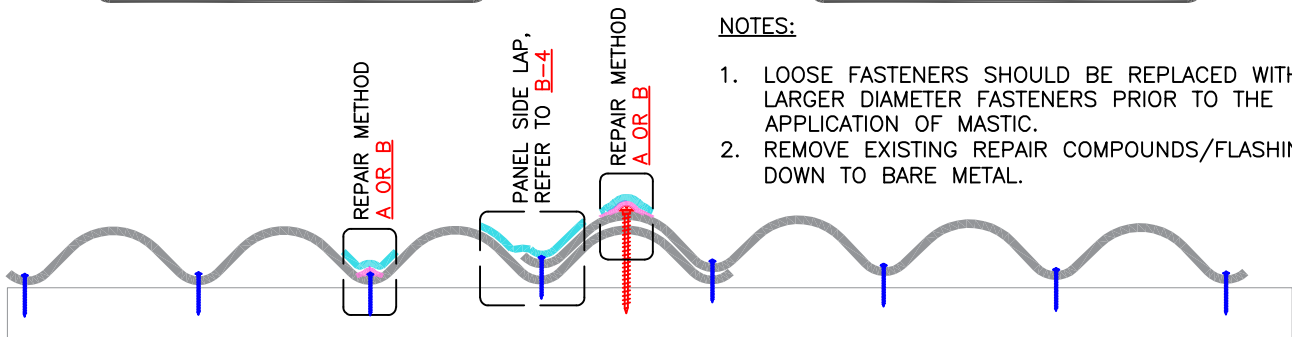
FASTENER HEAD TREATMENT PRIOR TO COATING

1. LOOSE FASTENERS SHOULD BE REPLACED WITH A LARGER DIAMETER FASTENERS PRIOR TO THE APPLICATION OF MASTIC.
2. REMOVE EXISTING REPAIR COMPOUNDS/FLASHINGS DOWN TO BARE METAL.

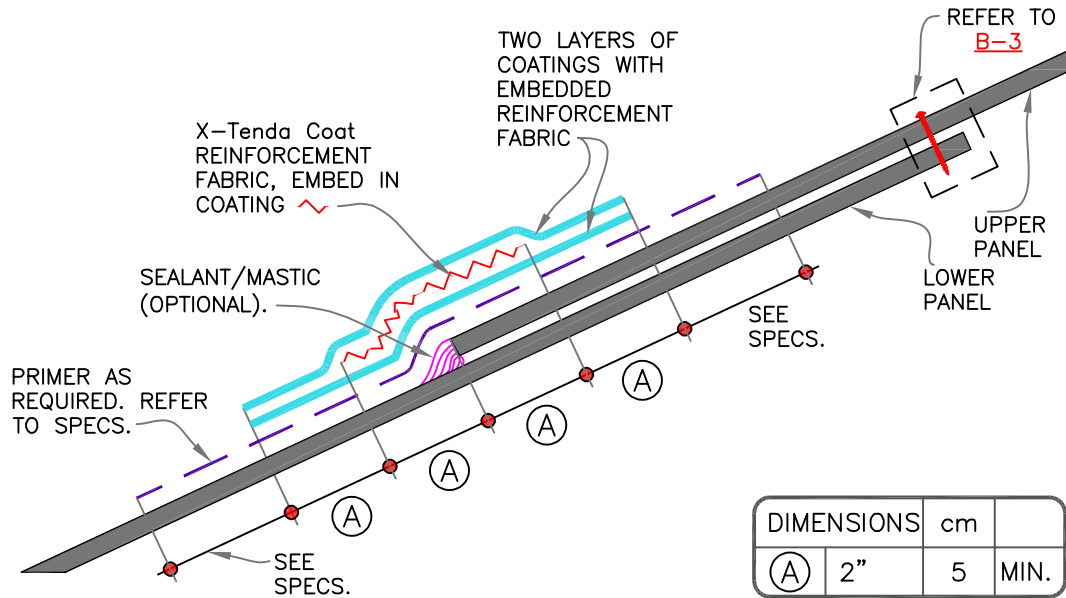
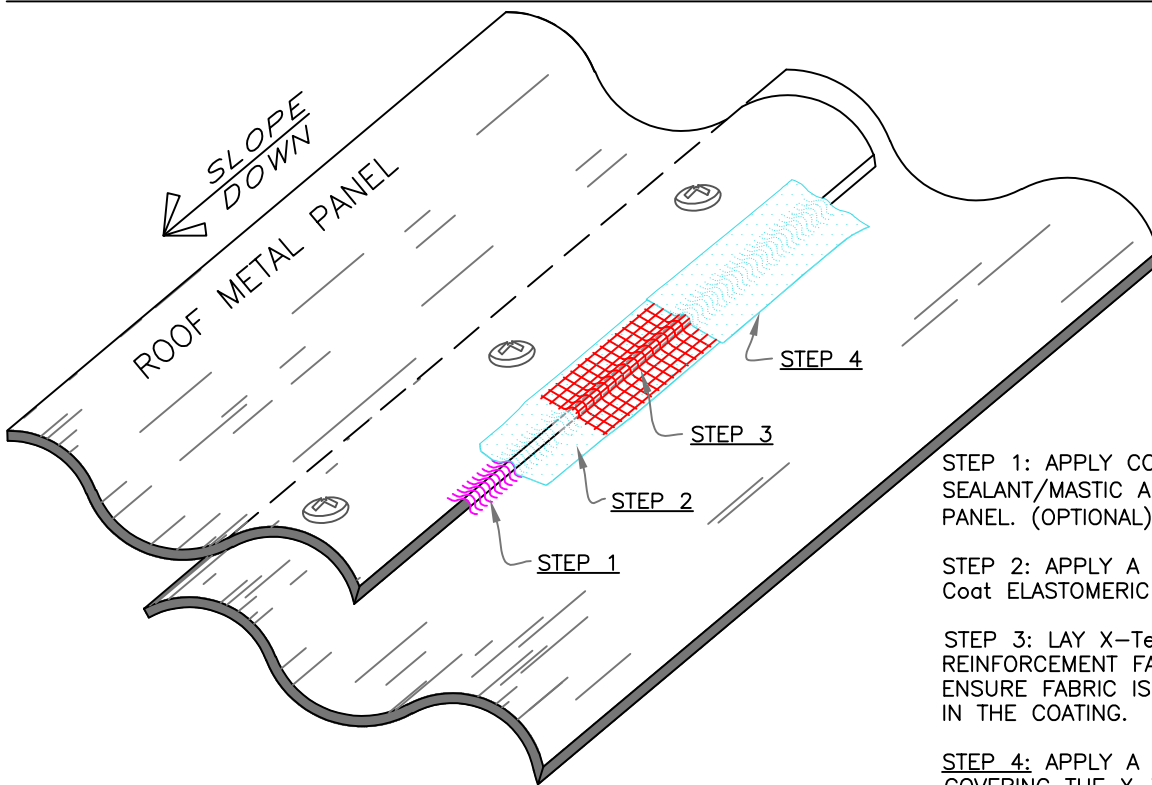
XCM-2C

PANEL END-LAP

STEP 1: APPLY CONTINUOUS SEALANT/MASTIC ALONG THE EDGE OF PANEL. (OPTIONAL).

STEP 2: APPLY A LAYER OF X-Tenda Coat ELASTOMERIC COATING.
