PREMOLDED FLASHING REPAIR # 1

EPDM ROOF RESTORATION
DETAIL
E 7.1.1

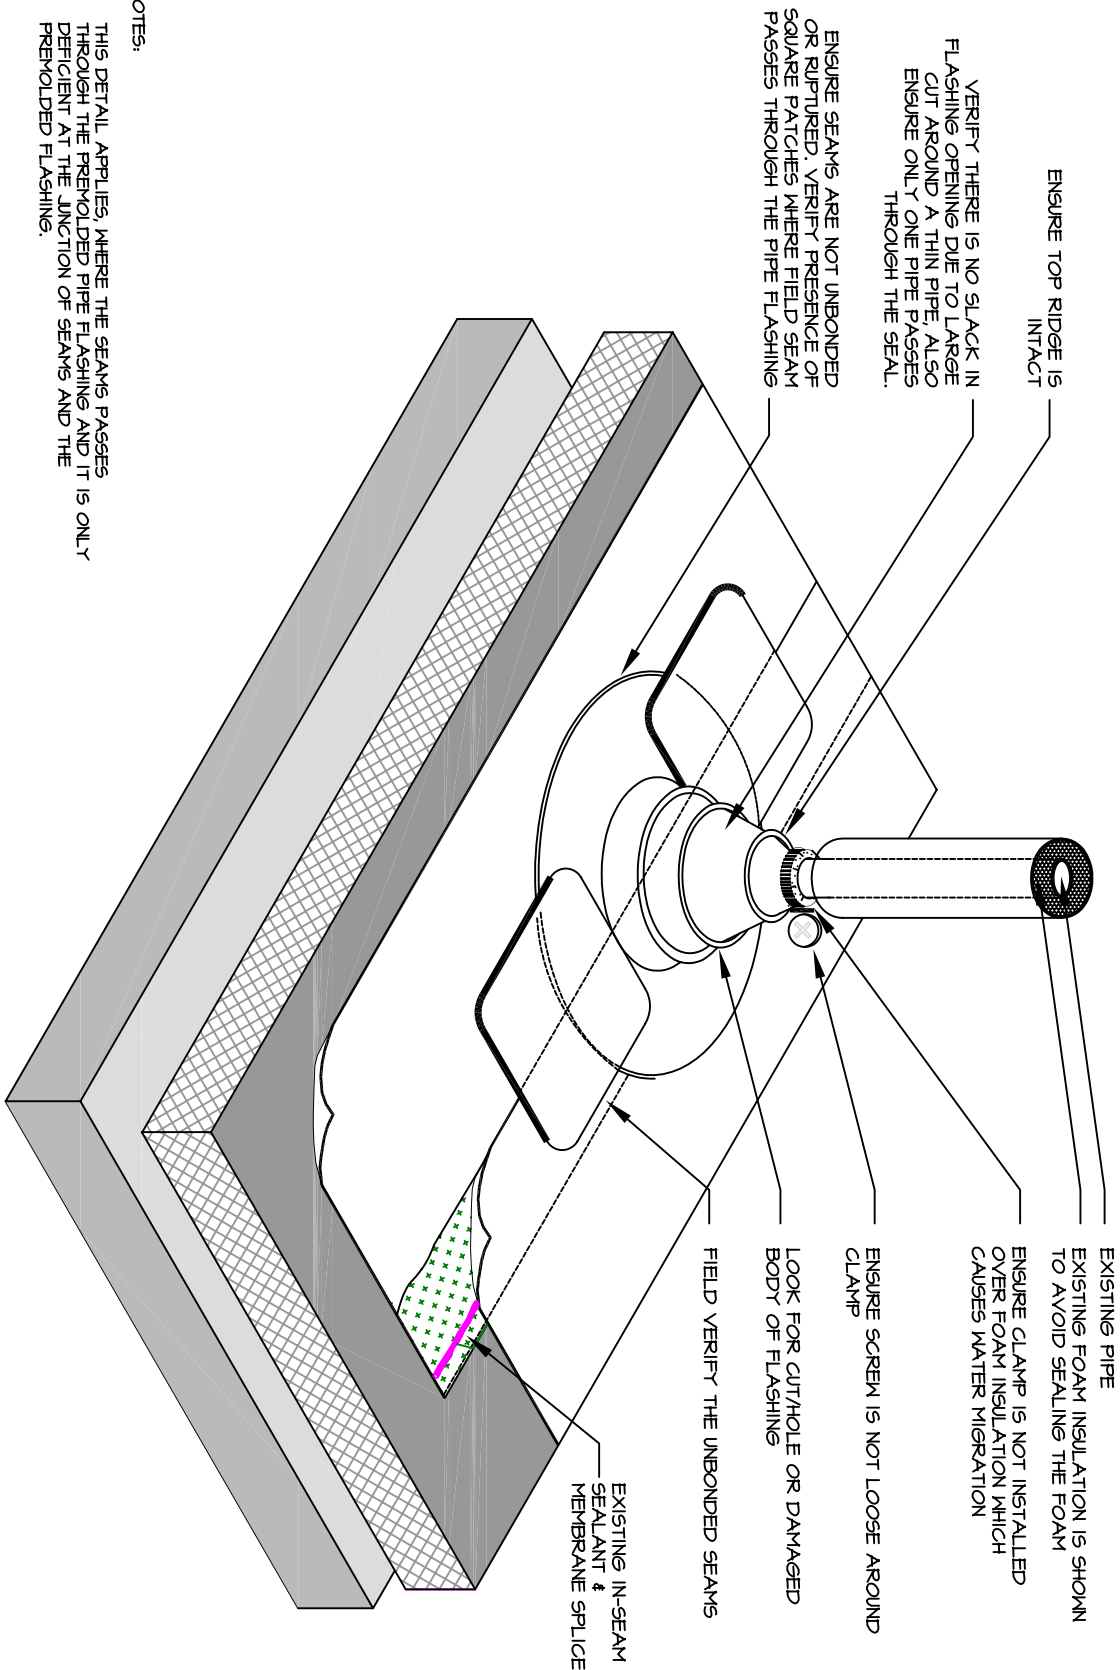
- NOTES:
1. THIS DETAIL APPLIES, WHERE THE SEAMS PASSES THROUGH THE PREMOLDED PIPE FLASHING AND IT IS ONLY DEFICIENT AT THE JUNCTION OF SEAMS AND THE PREMOLDED FLASHING.
