REPAIR:
WRINKLES AT ROOF-TO-WALL JUNCTION

NEW COATING ON EXISTING LOW SLOPE ROOFS

A-8

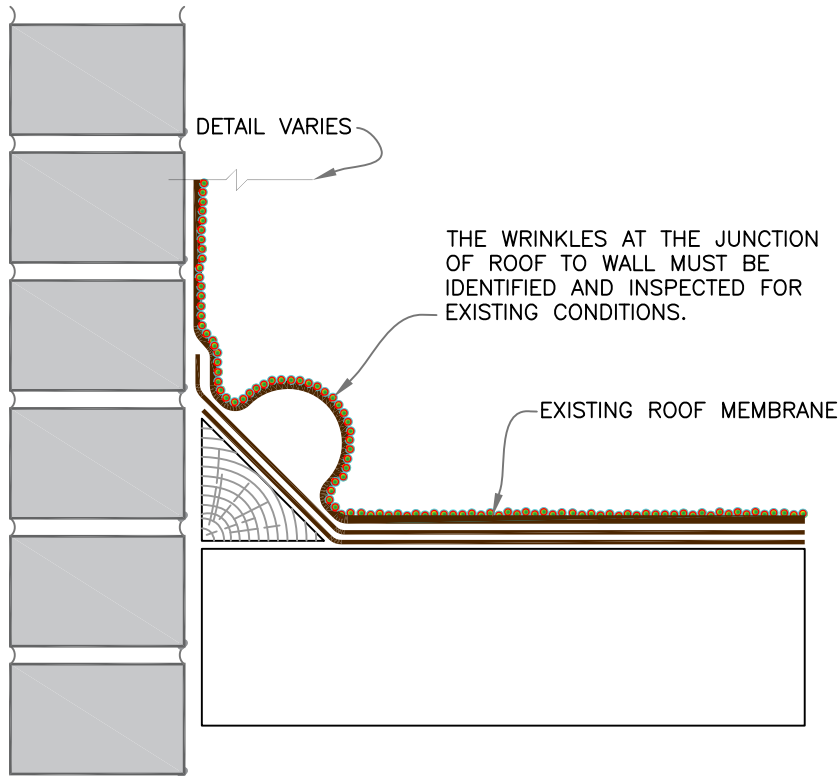
EXISTING WRINKLED BASE FLASHING

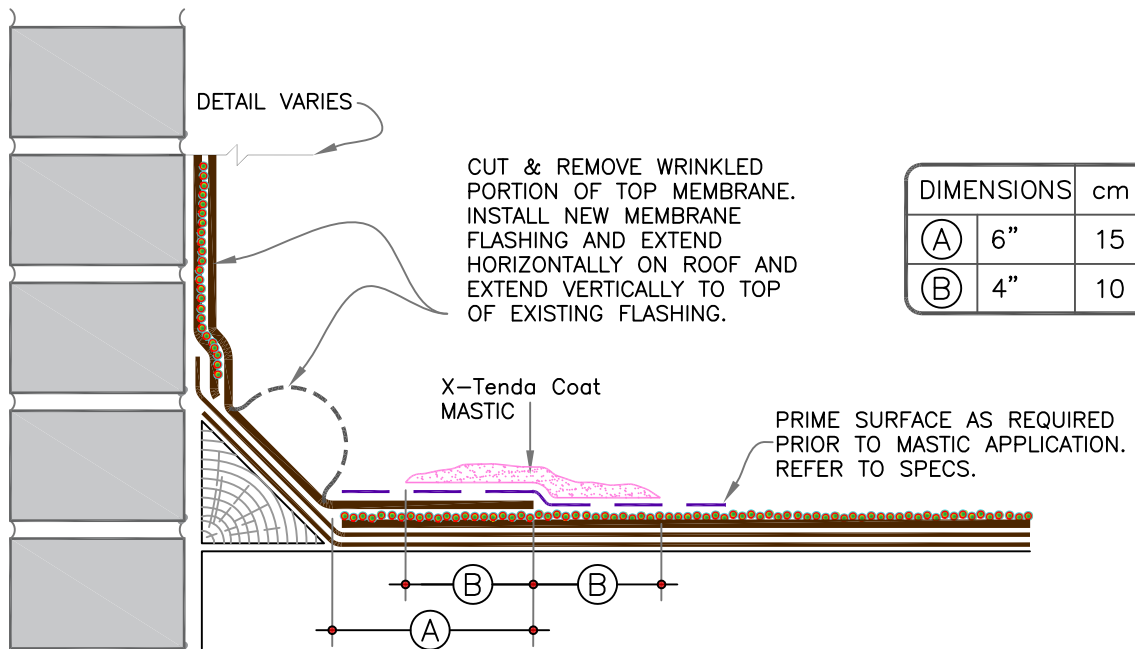
REPAIR & COATING

DIMENSIONS		cm	
(A)	6"	15	
(B)	4"	10	MIN.

- X-Tenda Coat COATING
- X-Tenda Coat PRIMER
- ~ REINFORCEMENT
- 0 NOTE(S)
- 0 X-Tenda Coat MASTIC
