REPAIR:
WRINKLES AT ROOF-TO-WALL JUNCTION

NEW COATING ON EXISTING LOW SLOPE ROOFS

X-Tenda Coat

A-8

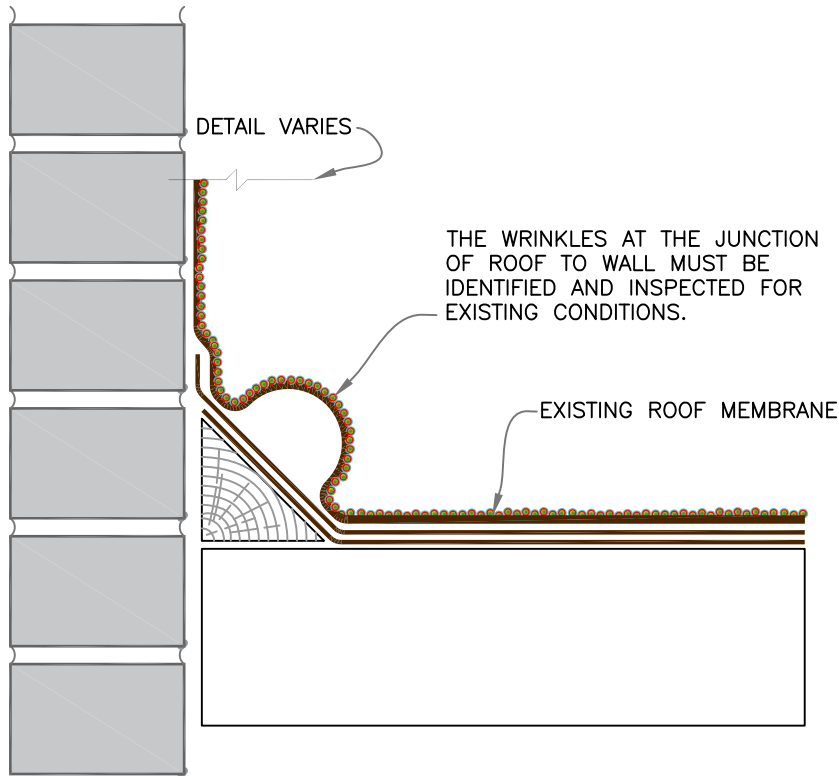
EXISTING WRINKLED BASE FLASHING

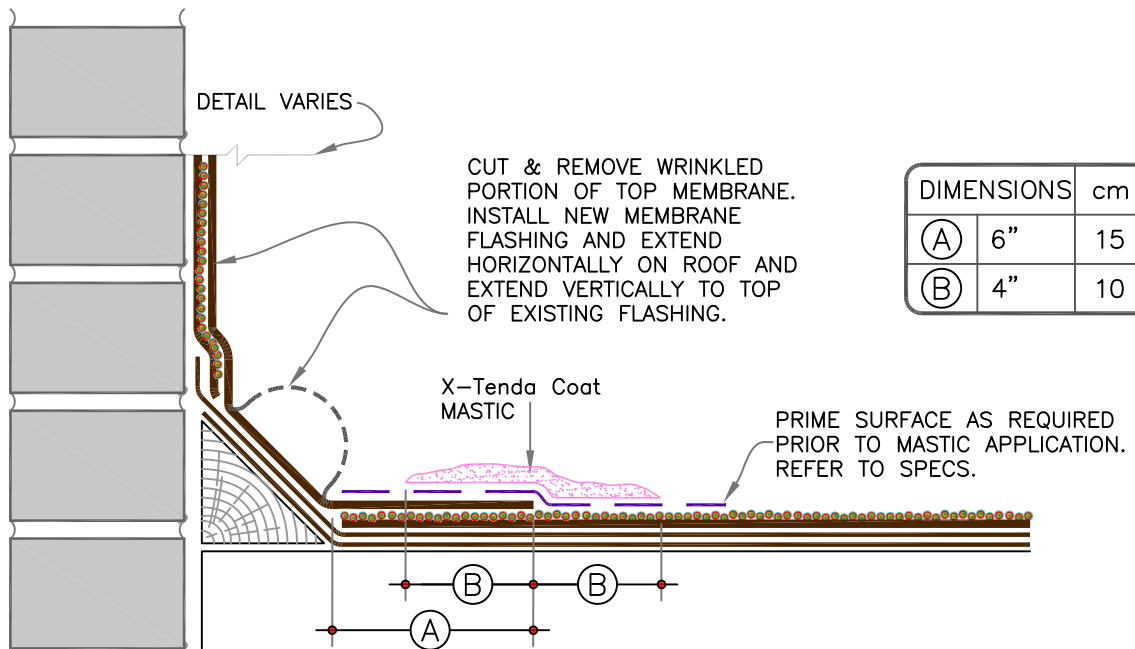
REPAIR & COATING

DIMENSIONS		cm	
(A)	6"	15	
(B)	4"	10	MIN.

- X-Tenda Coat COATING
- X-Tenda Coat PRIMER
- ~ REINFORCEMENT
- 0 NOTE(S)
- 0 X-Tenda Coat MASTIC
