# ROOF RESTORATION WITH ELASTOMERIC COATING

REPAIR:  
SEAM REPAIR AT DEFICIENT BASE FLASHING

NEW COATING ON EXISTING LOW SLOPE ROOFS

A-6

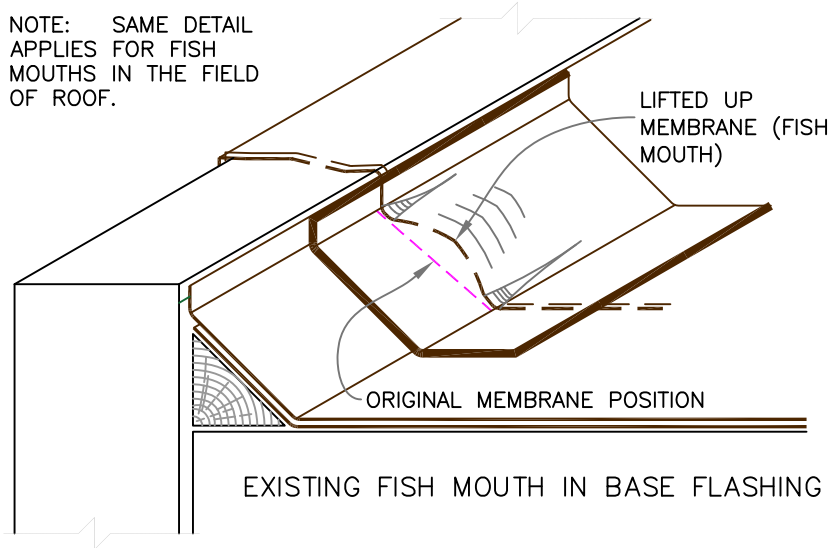
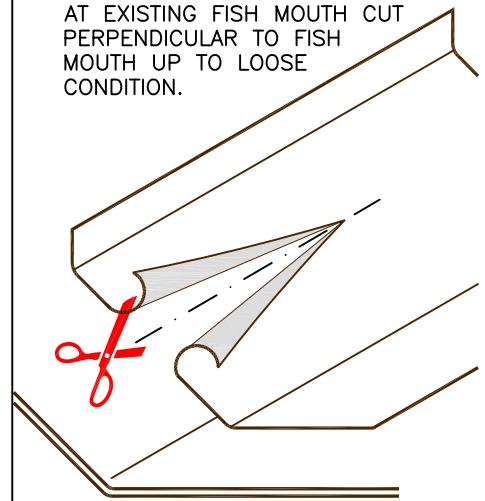
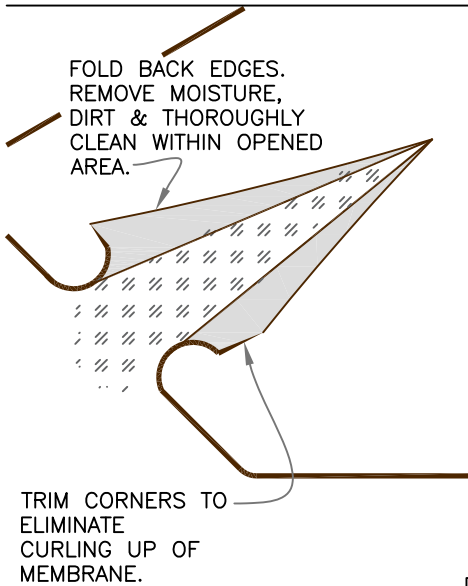
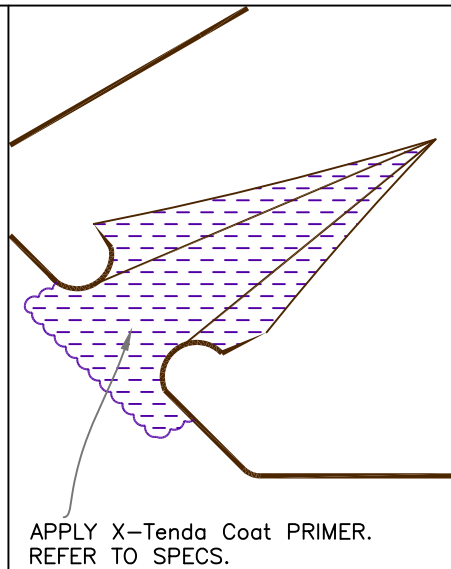
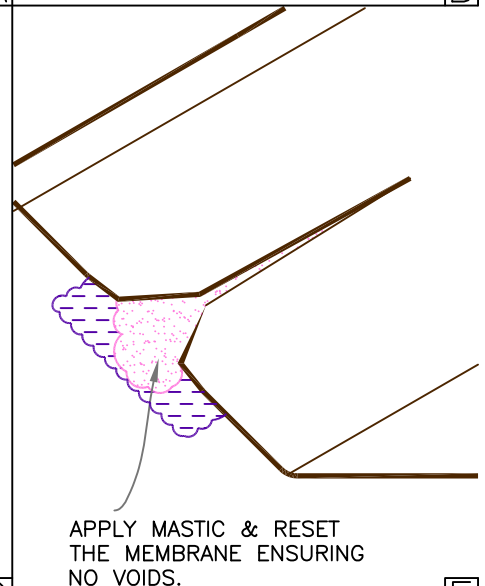
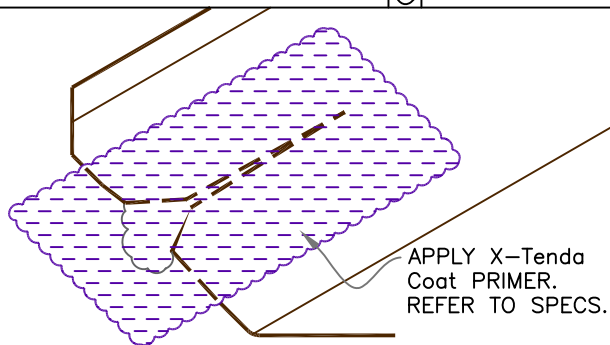
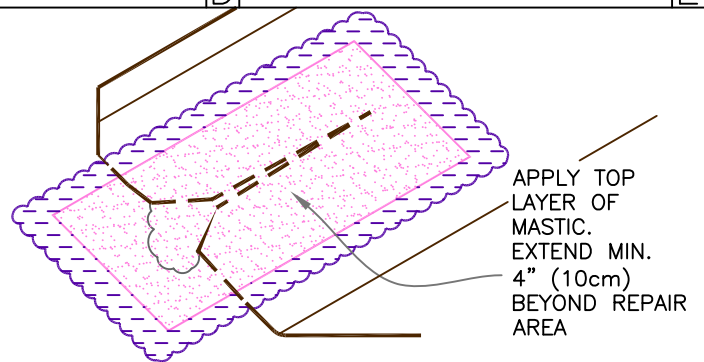
NOTE: SAME DETAIL APPLIES FOR FISH MOUTHS IN THE FIELD OF ROOF.

AT EXISTING FISH MOUTH CUT PERPENDICULAR TO FISH MOUTH UP TO LOOSE CONDITION.

X-Tenda Coat COATING  
X-Tenda Coat PRIMER  
REINFORCEMENT

X-Tenda Coat MASTIC
