**FleeceBACK® RL™ TPO**  
RapidLock Membrane

## CASE STUDY

### A Complex Re-Roofing Project

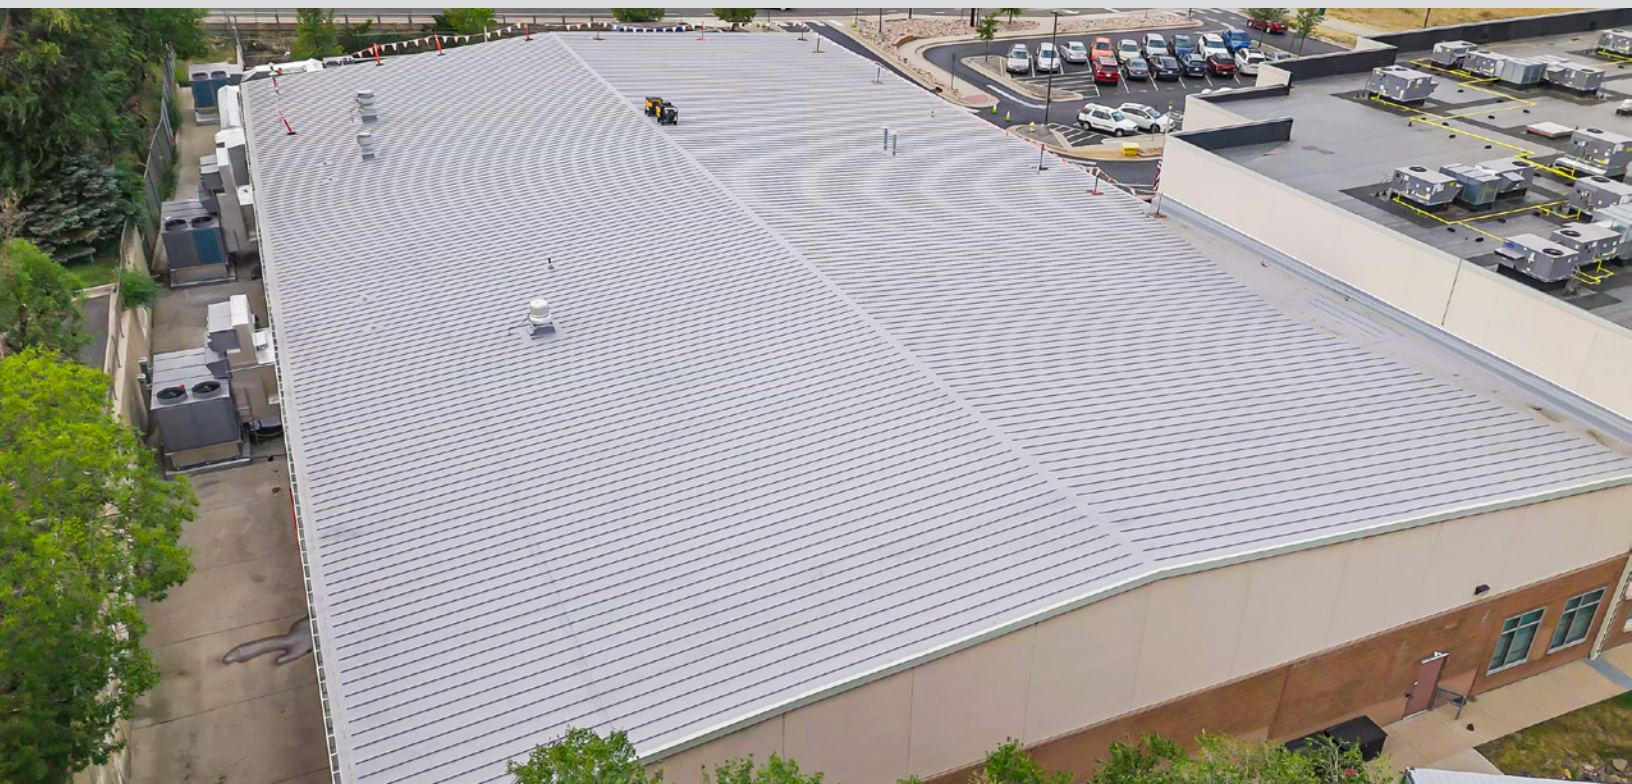
Working with Greg Farris, owner of FRW Consult, it was clear that they had the perfect solution – install a Carlisle RapidLock system over the standing seam roof and then upgrade it with Contour Ribs to mimic the look of a metal roof. Then, for the three flat roof sections, they would remove the existing membrane and install a new 90-mil EPDM membrane.

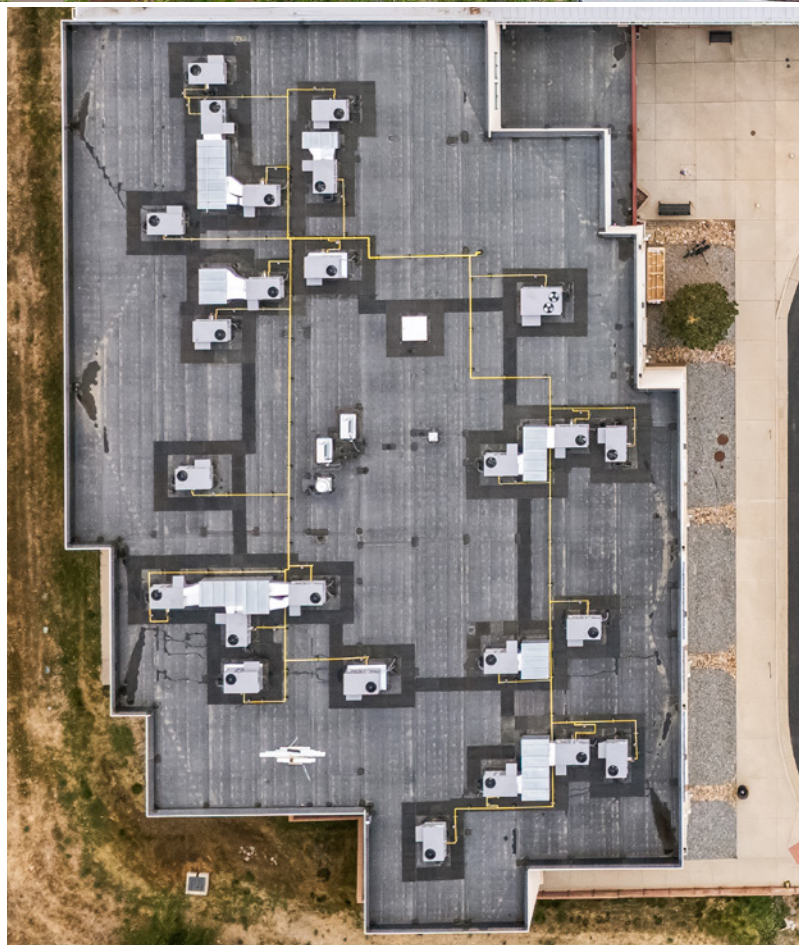
“Our guys really did a nice job installing the ribs. This was our first installation using the Carlisle ribs, and it came out great. The guys took their time to get the layout right, and the **end result speaks for itself.**”

The final step was installing the 10-foot-long Contour Rib profiles. The team first installed the Contour Ribs at the seam locations, starting from the ridge and working down the roof to the eaves. Next, they determined that each rib would be installed about 17 inches on center and snapped chalk lines, taking time to ensure that each was perfectly straight and aligned properly.

“Our guys really did a nice job installing the ribs,” said Smith. “This was our first installation using the Carlisle ribs, and it came out great. The guys took their time to get the layout right, and the end result speaks for itself.”

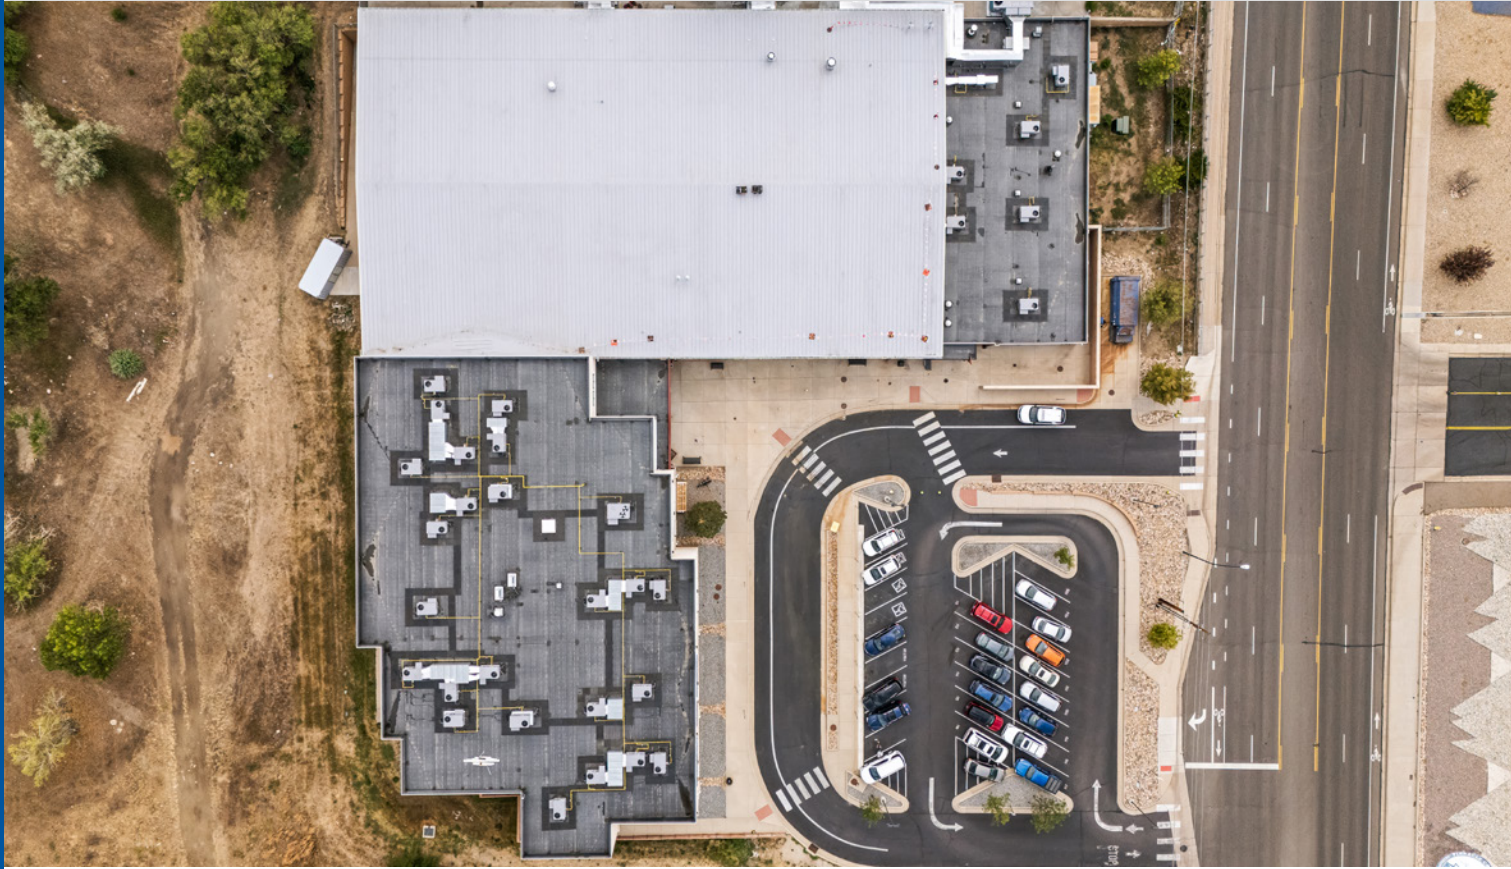
“These sections of the roof had numerous penetrations for large air handlers, vents, and pipes,” said Smith. “Many of the units had been replaced and there were several prefabricated curbs that had to be properly flashed. In addition, each section had parapet walls with several through wall scupper drains, and the largest roof had nearly 300 feet of gas line installed, which required our team to use extreme caution when working around it.”

For these sections of roof, the team first removed and discarded the aged membrane. The existing roof assembly included two layers of polyisocyanurate insulation, which the B&M team left in place, except for compromised, damaged, or wet areas that needed to be removed and replaced.

Once the existing insulation was cleaned of debris and the wet or damaged areas replaced, B&M installed ½-inch SecurShield HD Cover Board for a smooth and uniform substrate. The cover board was secured through the existing insulation and into the steel deck using 24 Carlisle InsulFast fasteners and 3-inch insulation plates in all roof zones.
