**FleeceBACK® RL™**  
RapidLock Membrane

CASE STUDY

**Preserving Senior Comfort: Revitalizing Grace Manor's Roof with Innovative Solutions**

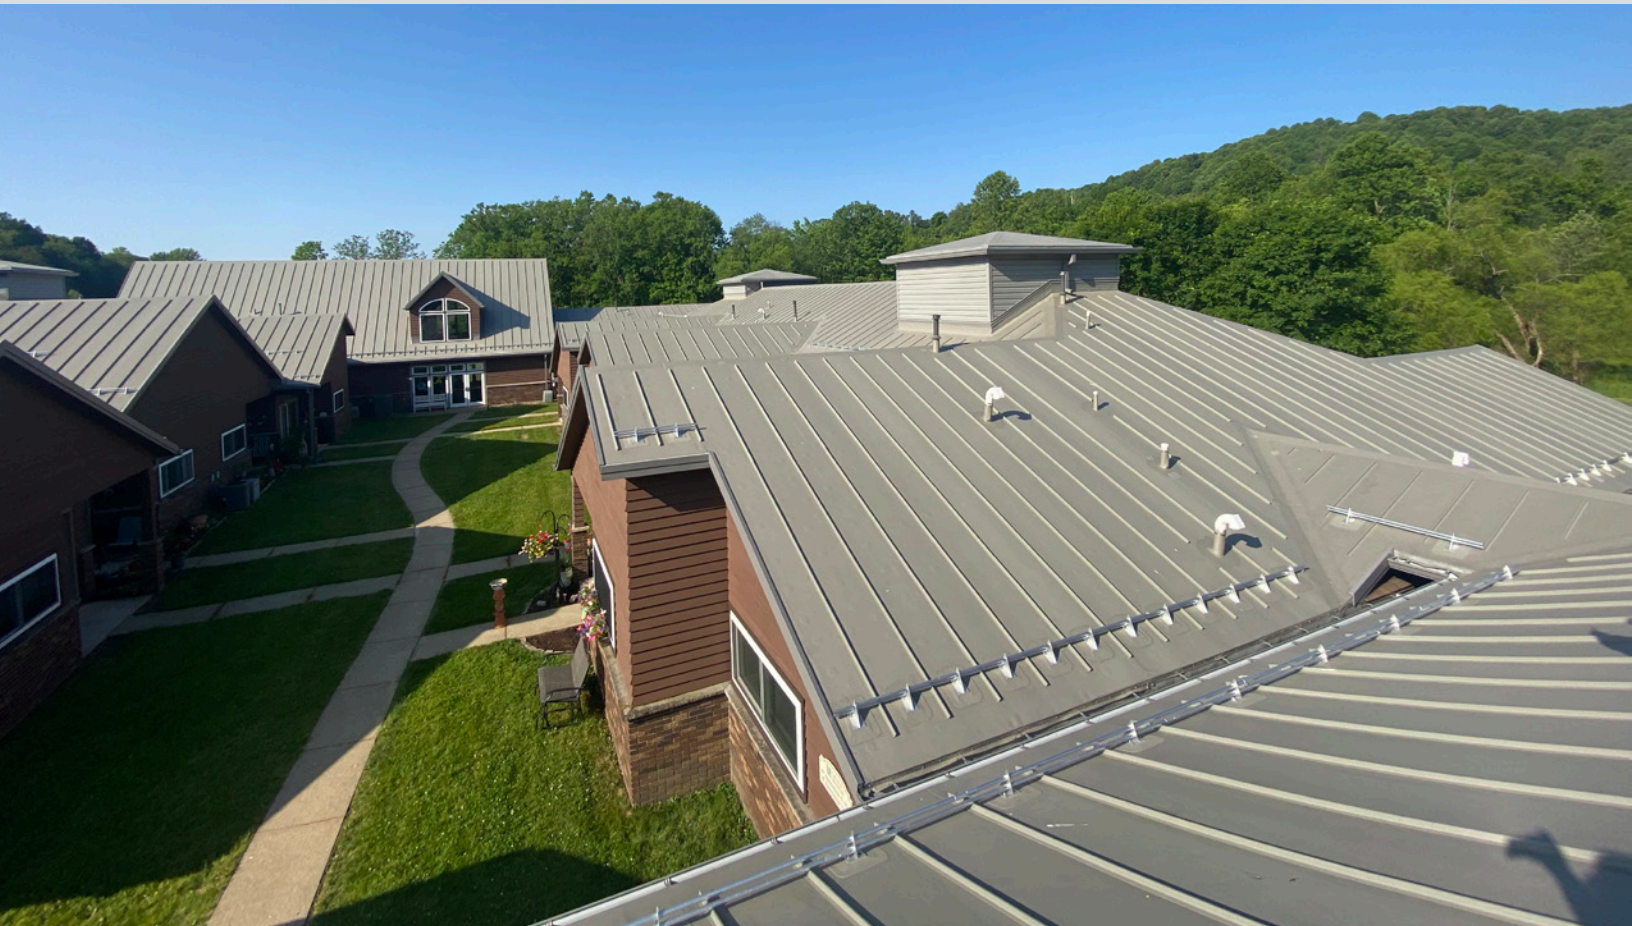
The 55-and-older community, which includes 17 one-and two-bedroom apartments, has a complicated hip roof design with several gabled dormers and valleys, as well as four cupolas around the structure, which surrounds a courtyard area below. In total, the roof was over 29,000 square feet and was covered in both asphalt shingles and metal shingles.

“The roof has many valleys that transition into other valleys,” said Spigelmyer, “and the previous roof had leak and ice dam issues in these areas, essentially beginning the day it was first installed. Our job was to find a workable solution that would preserve the residential appearance of the building, while providing effective protection against water and the elements.”

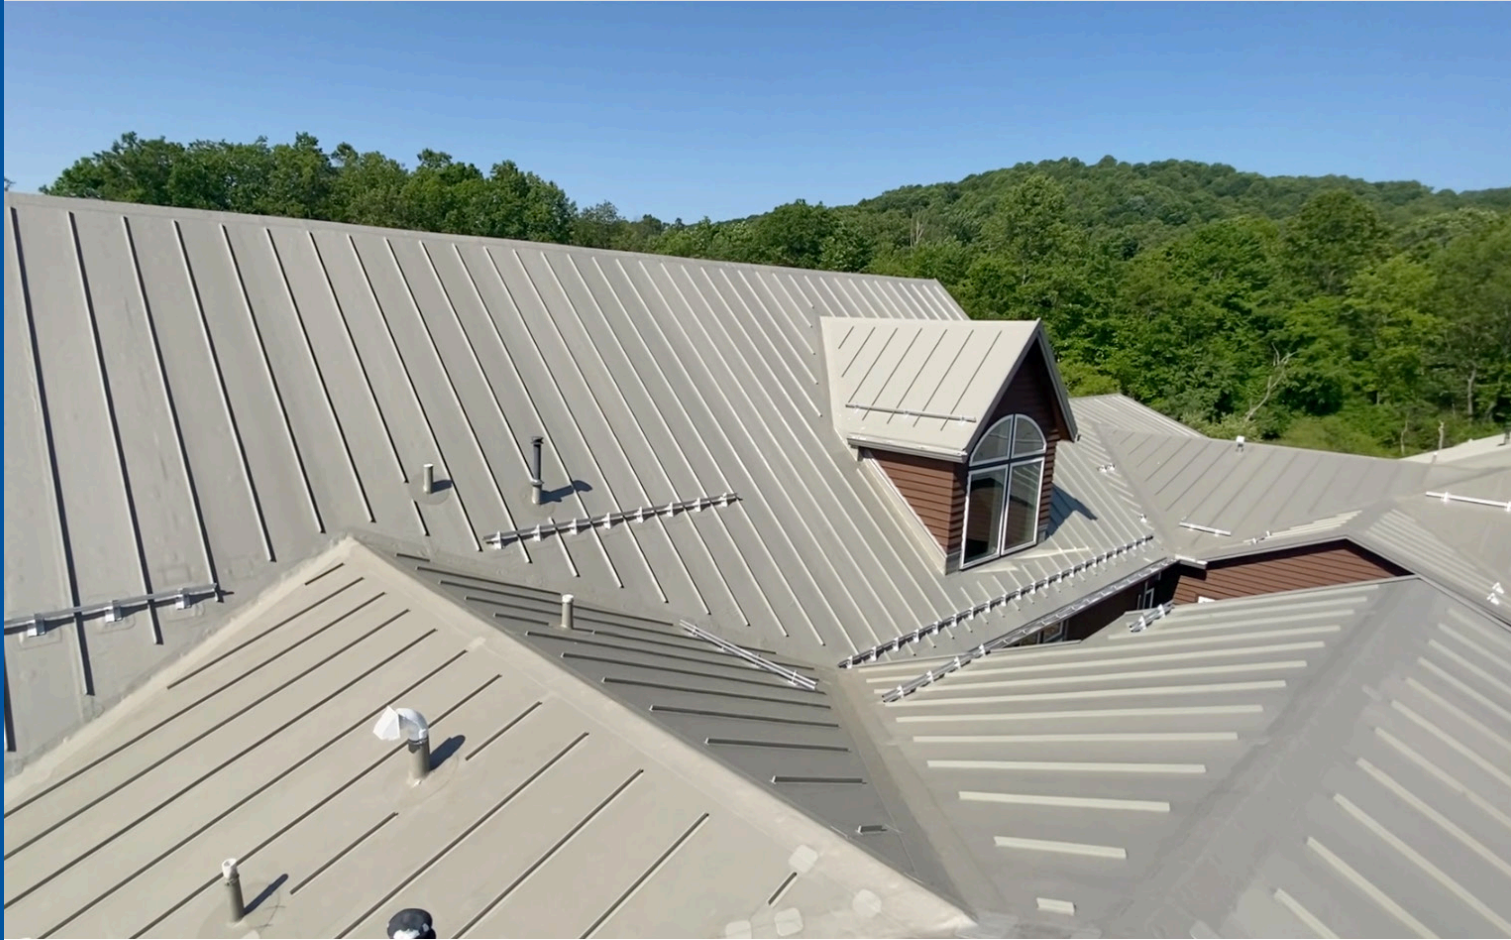
Once the membrane was installed, including separate PVC flashing in the valleys, at the peak, and in transition areas, it was time to install the Contour Ribs. First the team measured for the desired 20-inch rib spacing and snapped lines parallel with the laps to indicate where each rib would be installed. The spacing enabled TRS to install ribs at each seam, effectively hiding them from visibility.

“We welded the Contour Ribs to the roof using a VARIMAT Welder that had a special adaptor,” said Spigelmyer, that would

accommodate each of the 10-foot-long, 1 ¼-inch-tall by 2 ⅝-inch-wide Contour Ribs.
