ROOF RESTORATION WITH ELASTOMERIC COATING

REPAIR:
SEAM REPAIR AT DEFICIENT BASE FLASHING

NEW COATING ON EXISTING LOW SLOPE ROOFS

A-6

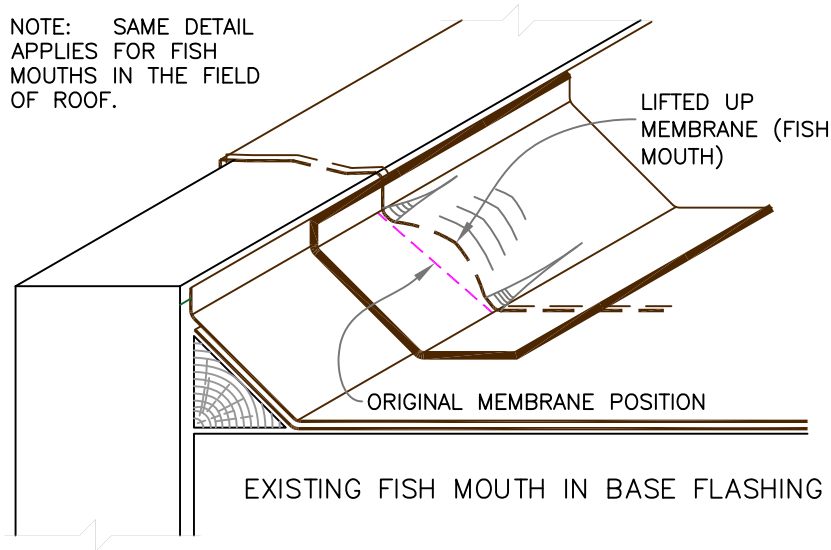
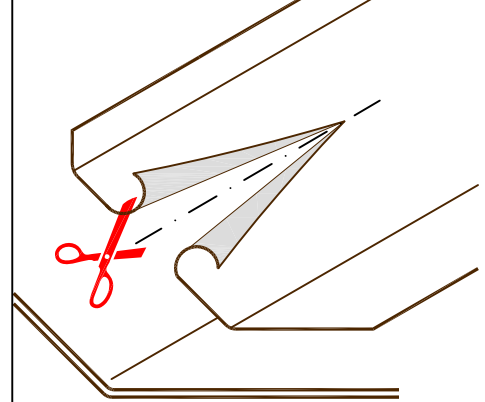
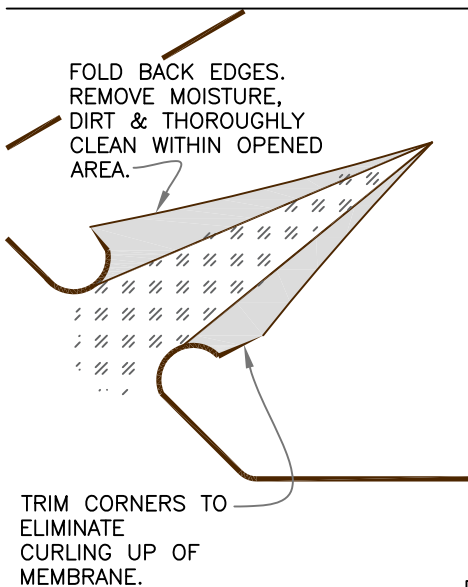
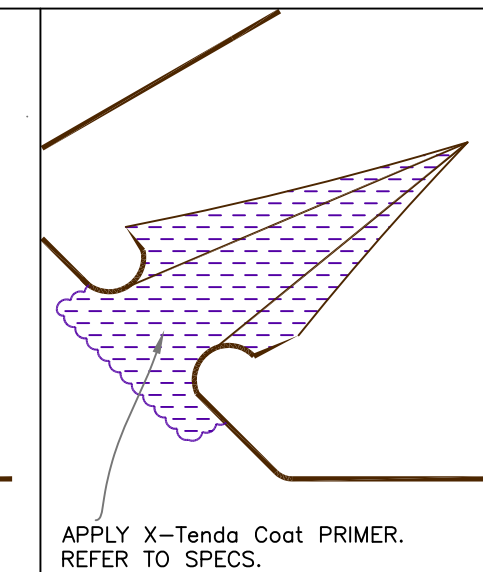
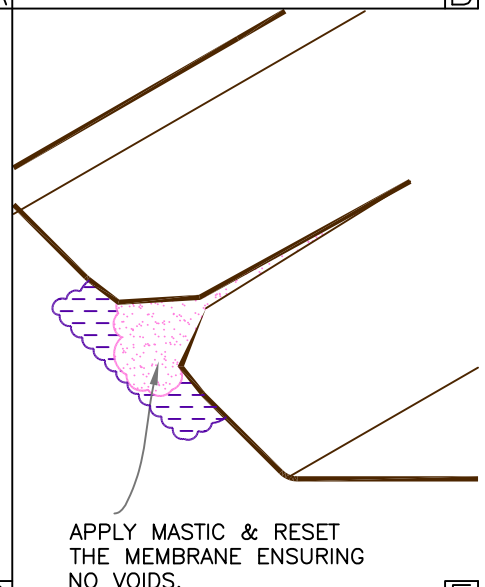
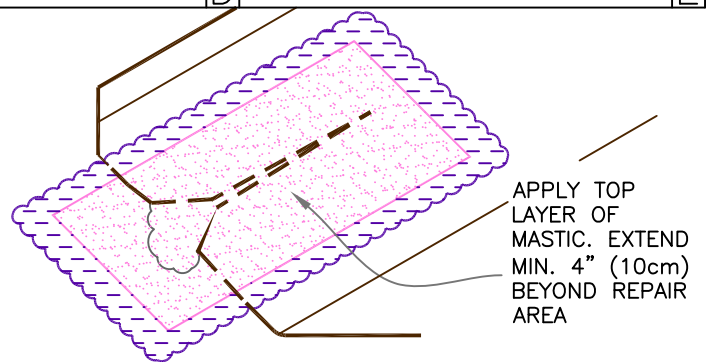
NOTE: SAME DETAIL APPLIES FOR FISH MOUTHS IN THE FIELD OF ROOF.

AT EXISTING FISH MOUTH CUT PERPENDICULAR TO FISH MOUTH UP TO LOOSE CONDITION.
