GUTTER WITH METAL BAR EDGE TERMINATION

MRI T1.4

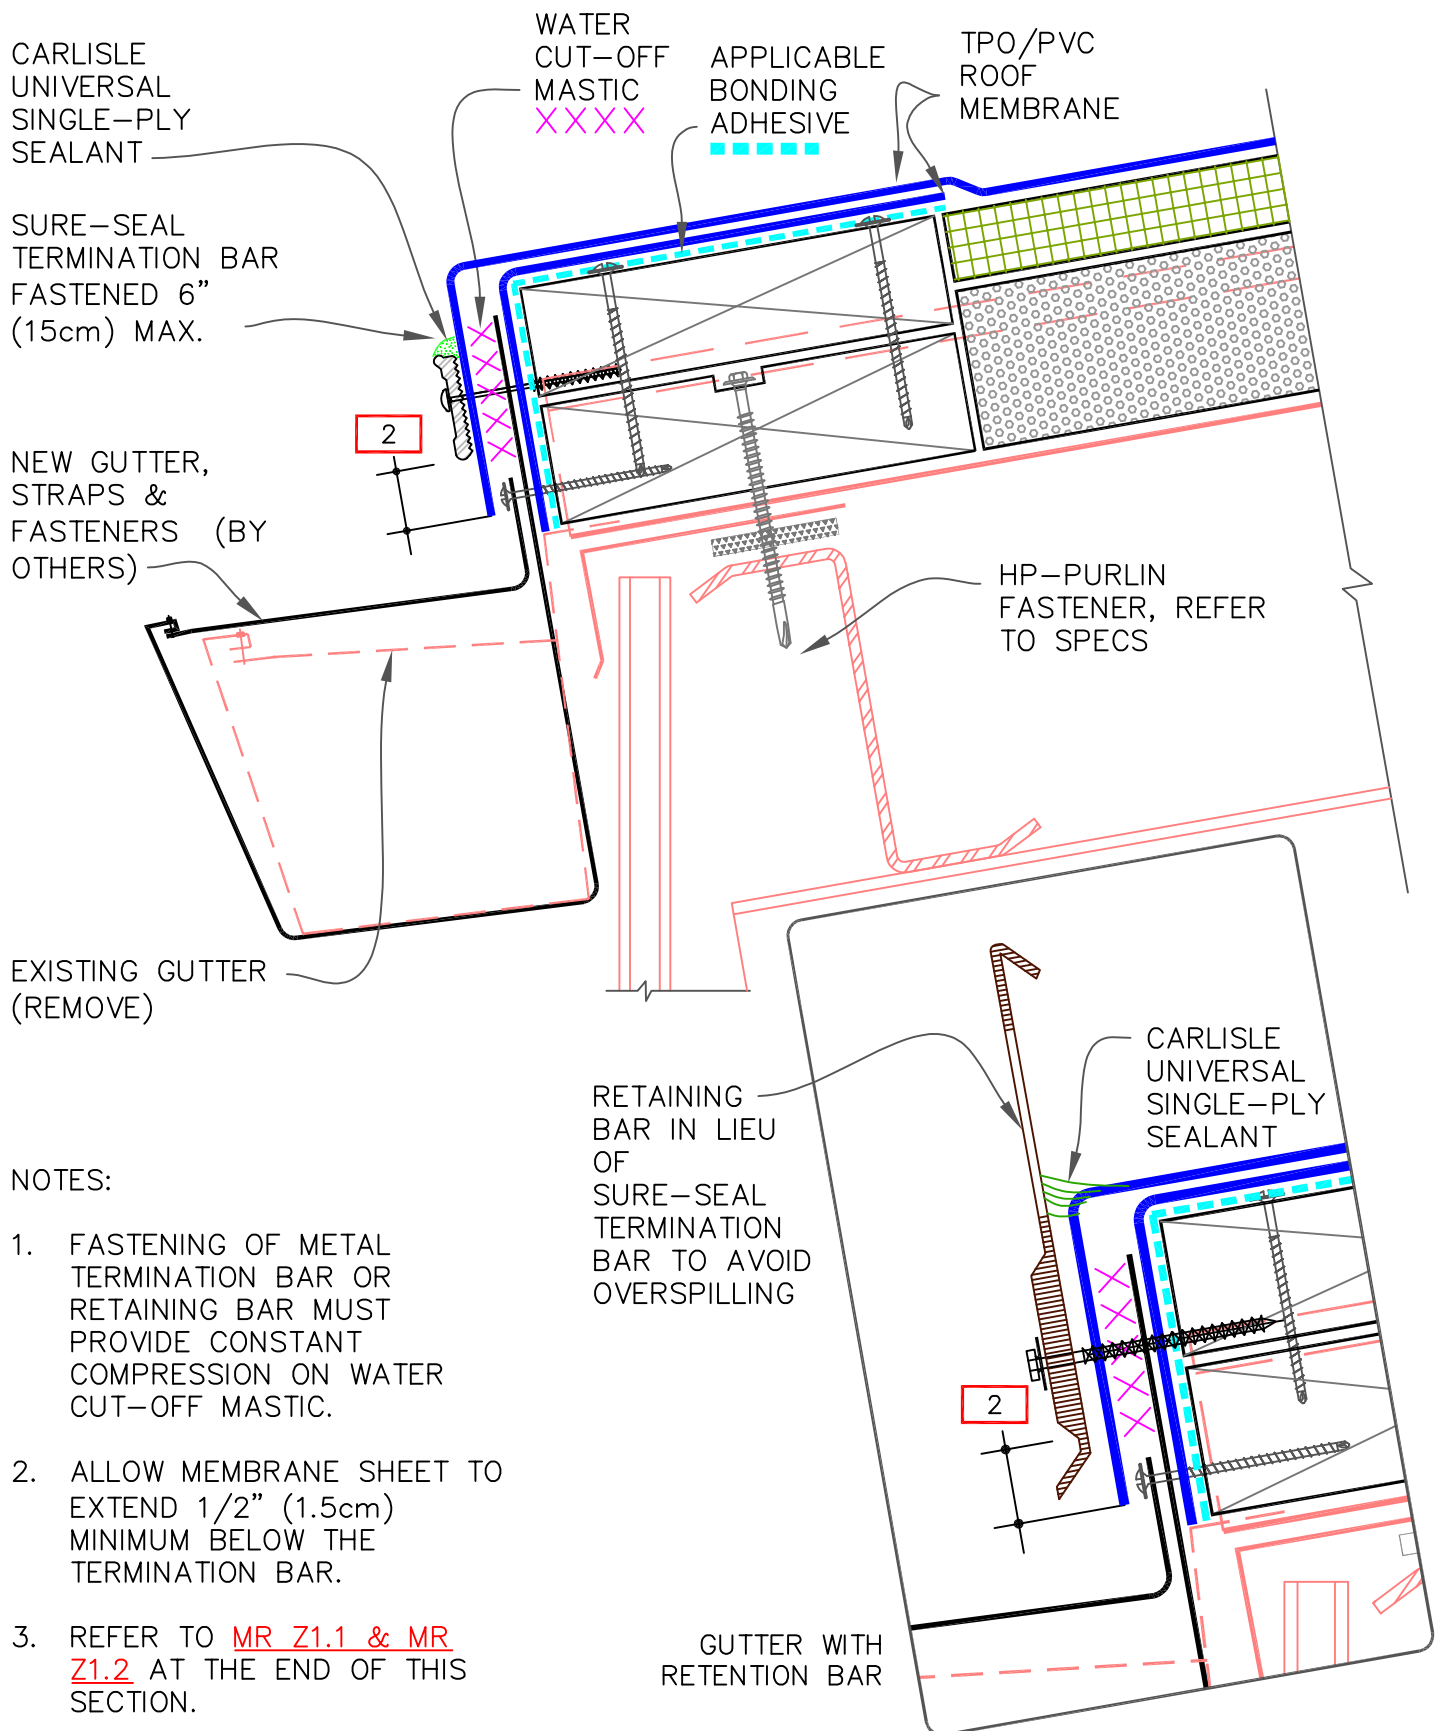
• HIGH DENSITY RECOVER BOARD		• ROOF MEMBRANE
	• IN-FILL INSULATION		• WOOD NAILER (BY OTHERS)
			• SEE DRAWING NOTE(S)
