# Mission Point Resort

## JOB PROFILE

**Name:** Mission Point Resort Re-Roofing Project

**Contractor:** Doyle Inc. Roofing

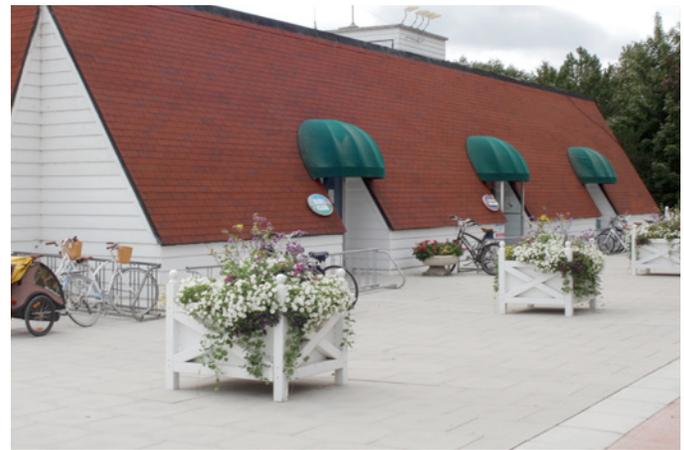
"It's amazing to see what it looks like now, compared to before we started the project,"  
Joel Ross, Doyle Inc. Roofing.

"The weather played a very big role [in the installation process]. We were faced with ice, snow, freezing rain, high winds, below zero temperatures," explained Joel Ross. The main roofing section, which amounted to 23,479 square feet, was installed. Doyle Roofing began with VersiWeld 80-mil TPO loose-laid over two layers of extruded

polystyrene (XPS) insulation boards. Versico's HP Protective Mat was then installed over the 80-mil TPO. HP Protective Mat is a nominal 6-ounce, UV-resistant fabric that is used above the membrane as a slip-sheet for pavers and provides added protection against membrane punctures. Once the HP Protective Mat was in place, approximately 7,100 concrete Sunnybrook Pedestal Pavers were installed. Concrete pavers are an attractive and functional choice for plaza decks and can provide long-term strength and weatherability.
